# GLWA Board of Directors Meeting

October 27, 2021

June 25/26 and July 16, 2021  
Post Event Analysis

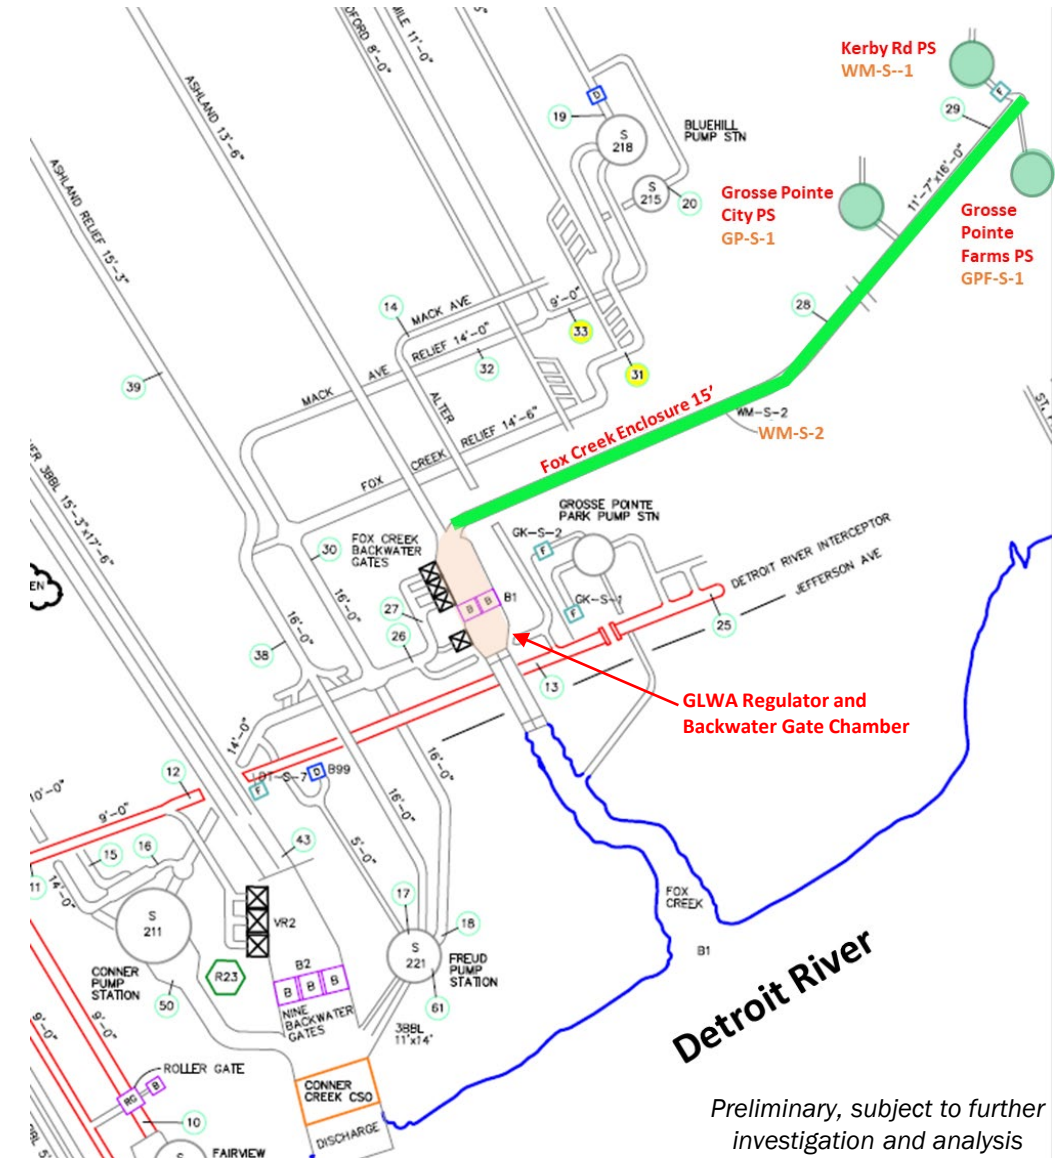
## Fox Creek Enclosure

- Not owned and operated by GLWA
- Location and Size
  - Extends from Kerby Road and Chalfonte Ave. on the northeast to Ashland Street near Jefferson Ave. on the west
  - Approximately 3.25 miles in length
  - Shallow sewer (4-5' below grade in some locations)
  - Conveyance capacity of about 5-year storm
- Member Partners Served
  - Southeast Macomb Sanitary District
  - Grosse Pointe Farms
  - Grosse Pointe City
