Great Lakes Water Authority

LINEAR SYSTEM
INTEGRITY PROGRAM

2025 ANNUAL REPORT

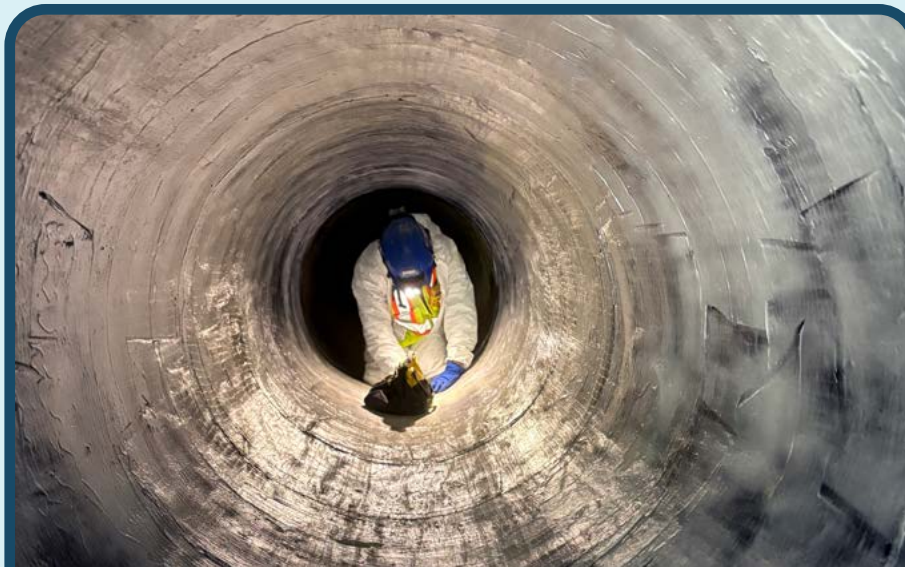
24-Mile Road Transmission Main Renewals

Following the 24-mile transmission main inspections completed in 2024, 121 pipes were repaired using carbon fiber reinforced polymer (CFRP) and 2 pipes were replaced.

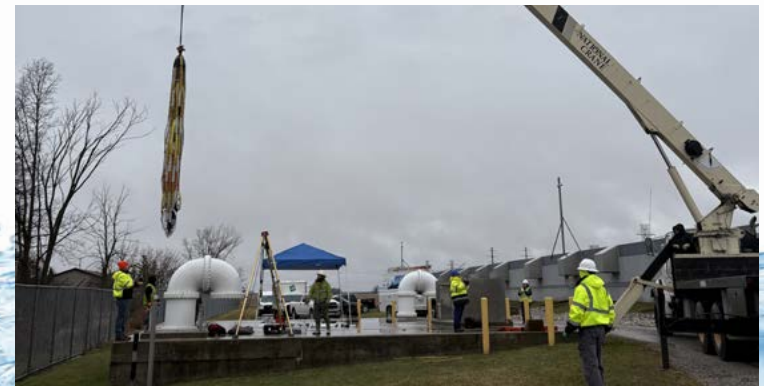
Inspection Tool Removal at Imlay City Booster Pump Station

In 2025, the 120-inch Metcalf, Fort Gratiot Transmission Main underwent a free swimming electromagnetic inspection. This high resolution inspection has provided valuable information which will be used to inform decisions to help improve the reliability of the pipeline, minimize breaks, and improve overall system resiliency.

The 120-inch Metcalf, Fort Gratiot Transmission Main delivers water from the Lake Huron Water Treatment Plant westward more than 26 miles to the Imlay City Booster Pumping Station. Electromagnetic inspection was performed using a free-swimming tool in April 2025. This inspection collected high-resolution data while the 120-inch transmission main remained in service, thereby allowing GLWA to maintain high levels of service to Member Partners during the inspection.

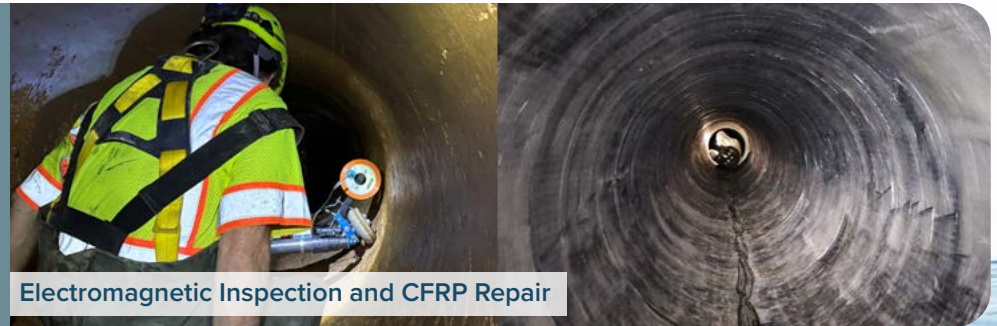
Electromagnetic Inspection and CFRP Repair

Following a 42-inch water main break on 14-Mile Road and Kingswood Boulevard, 3.8 miles of opportunistic electromagnetic and visual and sounding inspection was performed. Additionally, planning for the installation of Acoustic Fiber Optic (AFO) began for pro-active monitoring of the pipeline. In addition to the replaced pipe at the failure site, multiple pipe segments were renewed using CFRP.

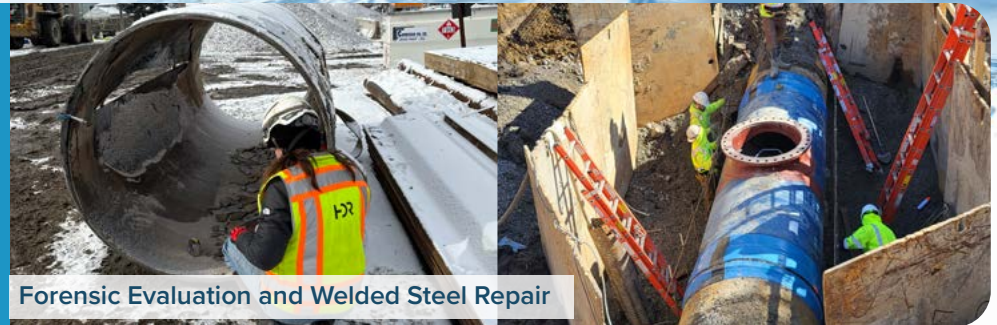
Forensic Evaluation and Welded Steel Repair

An in-situ investigation and metallurgical analysis was performed to infer the potential cause(s) of the failure on the 54-inch steel transmission main in February. This emergency response has emphasized a need for inspection of steel pipes, and has helped to evolve the trajectory and goals of the LSIP. The failed steel main section was removed, and a new steel pipe was welded in place to restore integrity to the line.

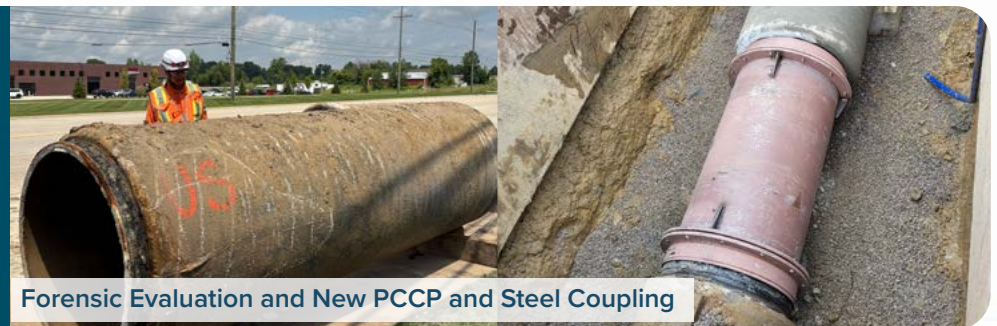
Forensic Evaluation and New PCCP and Steel Coupling

Following a reported leak on a 36-inch PCCP segment at Gratiot Ave and Hickey Road, a forensic evaluation and opportunistic visual and sounding inspection was performed on the pipes surrounding the failed pipe. The failed pipe section was removed and a new PCCP segment and a steel coupling was welded in place to restore the watermain.
