GLWA
Great Lakes Water Authority

Incident Report for 120-inch Water Transmission Main Break of August 13, 2022

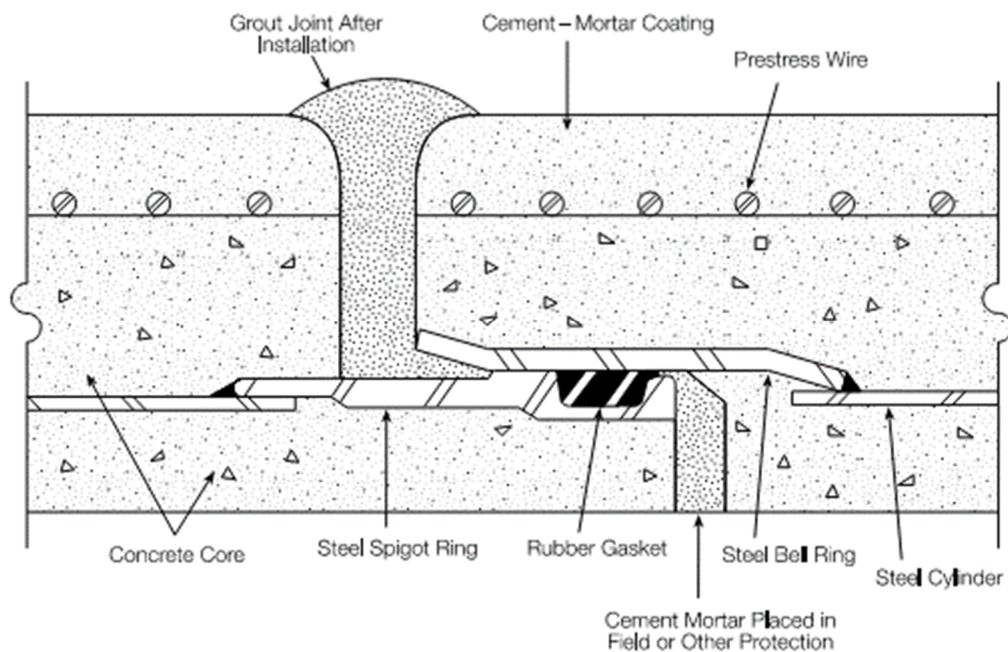
Figure 1 – Cross section of PCCP main at joint

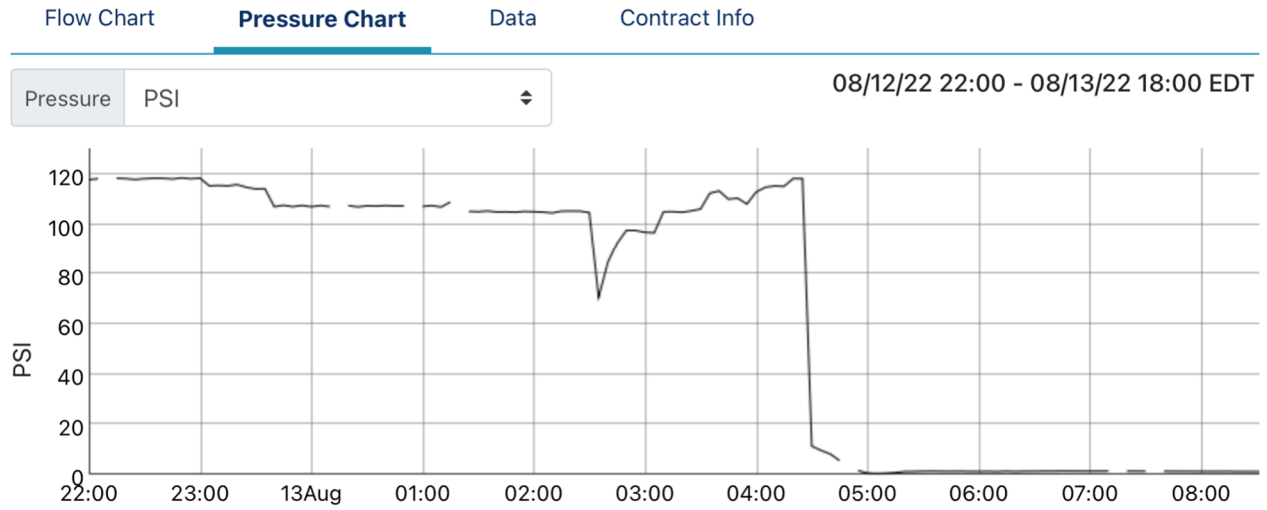
Figure 3 – Pressure at Greenwood Township Meter SN-01, August 12-14, 2022

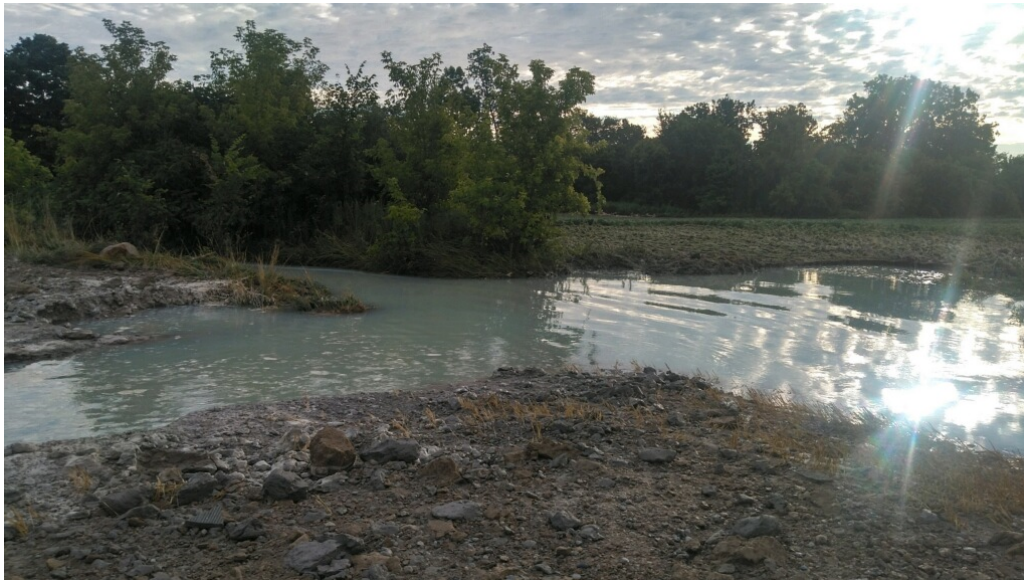
Figure 4 – Water main break on 120-inch Transmission Main, approximately 1/2 mile west of LHWTP

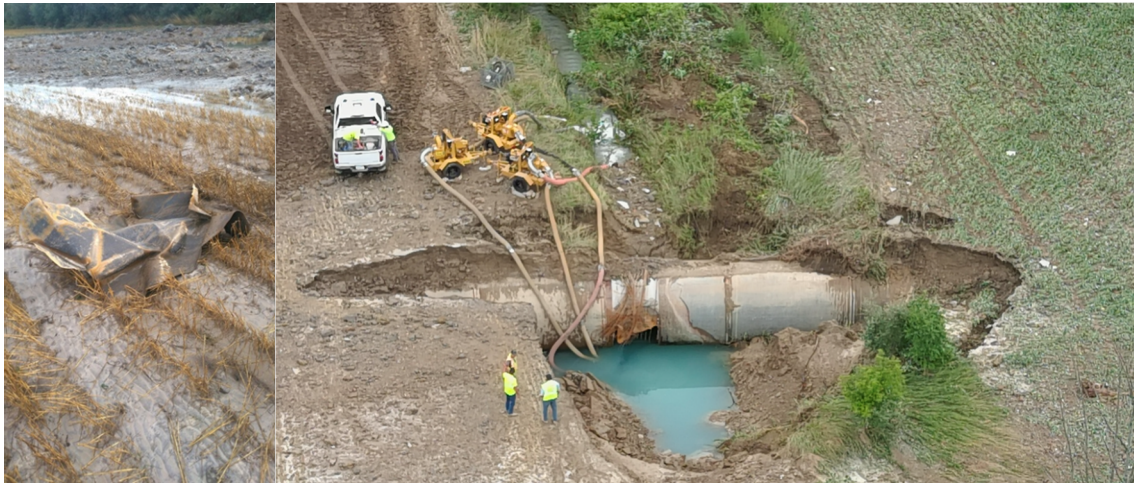
Figure 5 – Portion of the inner cylinder located approximately 100 feet from the break and aerial view of break

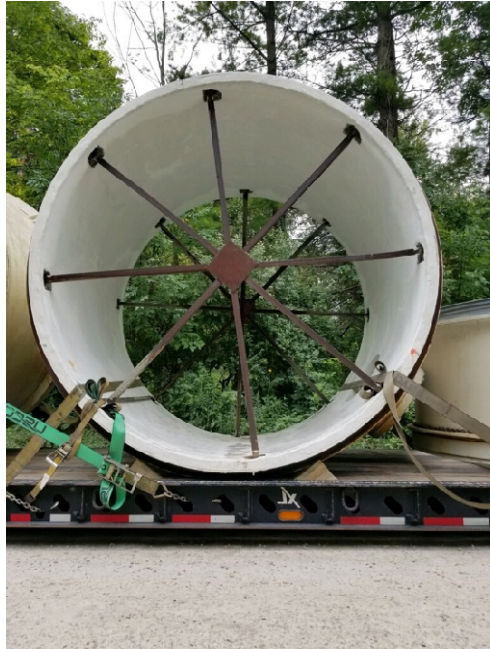
Figure 7 - Portion of repair pipe from Texas

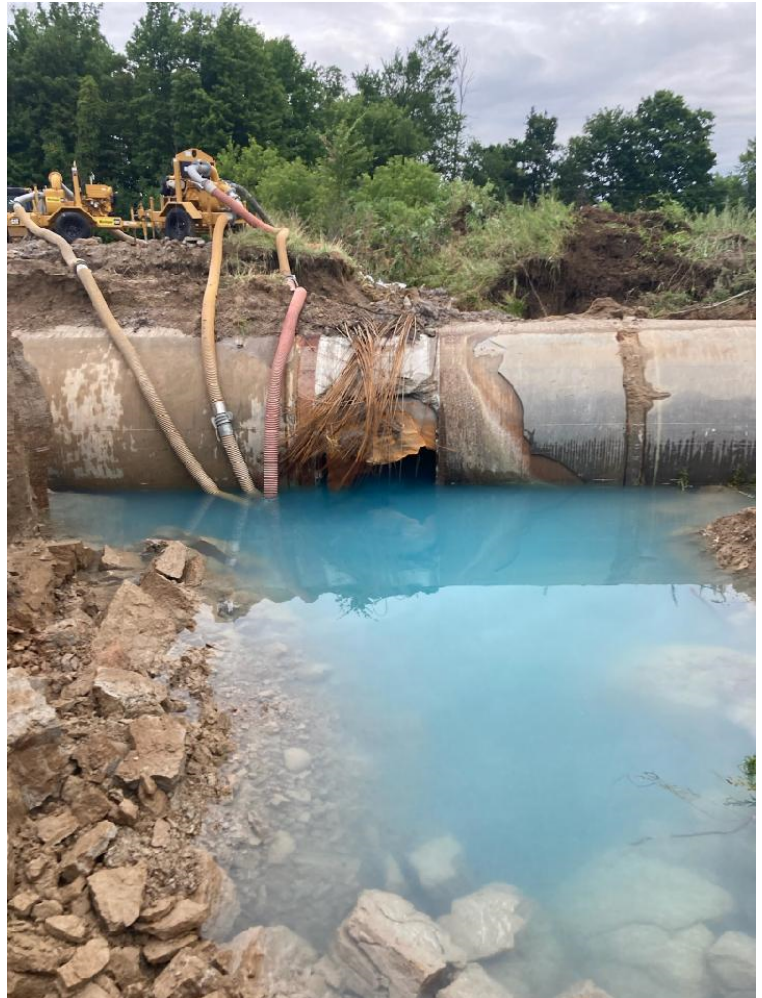
Figure 8 - Pumping water at break site

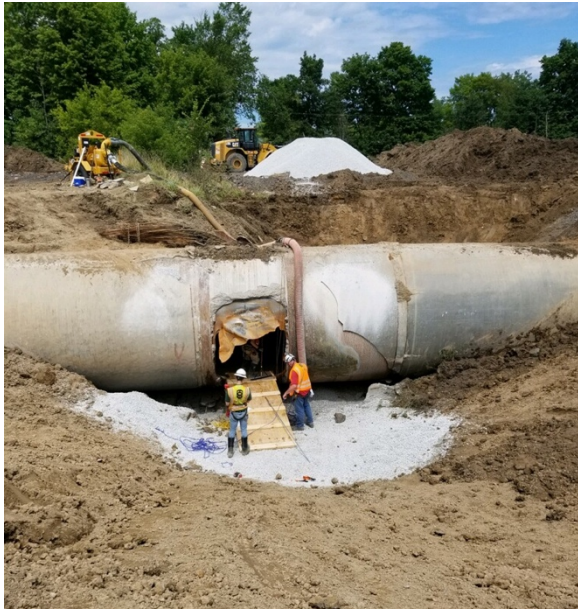
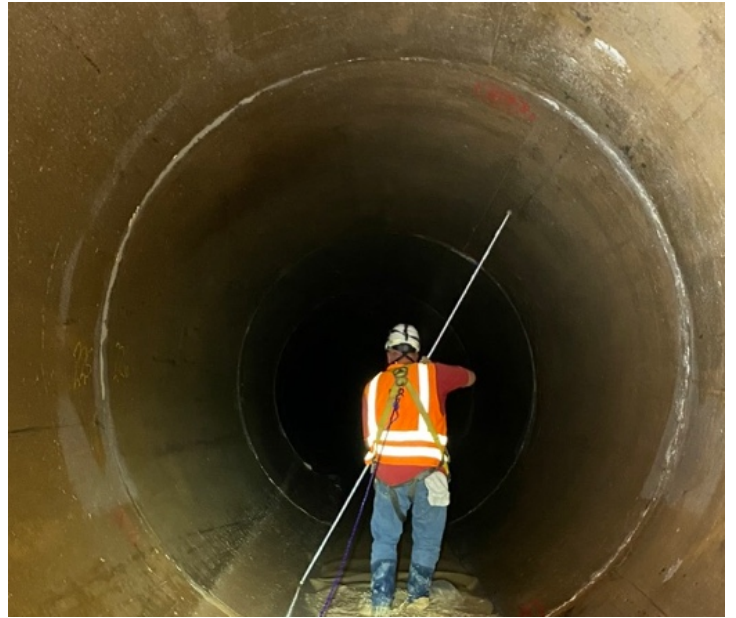
The 120-inch main was dewatered for inspection by GLWA consultant HDR, to determine if there was any evidence of distressed piping through visual and electromagnetic investigations. Investigations were completed without impact to the repair schedule. PICA inspected 0.5 miles east of the break and 1.0 miles west of the break and the report is included as Appendix C. Pure Technologies inspected 0.62 miles to the east of the break (Appendix D) and 3.77 miles to the west of the break (Appendix E).

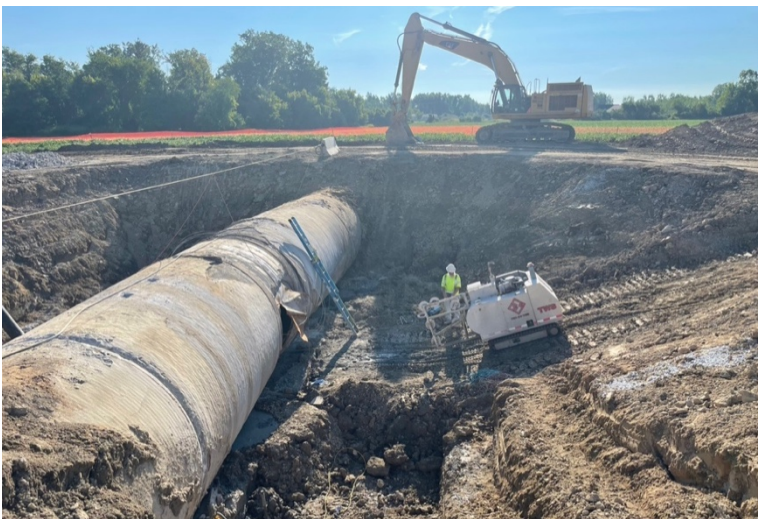
Figure 9 - Wire cutting and lifting section of main

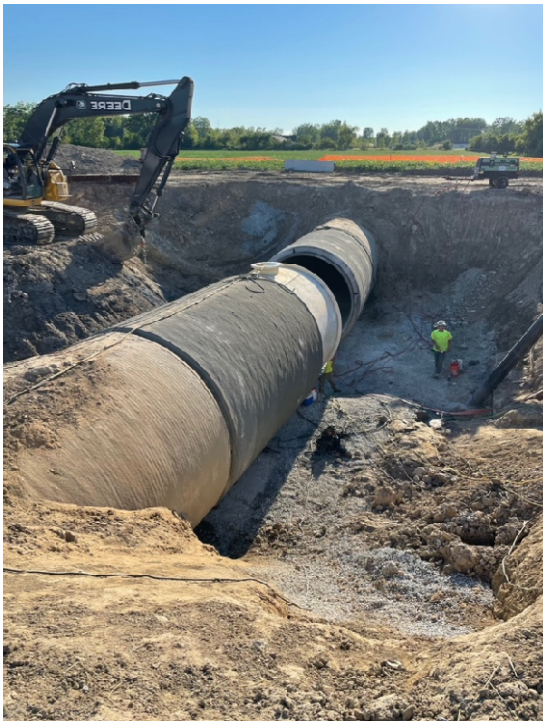
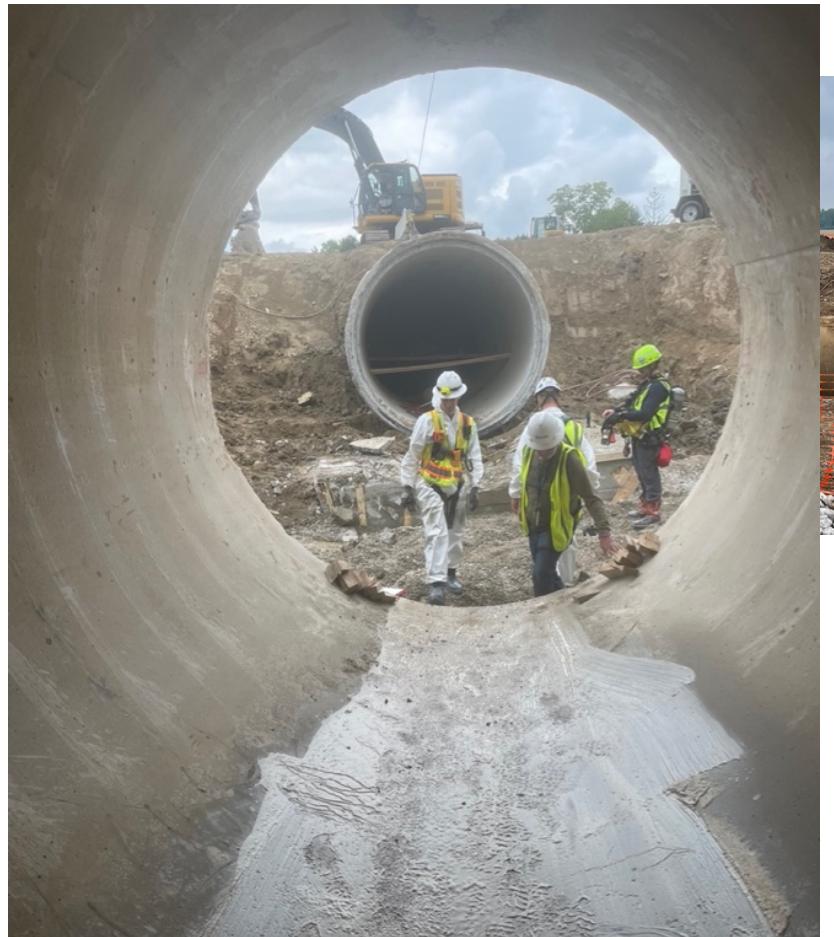
Figure 10 - Preparing for manned inspection of pipe

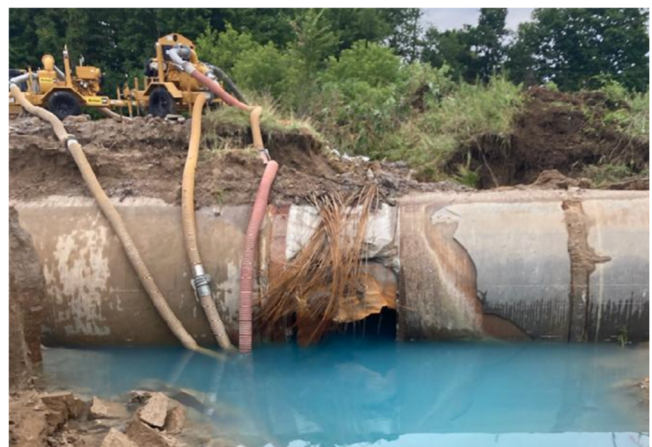
Figure 11 – Area of Pipe Failure

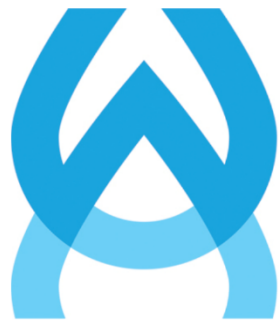
- 1) GLWA is re-evaluating the proposed decommissioning of the Northeast WTP. This facility was key in providing water north through the 96-inch transmission main from NSC;
- 2) GLWA is considering unmanned interior in-service assessment of the 120-inch main using the Pure Technologies “Pipe Diver” electromagnetic frequency technology;
- 3) GLWA is considering lowering the operating pressure of the 120-inch transmission main to prolong the life of the asset;
- 4) GLWA, GCDC, and City of Flint are reviewing the data collected during this event to determine improvements to the emergency operations procedures.

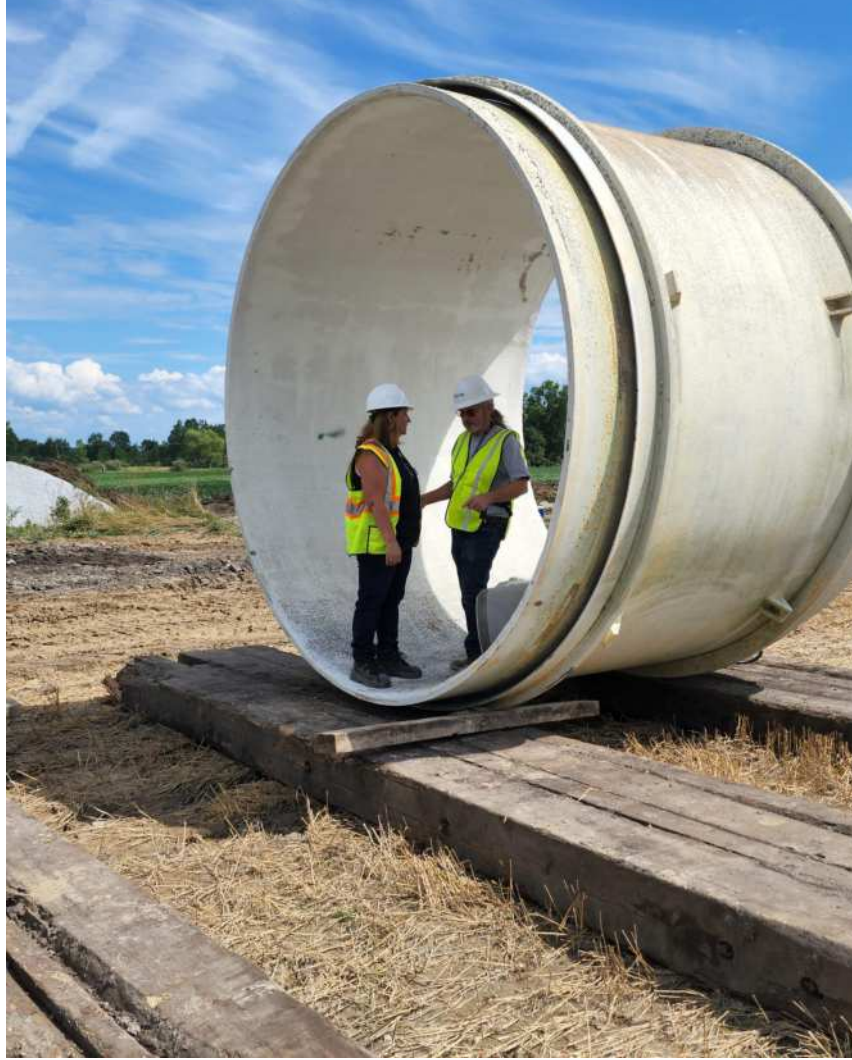
GLWA is currently investigating the cause of the break. GLWA will continue to provide updates as they become available.

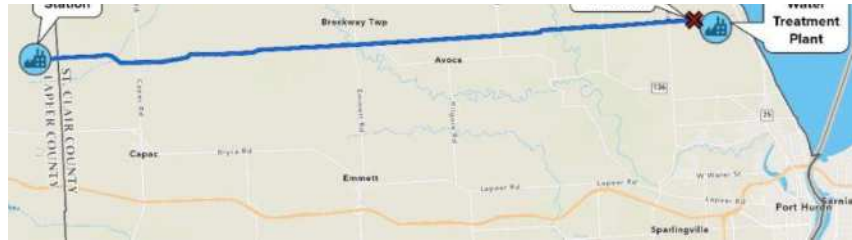
As of Thursday, August 18, 2022, the following seven communities remain under a precautionary Boil Water Advisory: the Village of Almont, Bruce Township, Burtchville Township, Imlay City, City of Rochester, Shelby Township, and Washington Township. In addition, there is also one business in Greenwood, and an industrial park in Romeo that remain under the Boil Water Advisory.

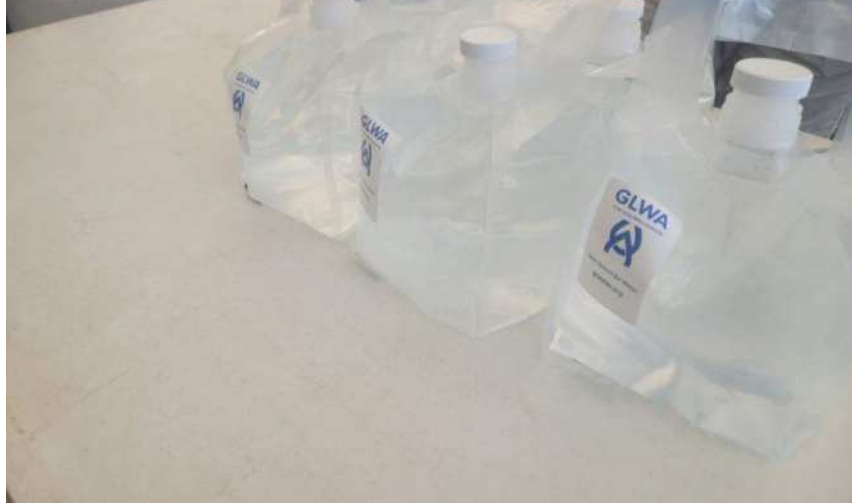
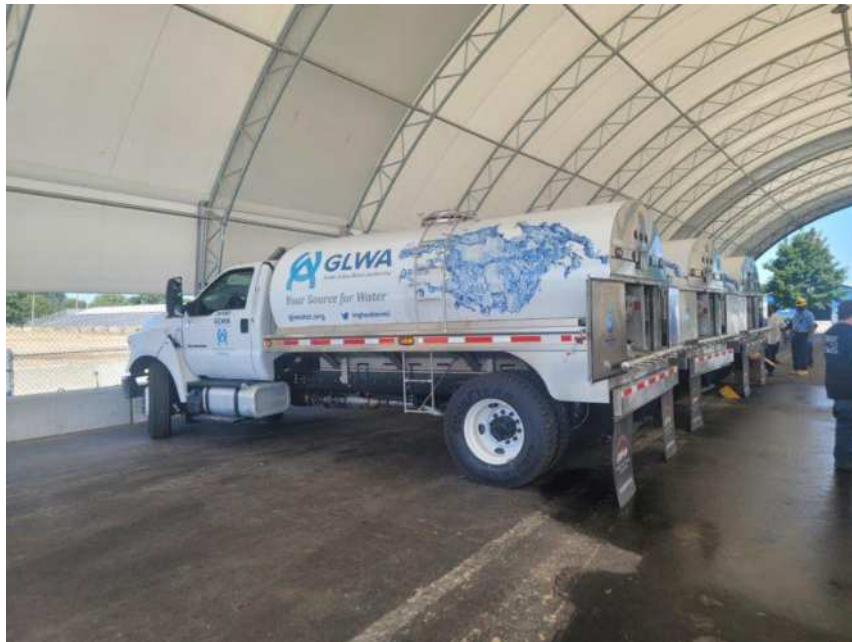
GLWA CEO Suzanne Coffey and Chief Operating Officer, Water and Field Services Cheryl Porter held a news conference on Tuesday, August 16 to provide an update on repair status. A link to the video can be found [HERE](#).

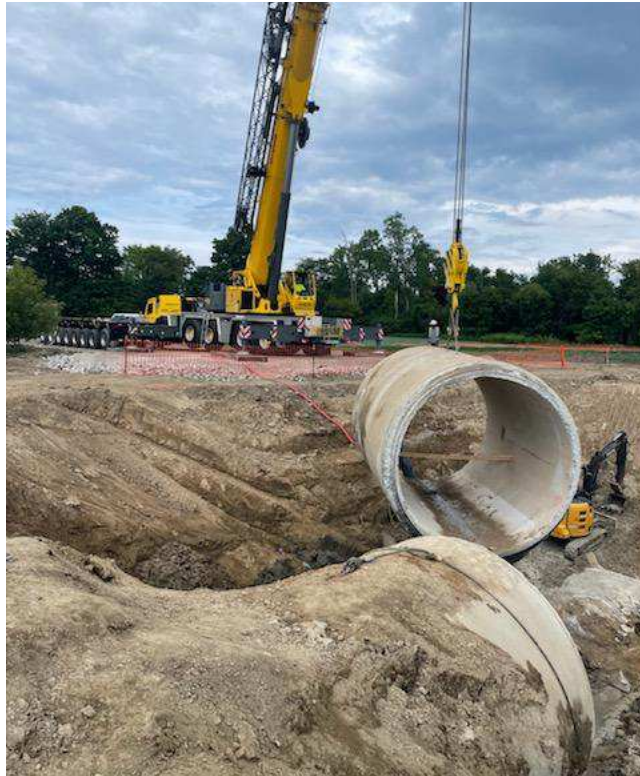
To assist resident and businesses coming out of the precautionary Boil Water Advisory, GLWA has created checklists for the actions for residents and businesses should take after a Boil Water Advisory is lifted. These checklists can be found [HERE](#).

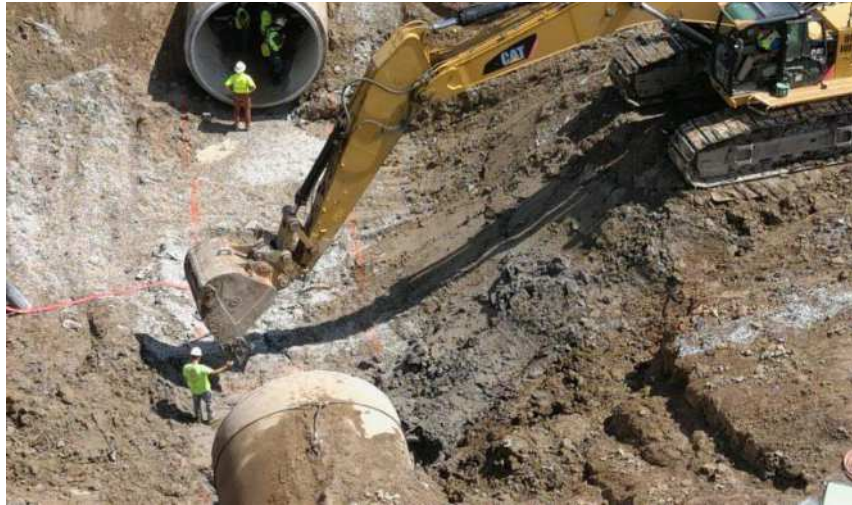
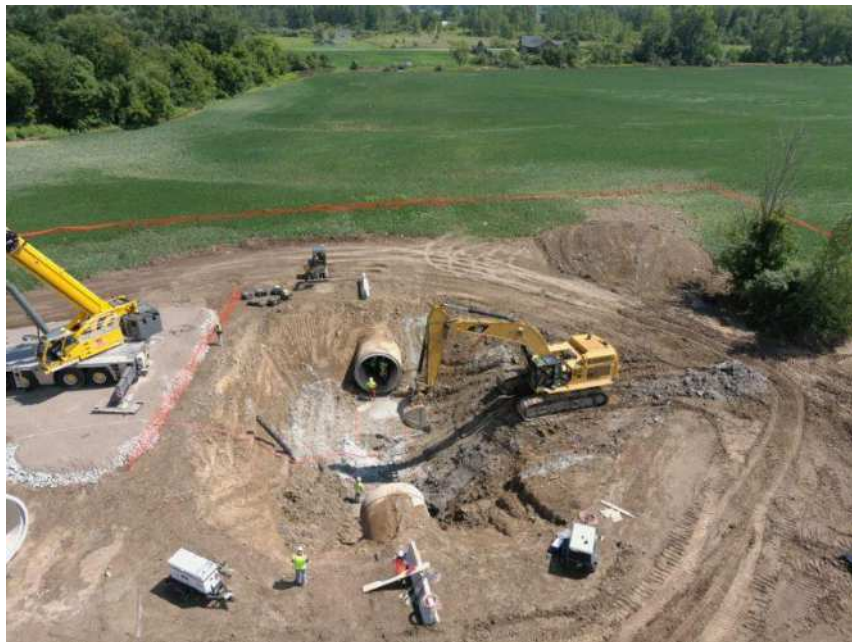
GLWA will share more information as it becomes available and plans to share photos and video with the media upon the pipe’s delivery.

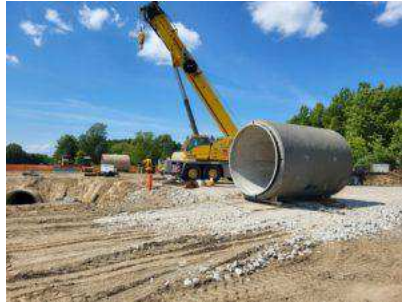
GLWA will share more information as it becomes available and plans to share photos with the media upon delivery of the remainder of the additional pipe.

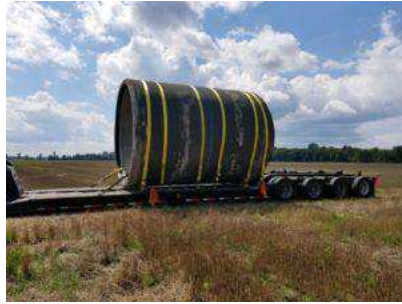
GLWA will share more information as it becomes available, as well as photos of progress being made at the repair site.

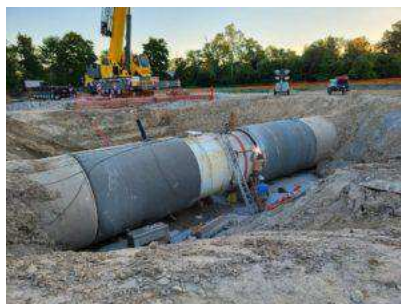
GLWA will share more information as it becomes available, as well as photos of progress being made at the repair site.

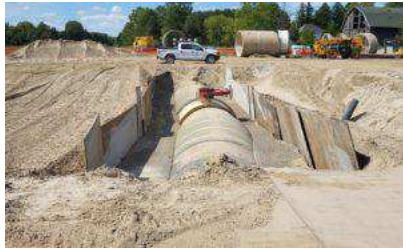
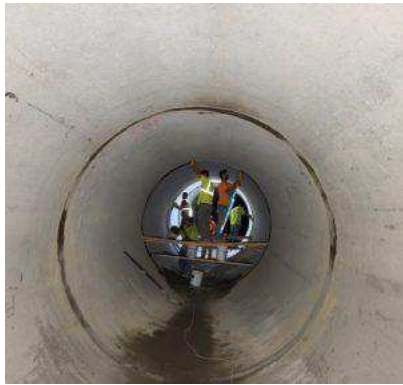
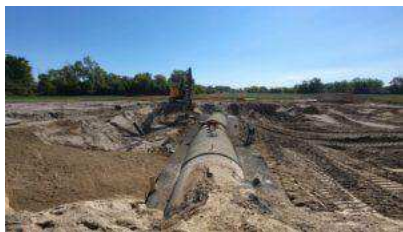
GLWA will share more information as it becomes available, as well as photos of progress being made at the repair site.

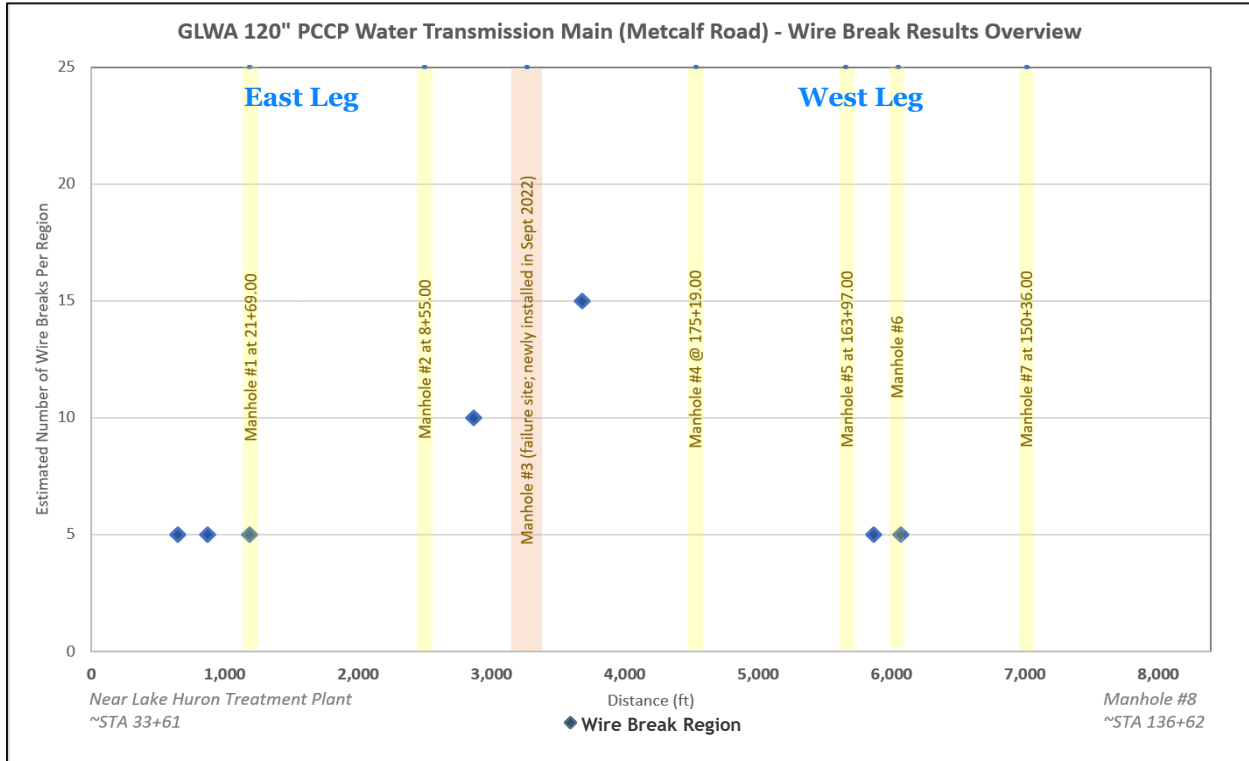
Figure 1. Distribution of wire break regions along GLWA’s 120-Inch PCCP Water Transmission Main between the 120”/108” Reducer near the Lake Huron Water Treatment Plant and Manhole #8 east of North Road.

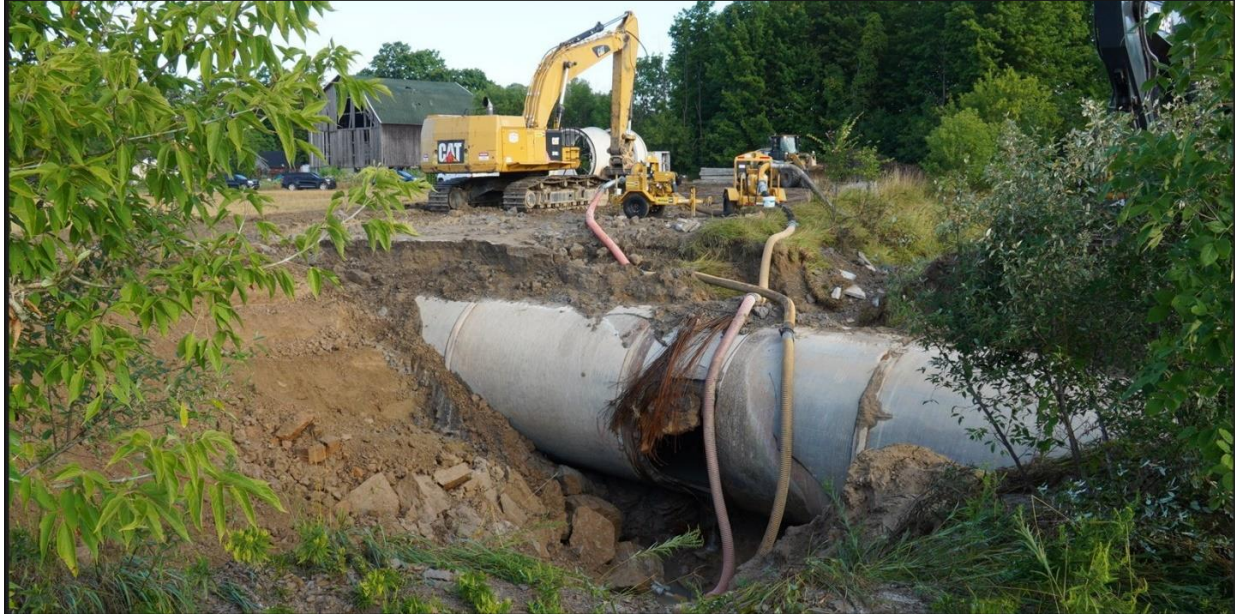
Figure 3. GLWA experienced a significant water main failure on its 120-inch Transmission Main originating from the Lake Huron Water Treatment Facility on August 13th, 2022, at 4:30 AM (image obtained from GLWA's social media post).

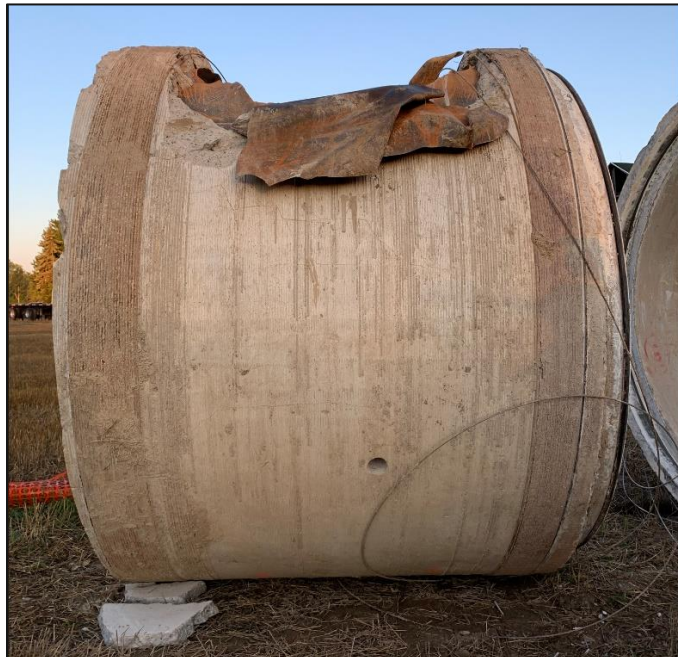
Figure 4a. Side profile image of the ruptured pipe. Note that the rupture occurred near the invert and on the south side of the pipe.

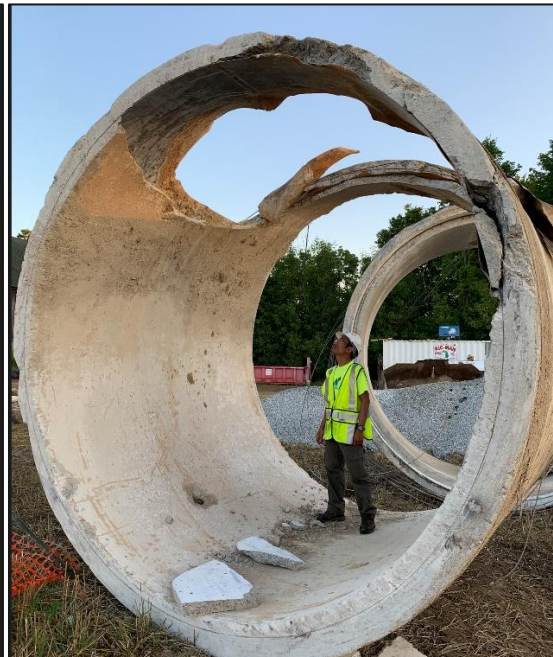
Figure 4b. PICA closely inspecting the inside of the ruptured pipe.

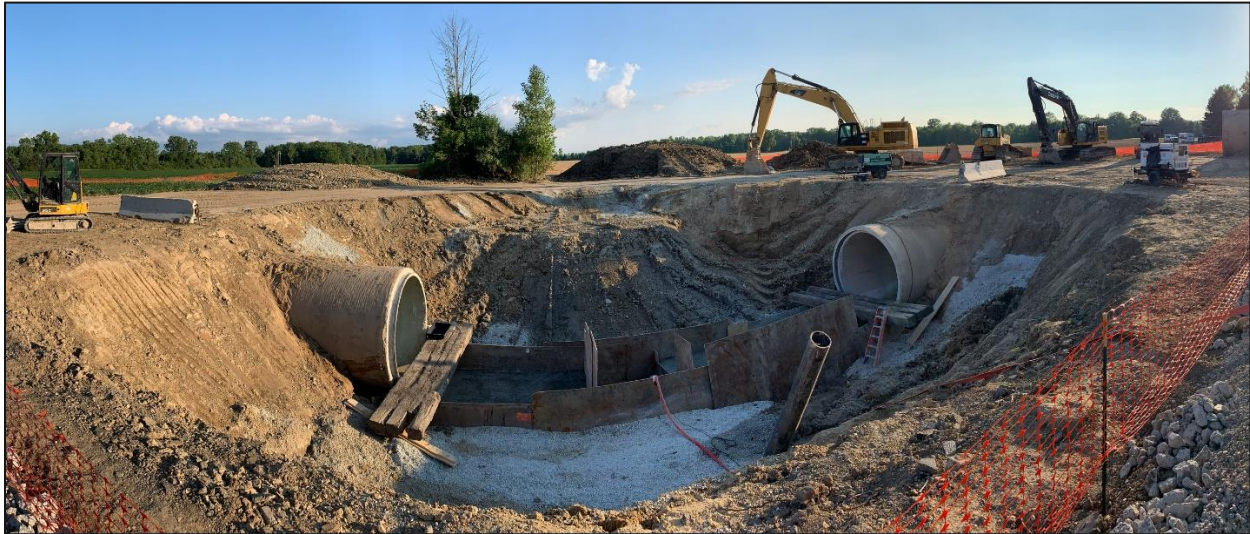
Figure 5. Panoramic image of the excavation, (looking south) prior to the concrete base pour and repairs.

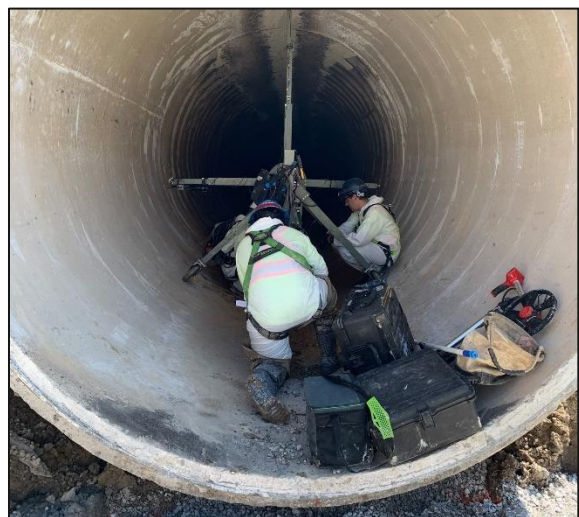
Figure 6. PICA crew completing the assembly of the NFT tool during the inspection of the East leg.

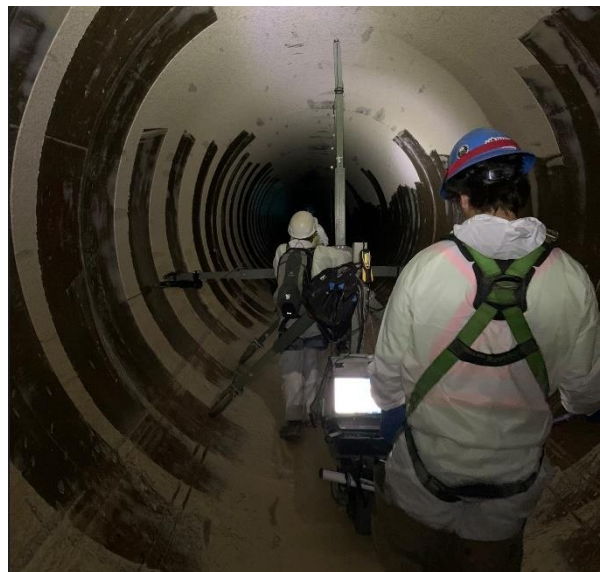
Figure 7. PICA operator monitoring the EM data as it’s collected during the August 2022 NFT inspection of GLWA’s 120-inch PCCP Transmission Main.

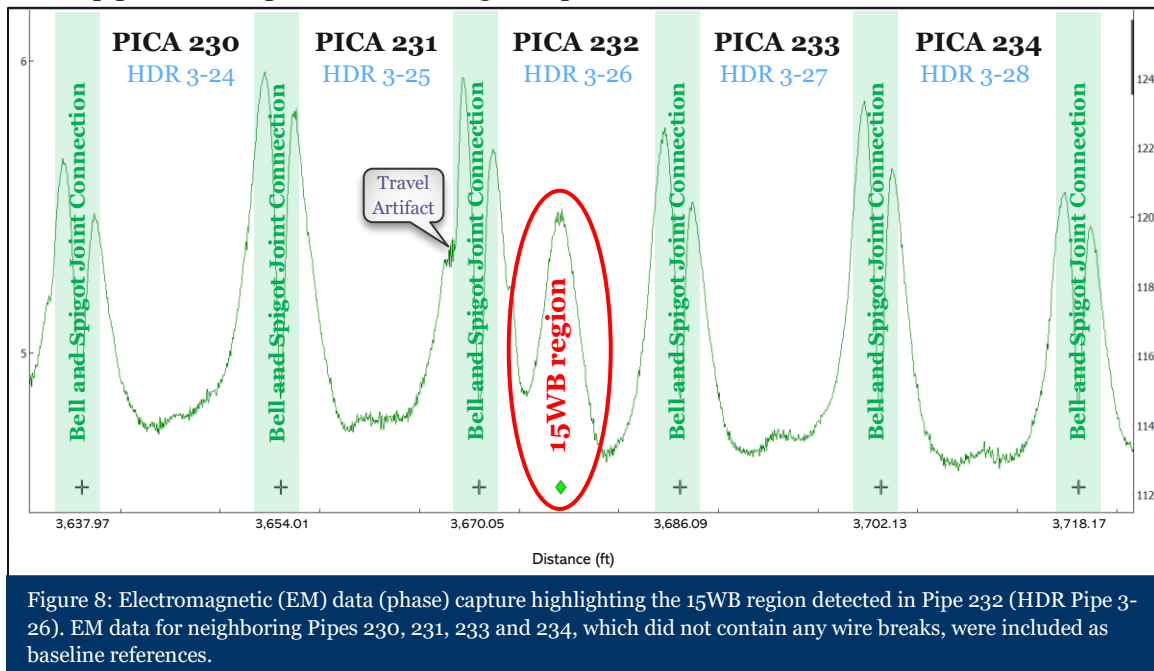
A distribution graph with respect to the location of the wire break regions along the inspected section is provided in Figure 1 as part of the executive summary on page 4. Detailed wire break results and locations can be found in the supplementary spreadsheet, **GLWA 2022 - 120in PCCP Water Transmission Main RESULTS.**

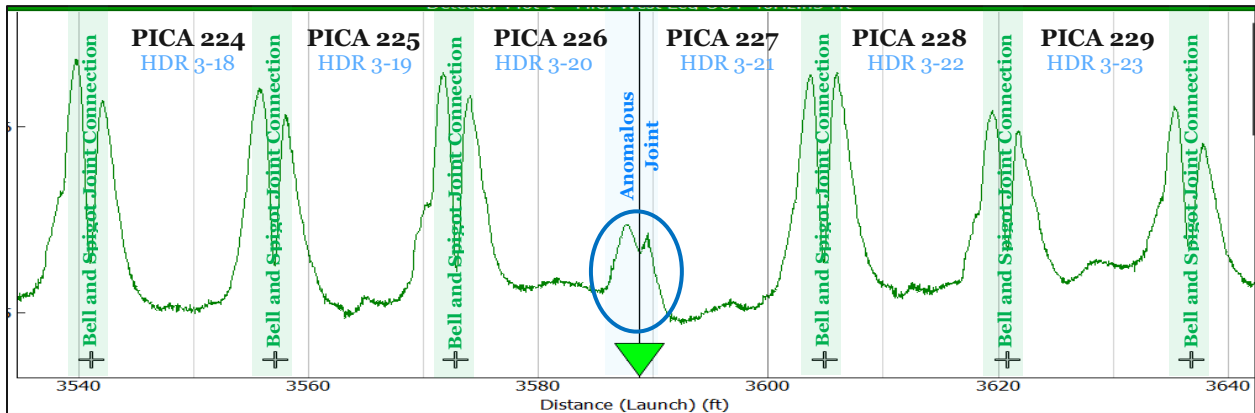
Figure 10. EM (phase) data showing one (1) of the 19 anomalous joints (highlighted in blue) between pipes 226 and 227 (HDR Pipes 3-20 and 3-21). These unique joints appear stunted in the EM data compared to the common bell and spigot joint

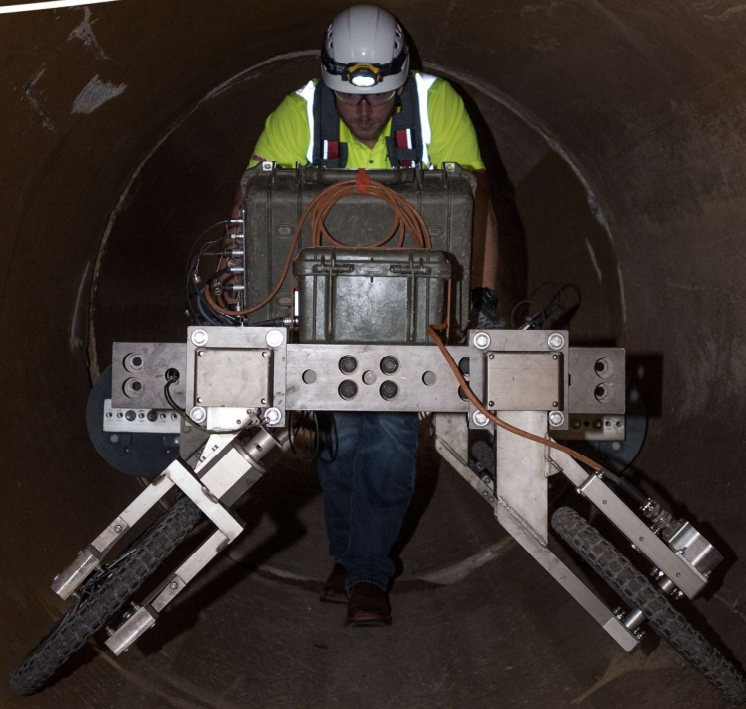
PipeWalker® Electromagnetic Inspection Report
120-inch PCCP Main – East of Failure Location
Great Lakes Water Authority and
Ric-Man Construction Florida, Inc.

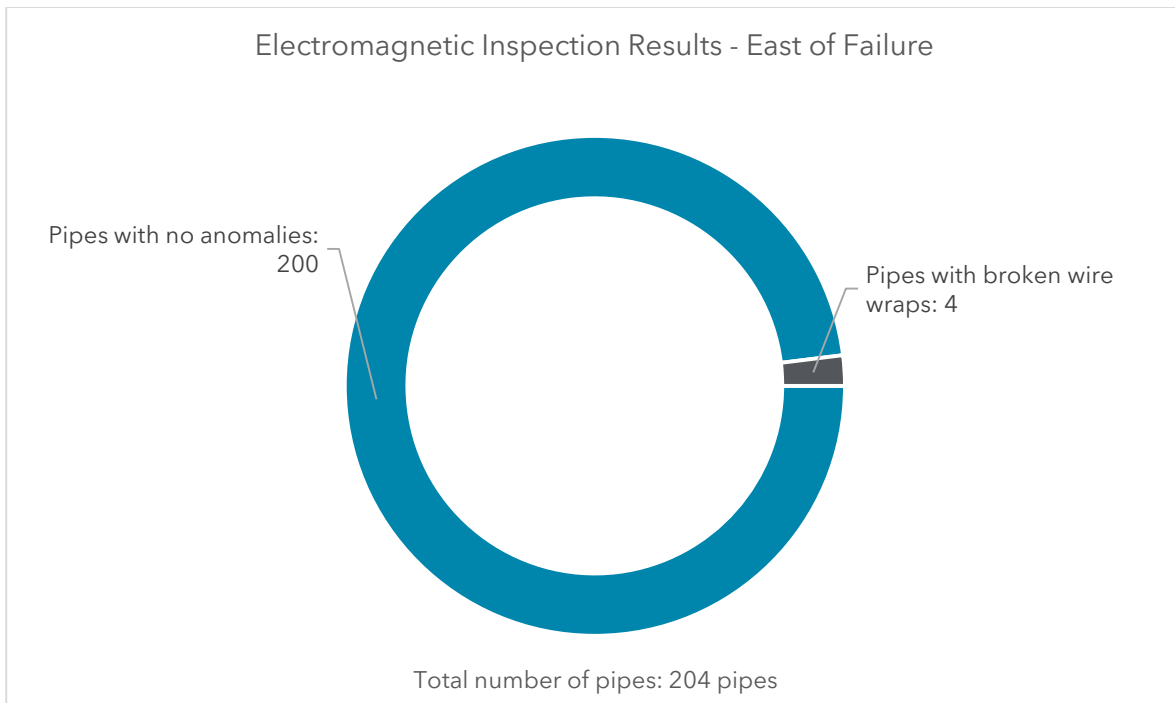
Figure ES.1: Electromagnetic Inspection Results

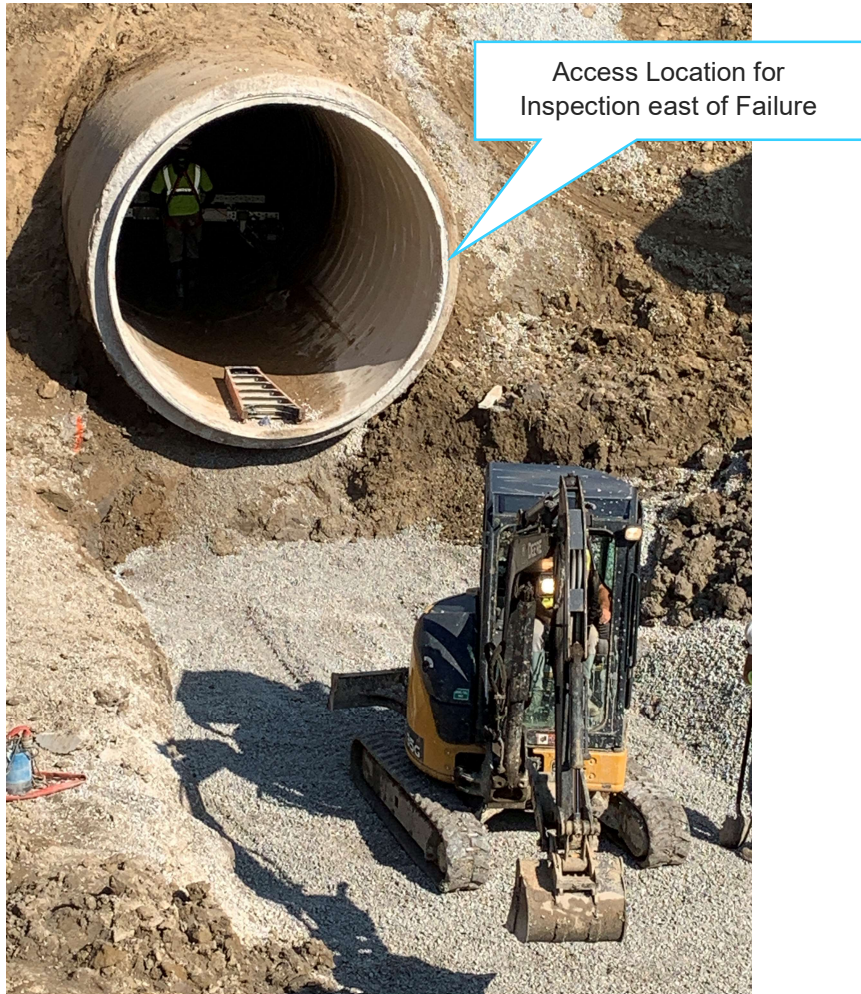
Figure 1.2: Access for the Inspection was the Failure Location

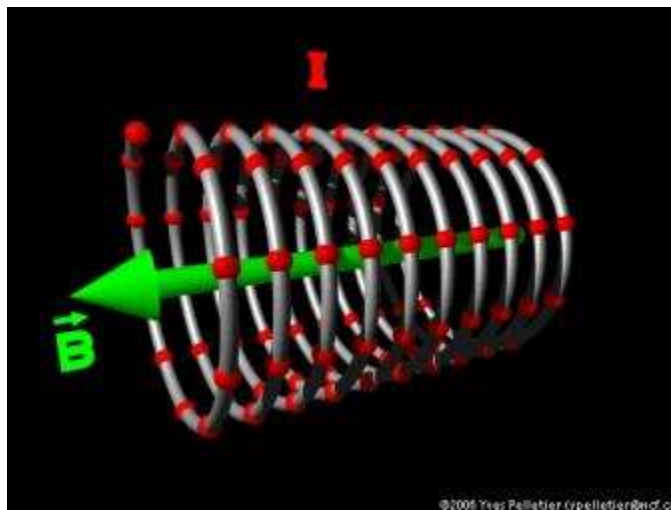
Figure B.1: Electric currents induced by time-varying magnetic field

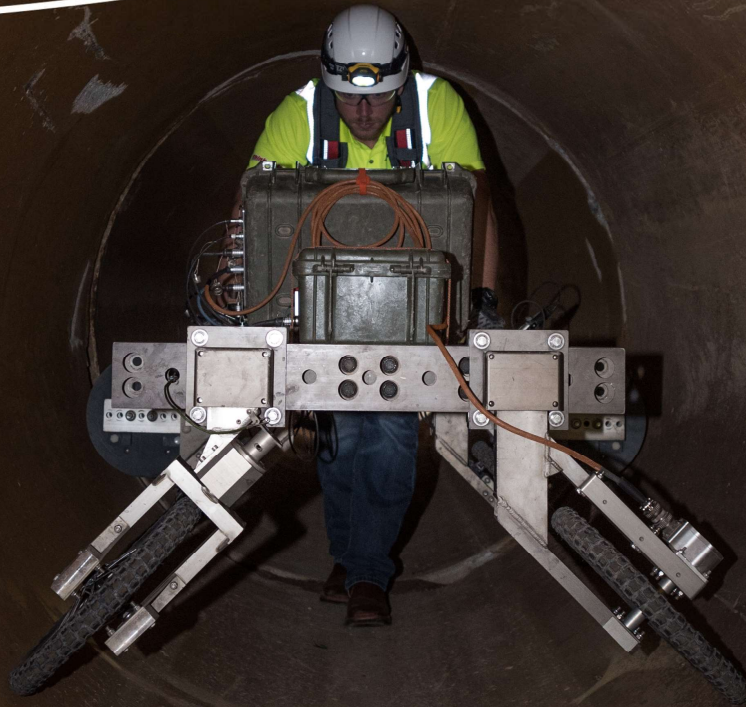
PipeWalker® Electromagnetic Inspection Report
120-inch PCCP Main – West of Failure Location
Great Lakes Water Authority and
HDR Engineering Inc.

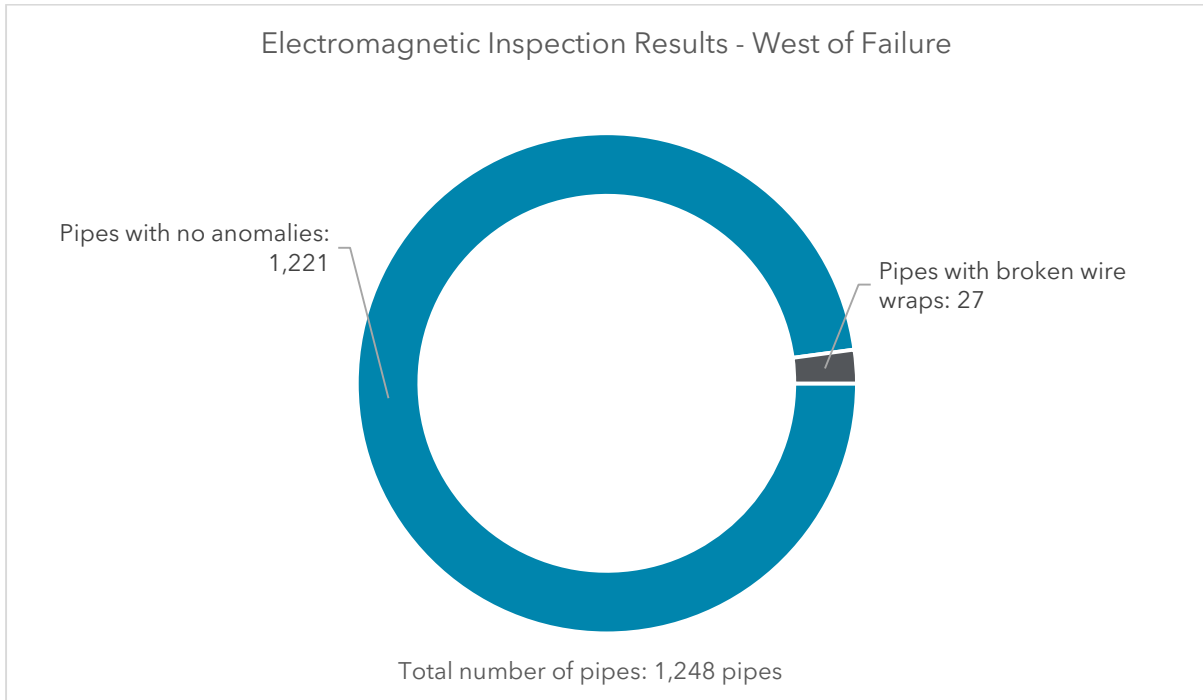
Figure ES.1: Electromagnetic Inspection Results

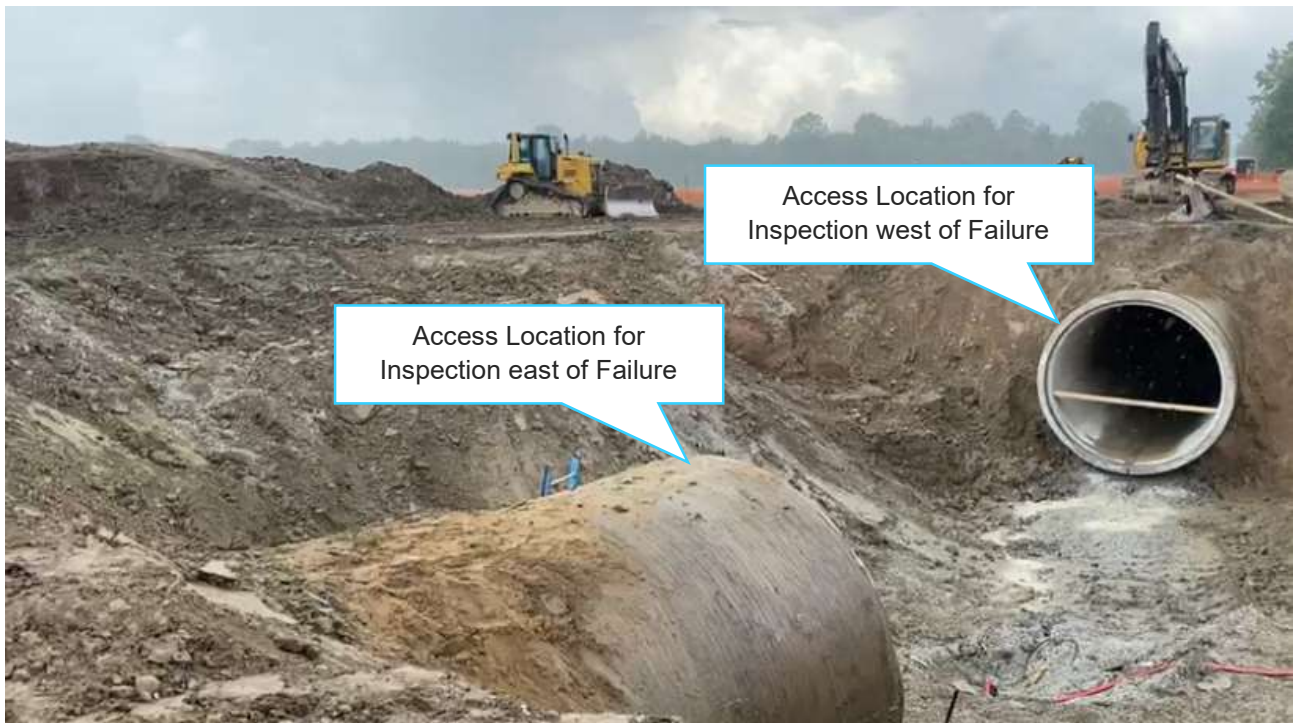
Figure 1.2: Primary Access for the Inspection was the Failure Location

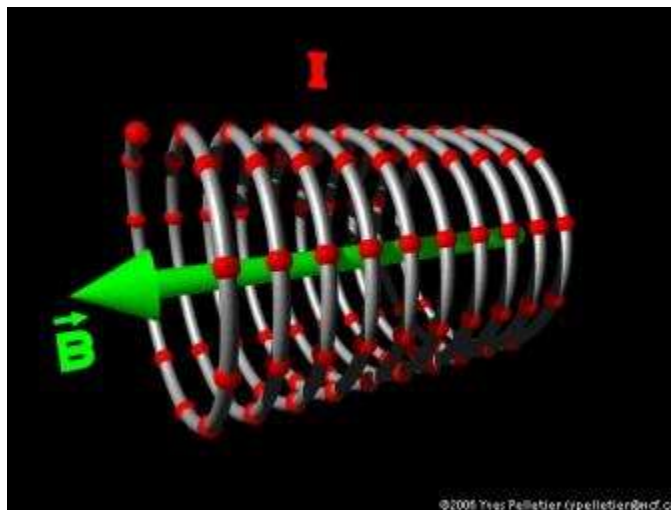
Figure B.1: Electric currents induced by time-varying magnetic field
