**Connors Creek Sewer System
Rehabilitation **DRAFT****

**State Revolving Fund (SRF)
Project Plan
April 2021**

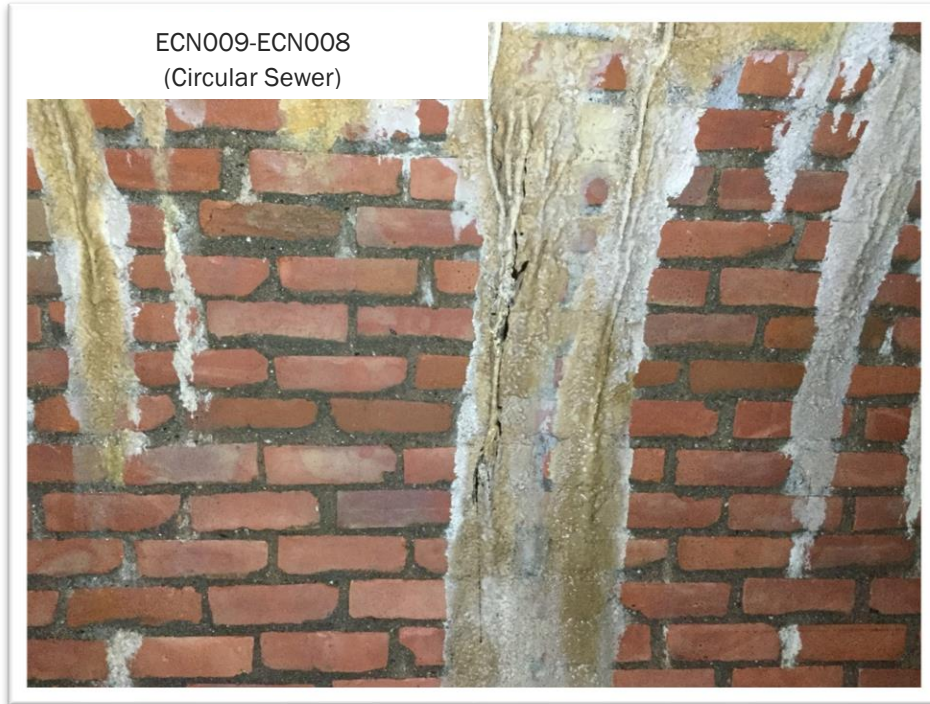
Figure 1-10. Typical Defect - Infiltration Dripper in Brick Sewer

The most common defect observed in the CCSS is Grade 3 Infiltration Drippers, which may develop into Infiltration Runners and Gushers (Grade 4 and 5), if they are not repaired properly. These kinds of defects will increase the risks of basement backups and combined sewer overflows resulting structural damage to facilities (i.e., pipes and manholes) in the CCSS.

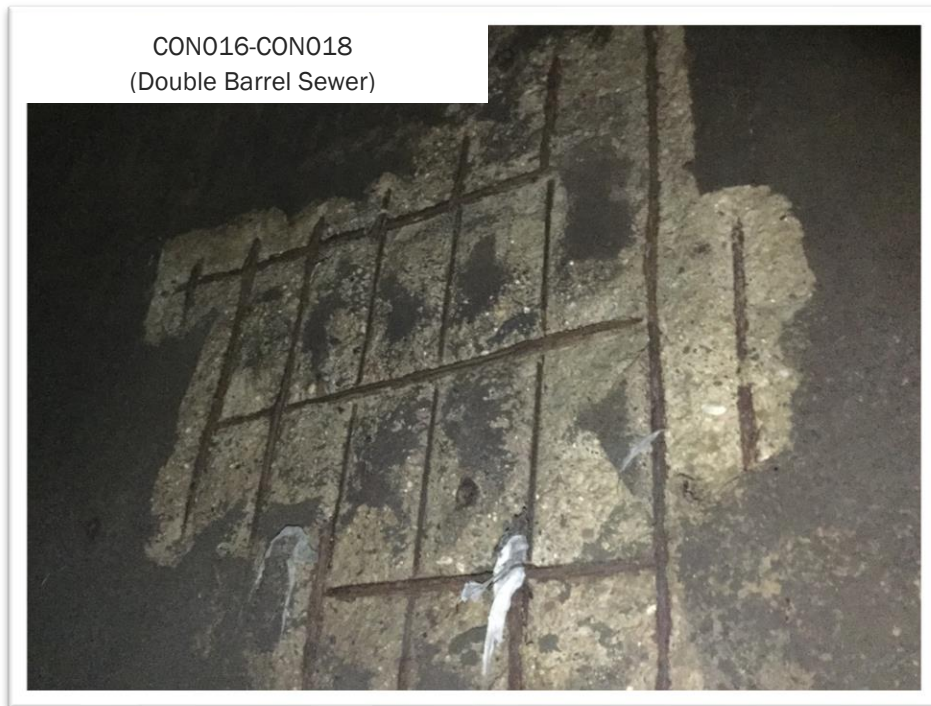
Figure 1-11. Typical Defect - Surface Damage Reinforcement Visible with Spalling

Grade 4 defects in this project typically include visible reinforcement, which is sign of structural failure of reinforced concrete pipe (RCP). Exposed reinforcement will be corroded quickly, resulting cracking or even holes along the sewer. If sediment, subgrade, or overburden soils are allowed to migrate into the sewer from those gaps, sink holes may open up to the ground surface.

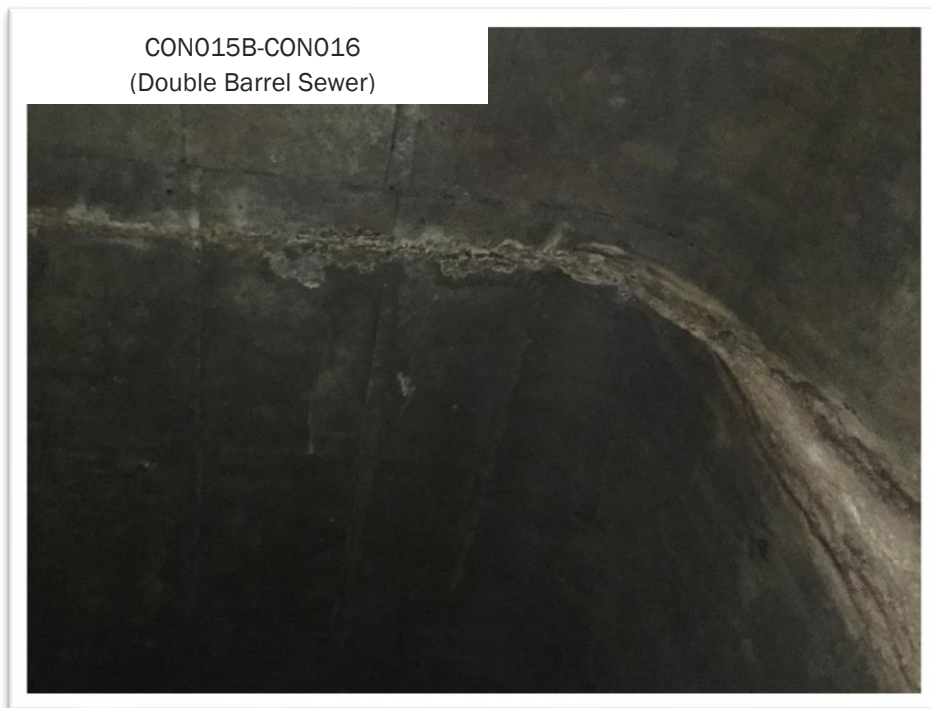
Figure 1-12. Typical Defect - Infiltration Runner

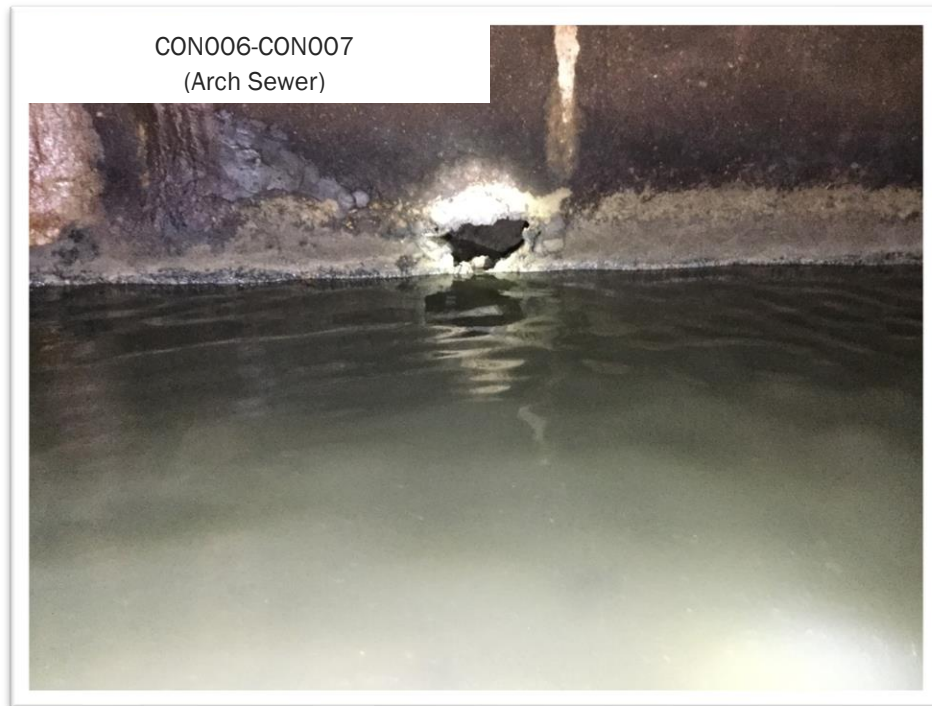
Figure 1-13. Typical Defect - Hole in Sewer Wall

Example of Grade 5 defects in this project is open holes on the pipe, which are considered very severe defects and need immediate attention. There are several critical transportation infrastructures and hospitals in the study area of this project, including Interstate I-94, Coleman A. Young International Airport and Conner Creek Health Center. In additional, the Chrysler Jefferson North Assembly Plants, who employs thousands of workers, and the Mt. Olivet Cemetery are of great importance to local and regional residents. The cost of reconstructing a failed sewer would be astronomical; and potential disruption to the residential, commercial, and industrial parties in the project corridor are significant, if no action is taken now.
