Great Lakes Water Authority

Freud Pump Station Improvement Project

Project Plan - DRAFT

April 2022

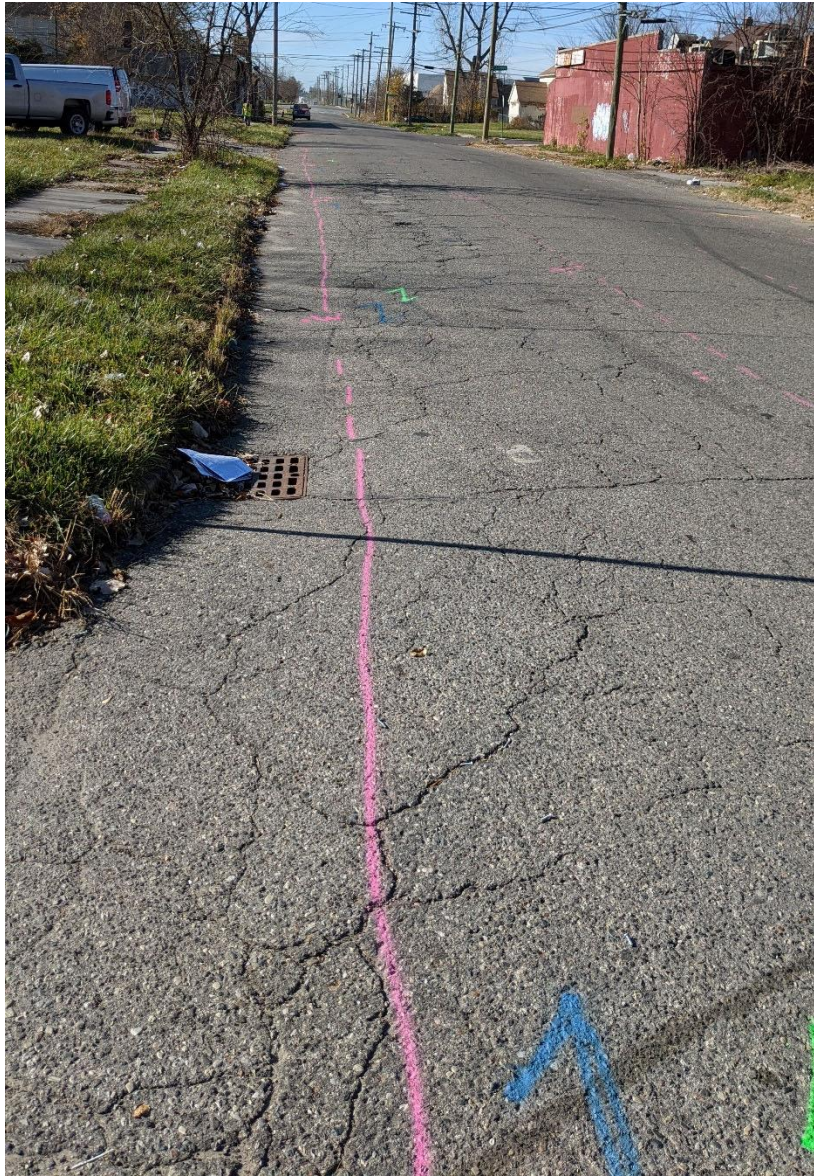
Photograph 1: 16" Watermain along Freud Street looking west.

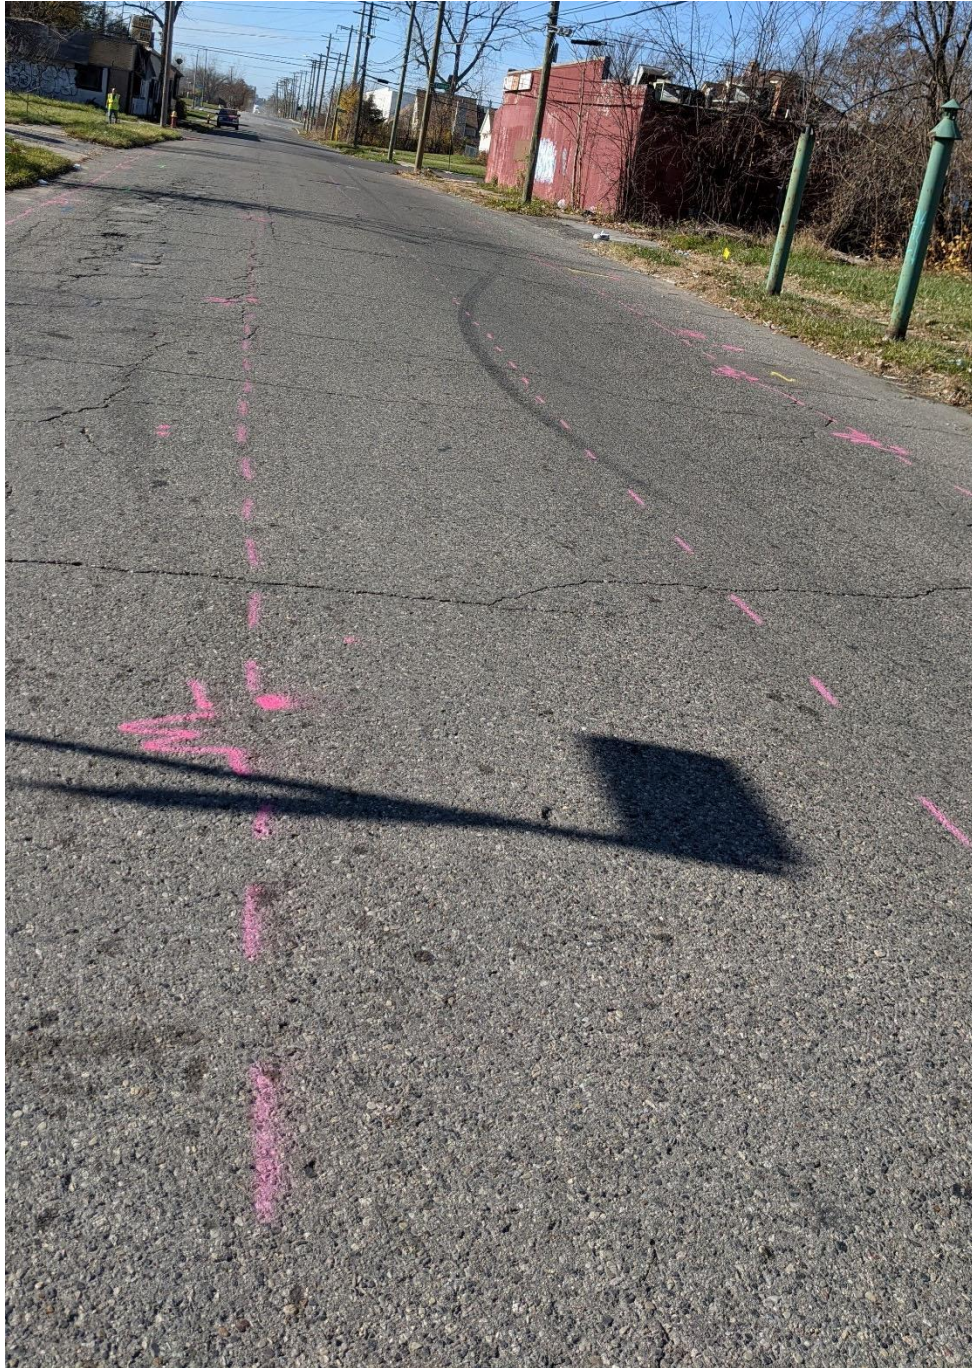
Photograph 2: 24" Watermain, storm sewer, and gas main along Freud Street looking west.

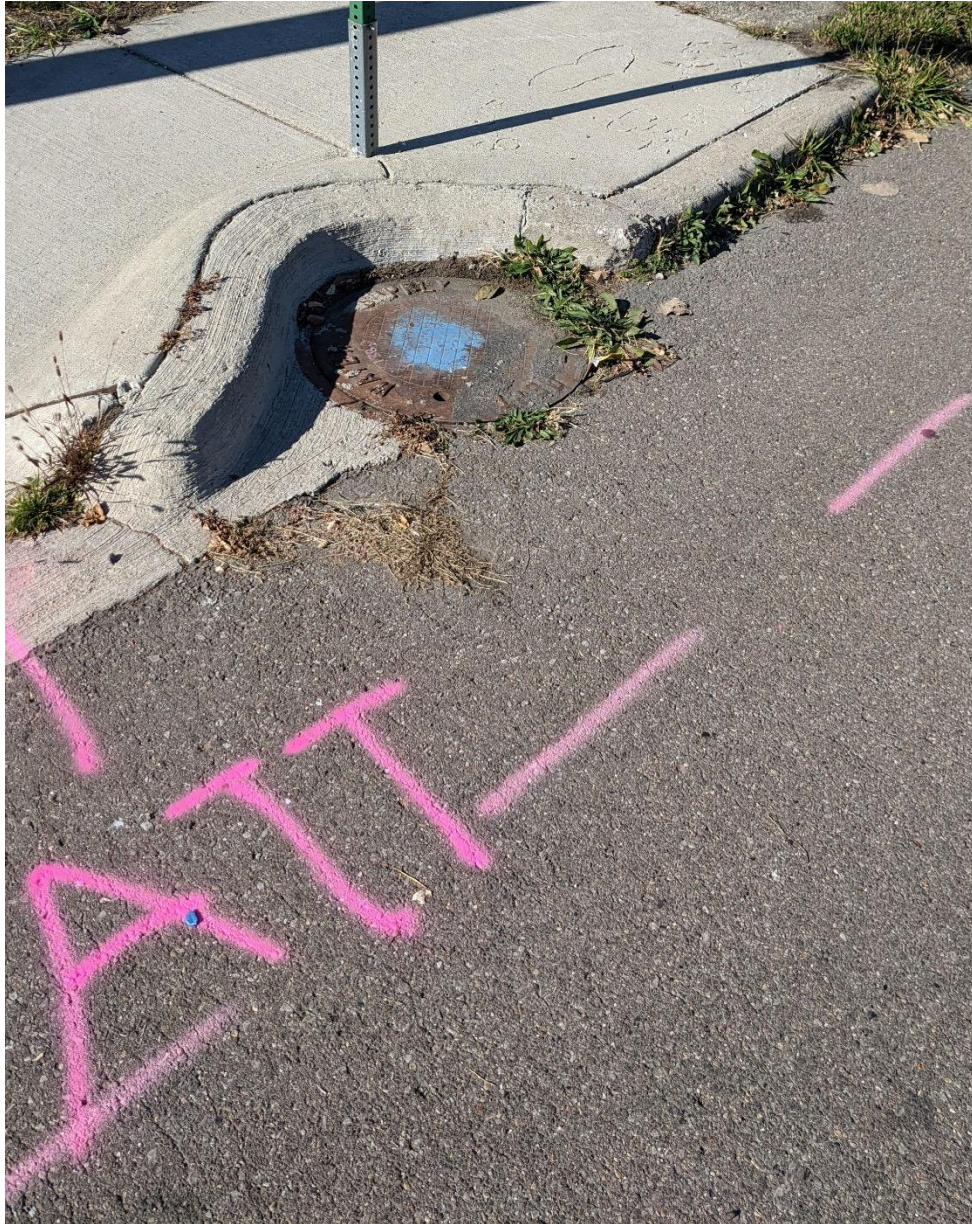
Photograph 3: Water gate valve and ATT communication at northwest corner of Freud Street and Conner Street.

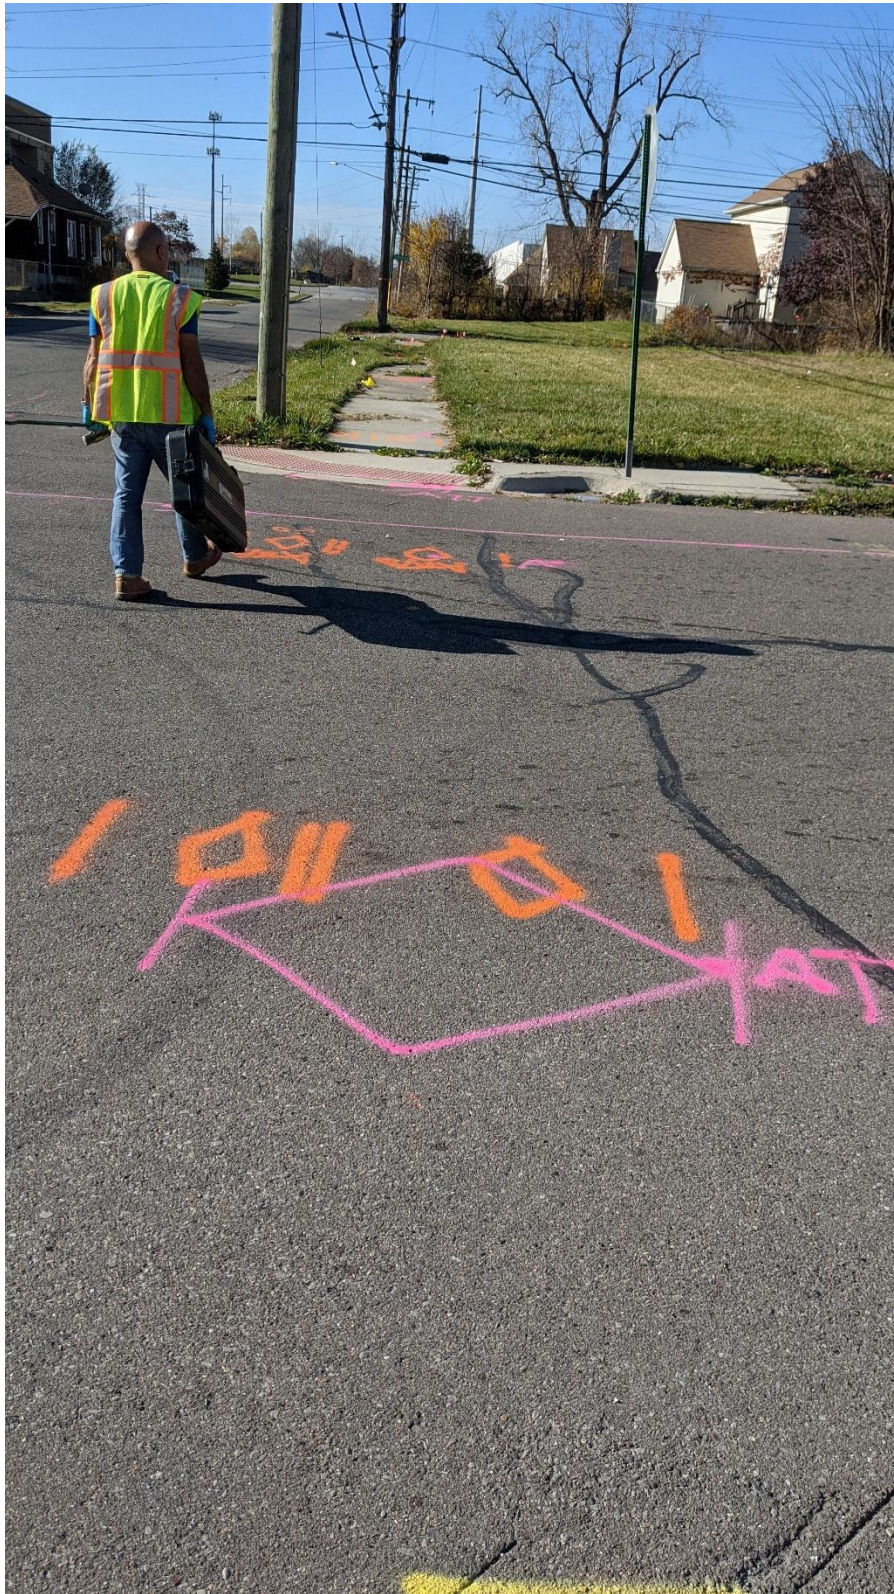
Photograph 4: Communications duct bank crossing Conner Street looking west.

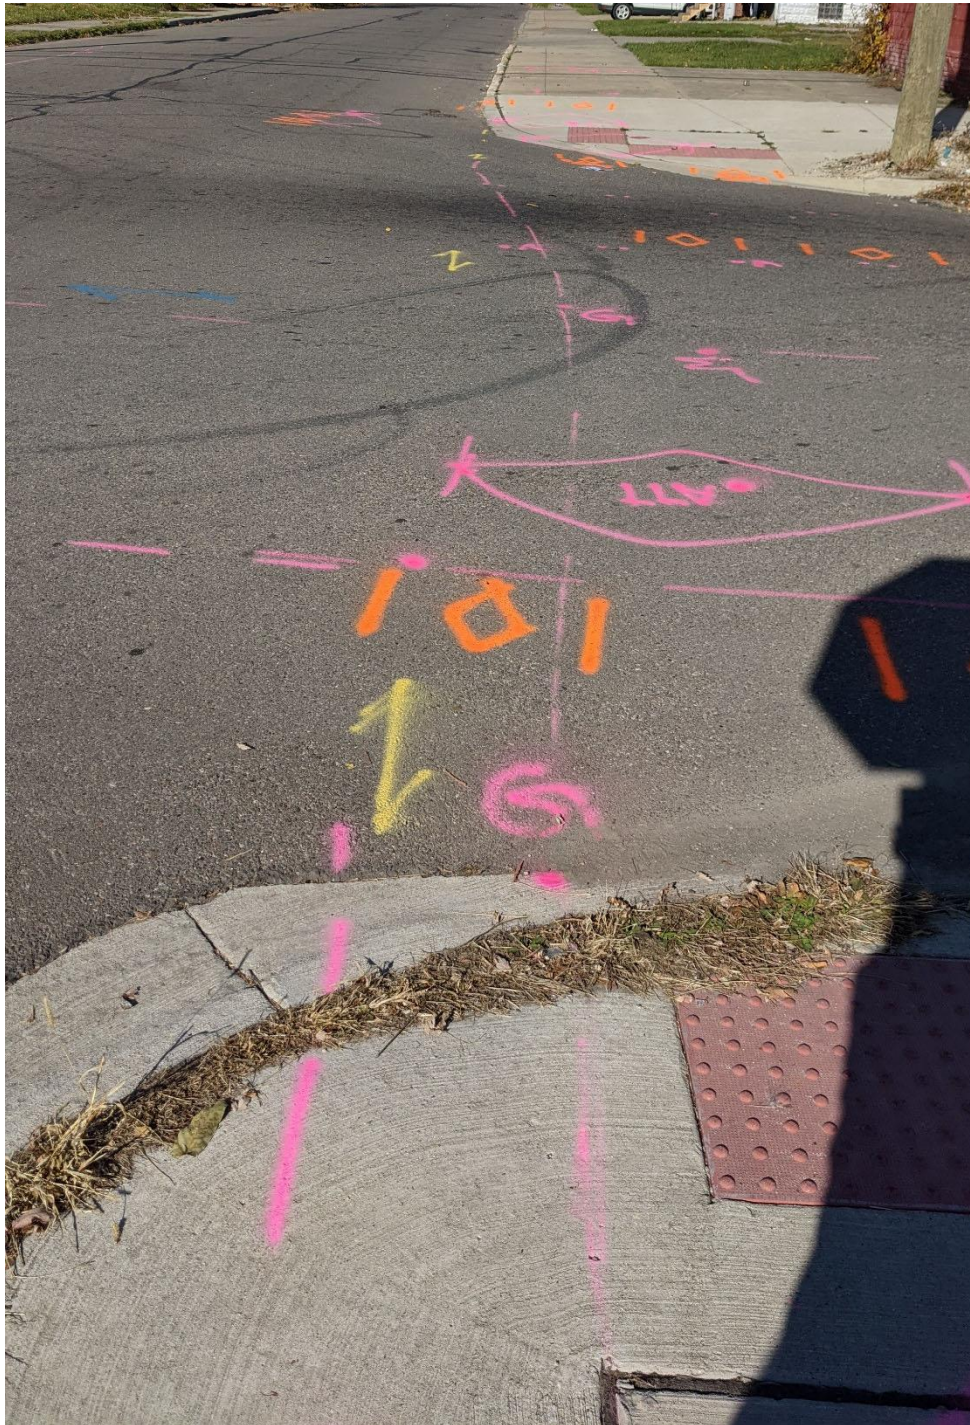
Photograph 5: Gas man and communications duct back crossing Freud Street at Conner Street looking north.

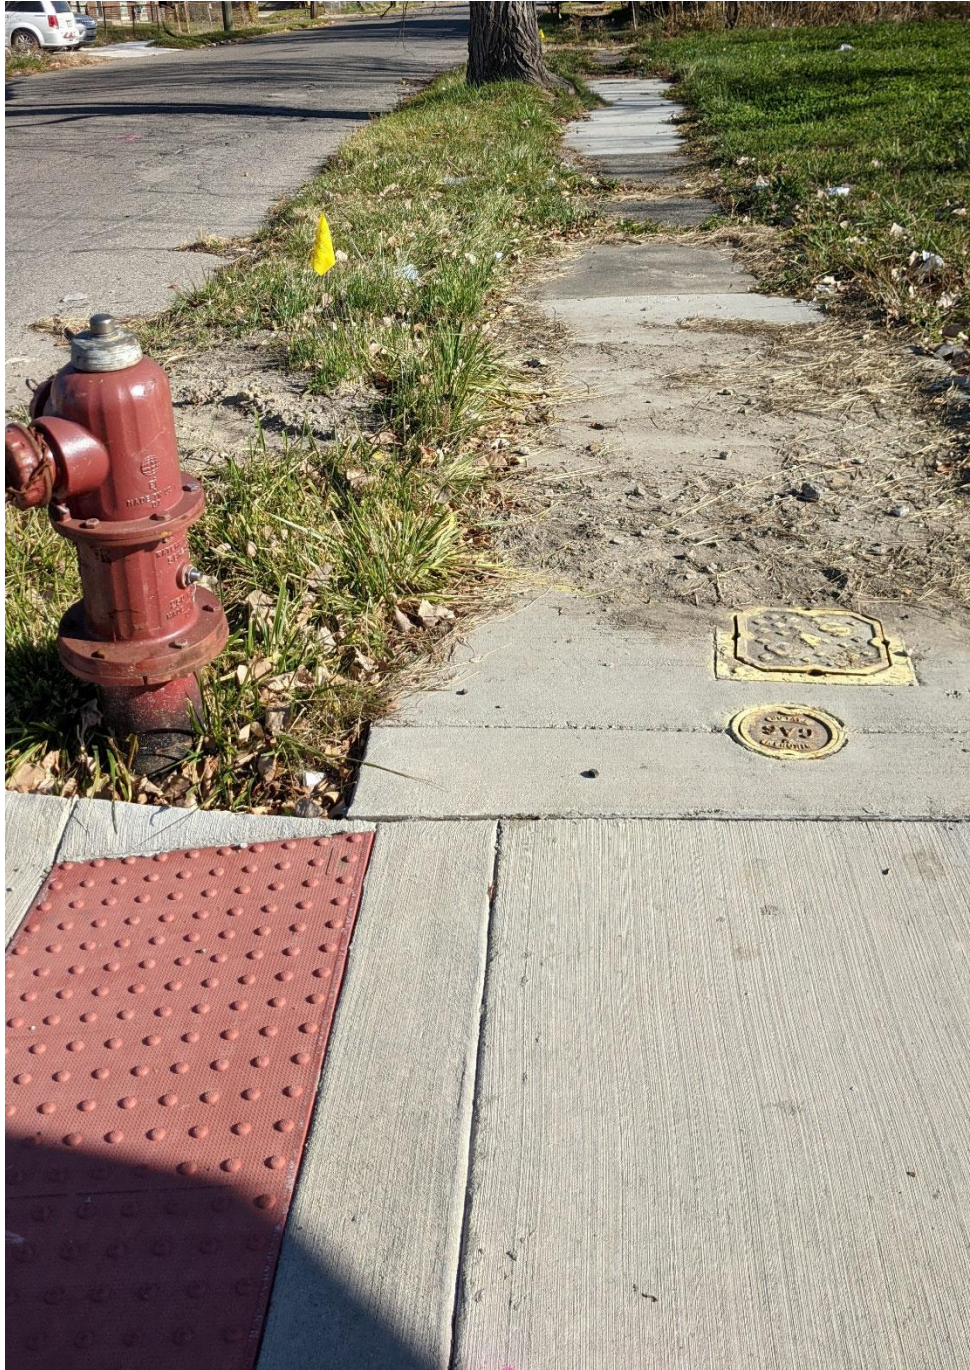
Photograph 6: Gas valve at southeast corner of Freud Street and Navahoe Street looking east.

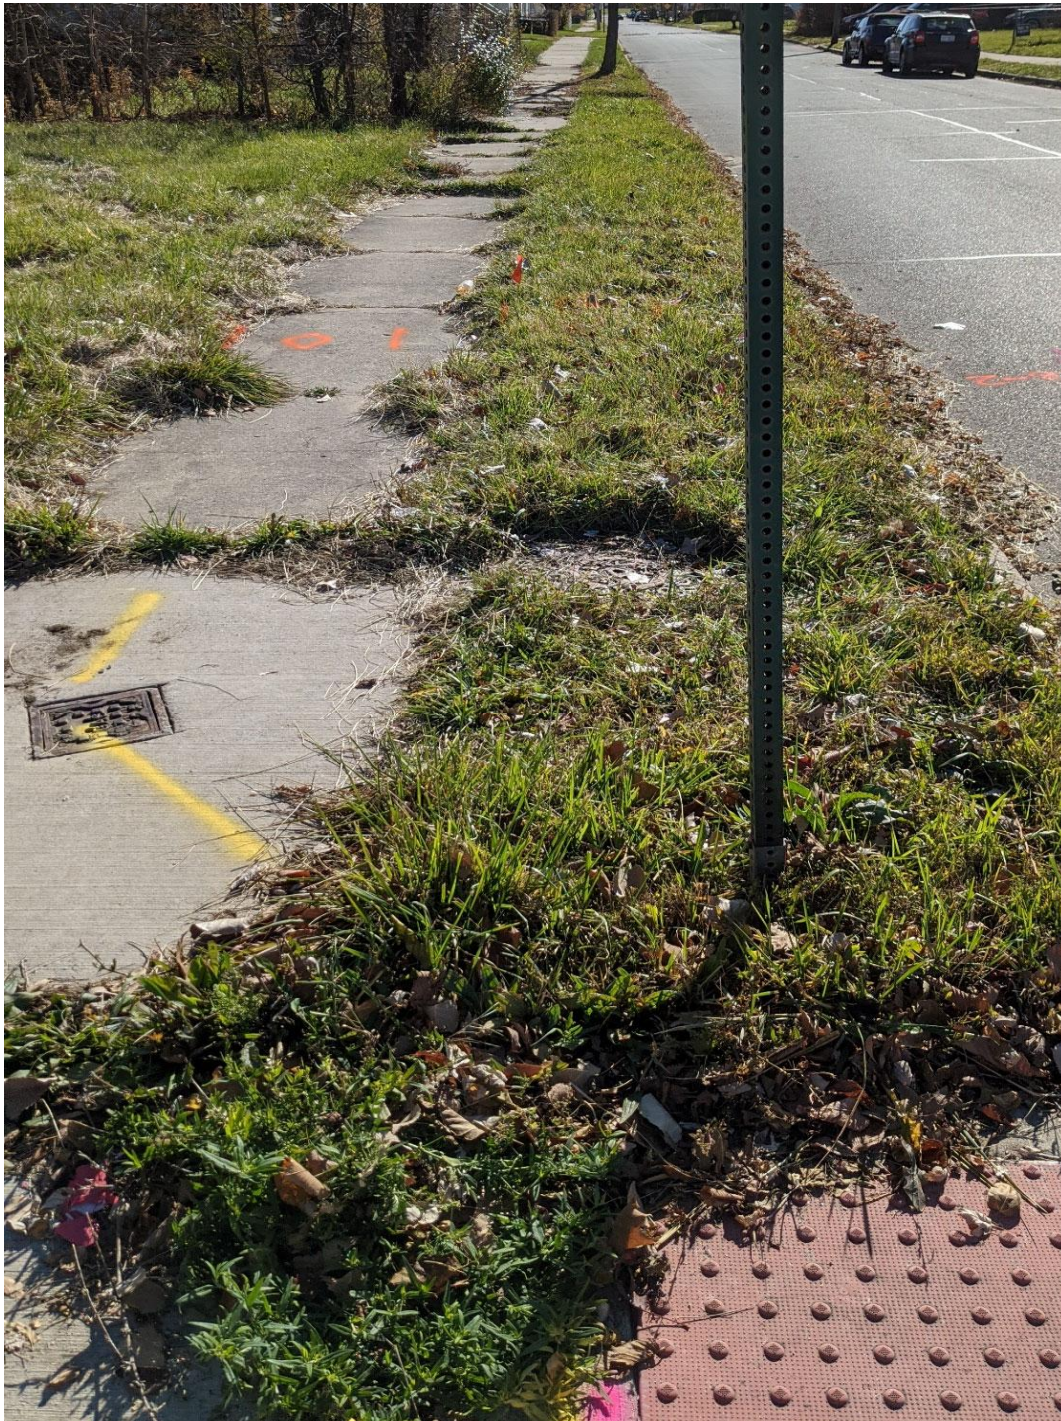
Photograph 7: Gas valve at southeast corner of Freud Street and Conner Street looking south.

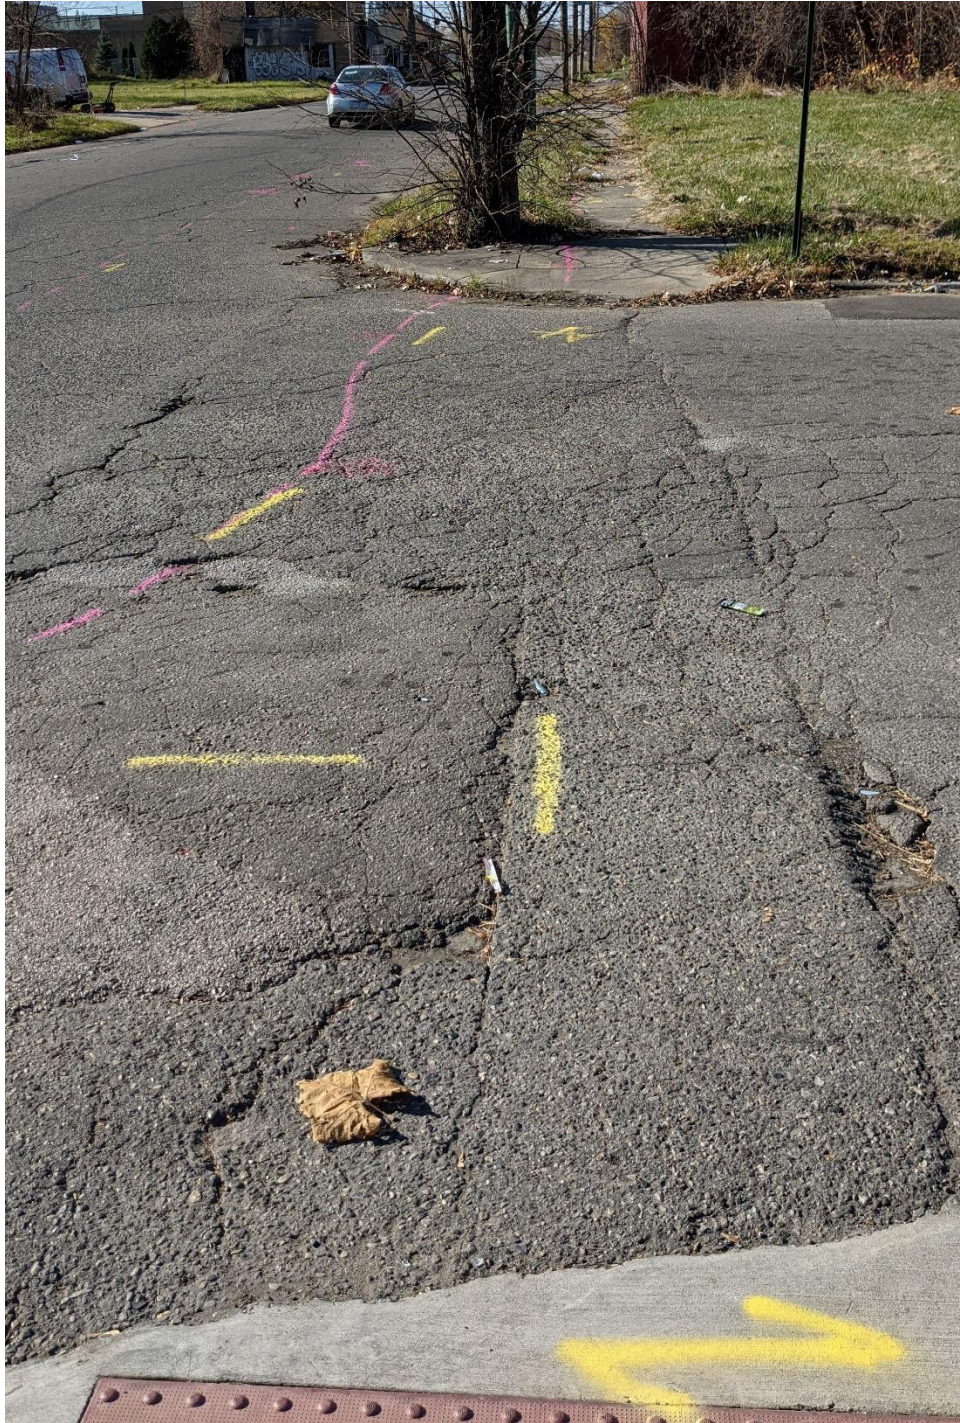
Photograph 8: Gas main along Freud Street at Navahoe Street looking west

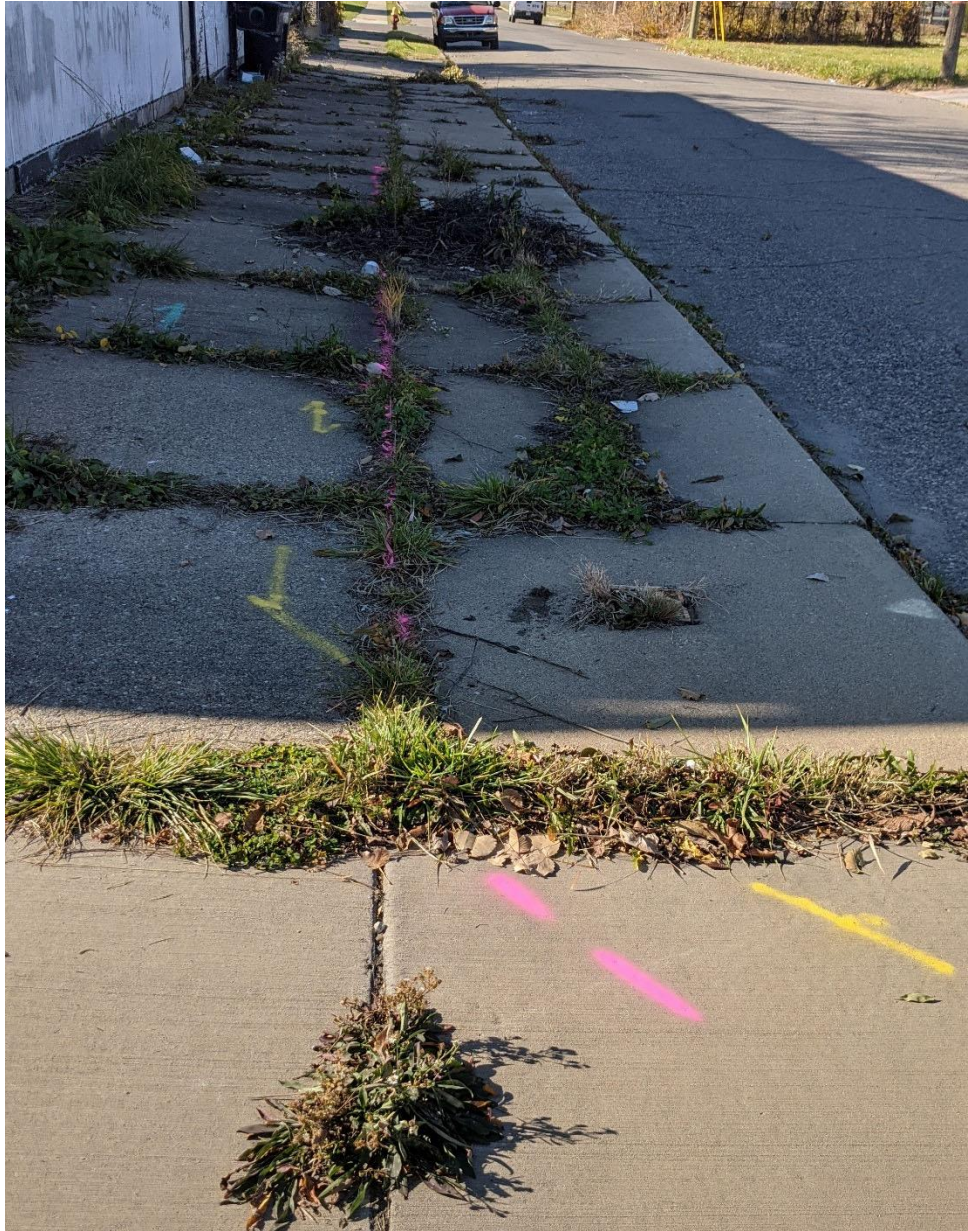
Photograph 9: Gas main along Freud Street west of Conner Street looking west.

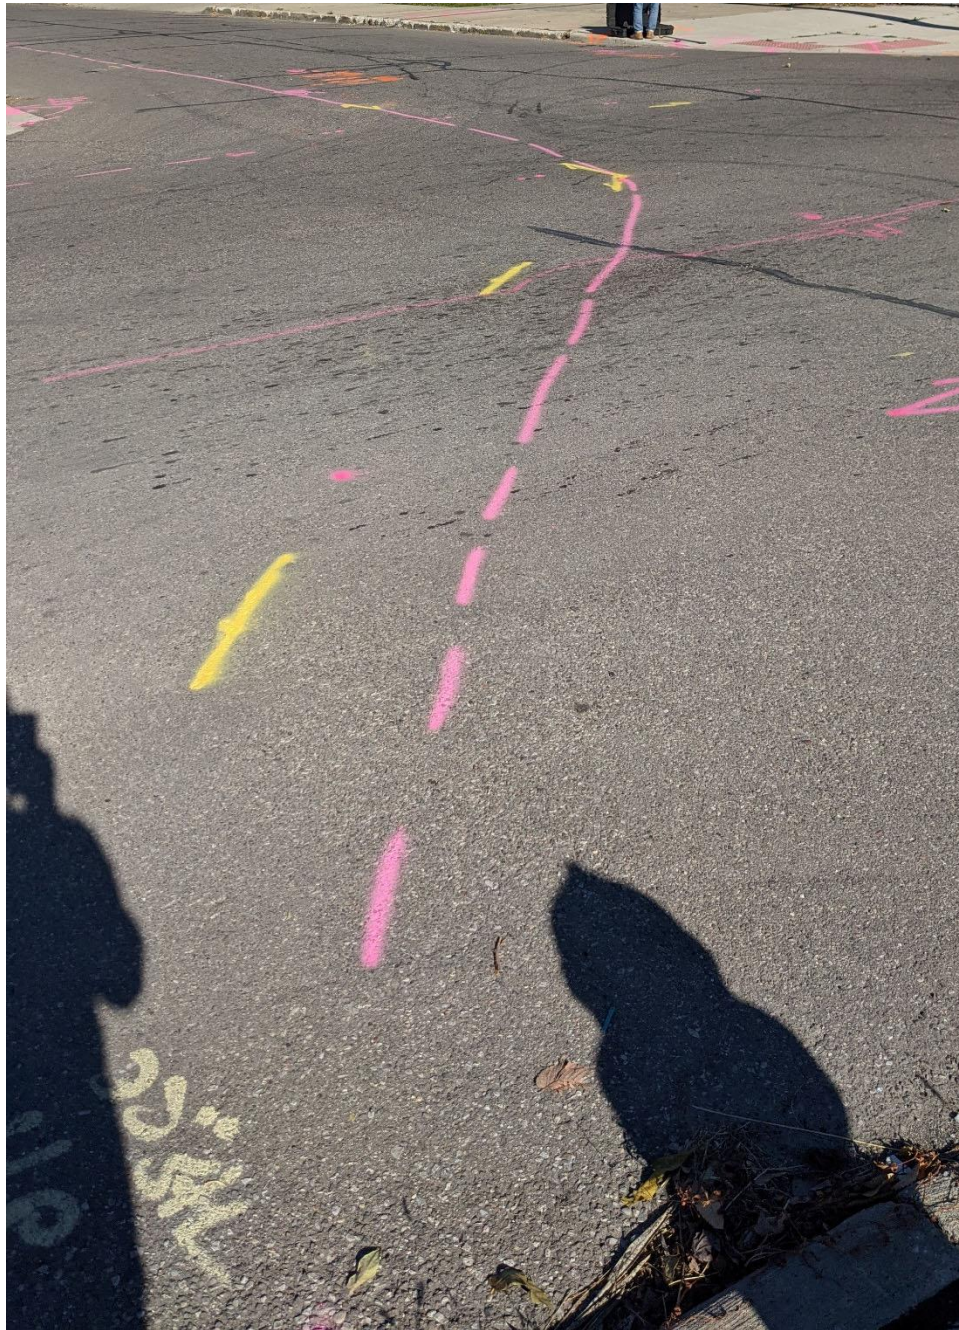
Photograph 10: Gas line through the intersection of Freud Street and Conner Street looking northeast.

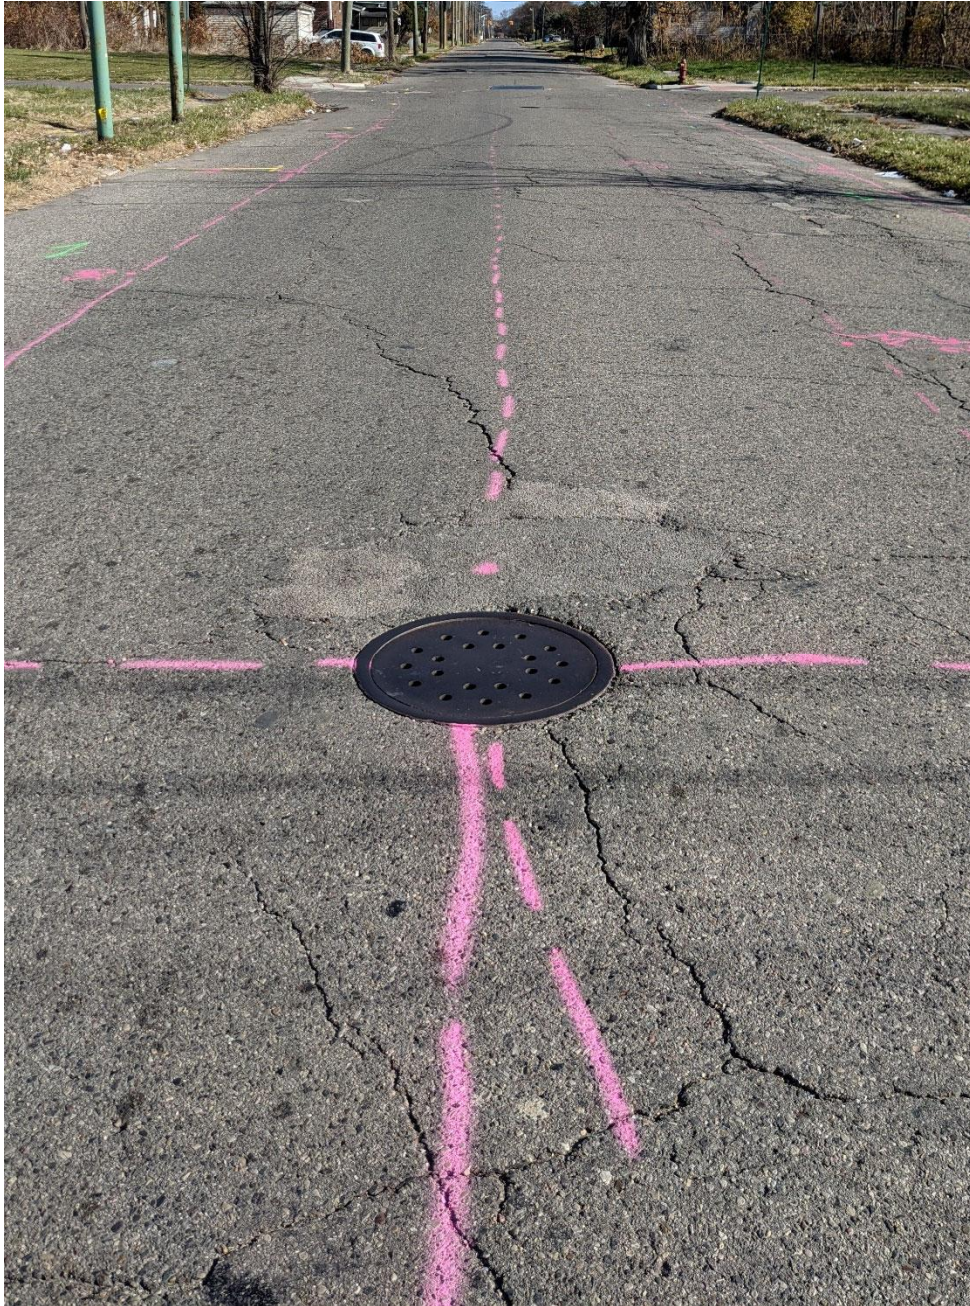
Photograph 11: Storm sewer along Freud Street and alley looking east

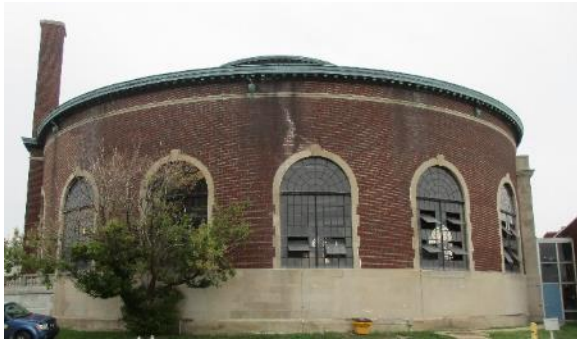
The masonry brick on the exterior face of the exterior walls was repaired, tuckered, and pointed in 2016. Visually, the replaced mortar is noticeable as a different color from the original. For bidding purposes, it may be desirable to include 20% of wall area for tucking, pointing, or repair work for any mortar the contractor may find that was not adequately addressed during the previous work. This can be handled as part of the base bid or an allowance. There remains staining of the brick in certain areas from roof drainage through the gutters and downspouts. GLWA staff informed us during our site assessment that leakage is still occurring from the gutters and downspouts which may lead to future damage of masonry. Arcadis observed evidence of water traveling down the inside face of the exterior wall in at least one location as well as evidence on the floor of water infiltration (see photo below in sections “*Exterior Walls – interior side*” and “*Floors*”).

One possible option to reduce the potential for future damage to the exterior walls is to remove the existing interior downspouts altogether, infill the wall penetrations, and install new exterior downspouts. If this option is not desirable, it is recommended to more thoroughly evaluate each downspout penetration of the exterior wall to determine if there are gaps through which water is getting inside the building.

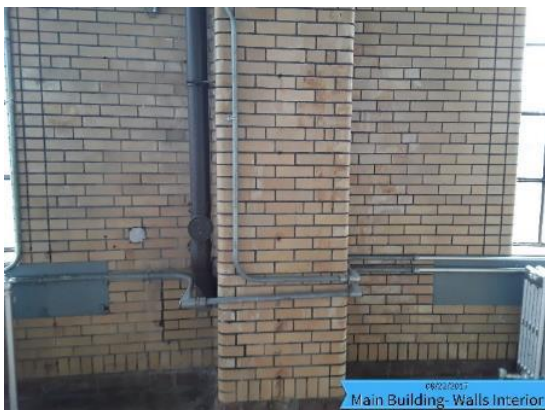
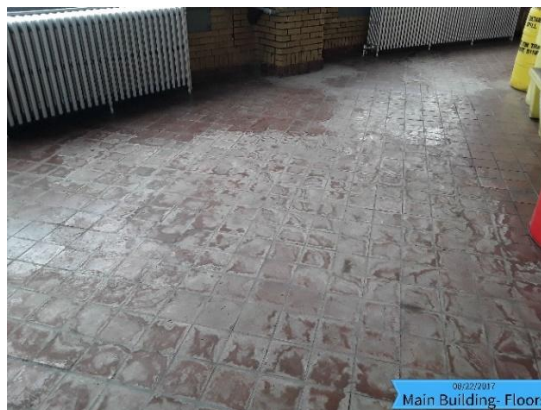
Overall, the glazed masonry on the interior side of the exterior walls is in good condition. However, some areas have water damage requiring surface cleaning at a minimum. It is possible that there is still leakage occurring from the gutters and downspouts which may lead to future damage of exterior and interior masonry.

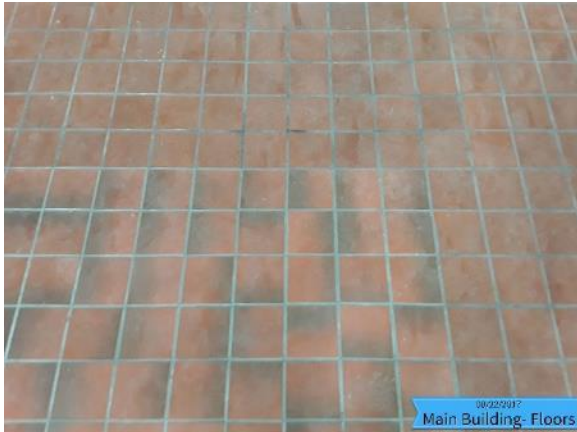
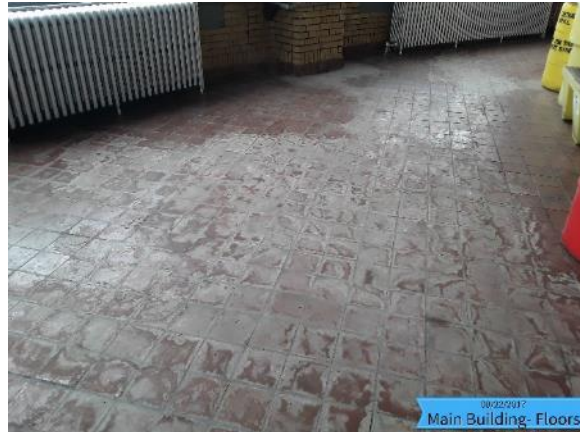
Overall, the quarry tile is in good condition. However, some areas have water damage requiring surface cleaning. As described in the paragraphs above and as can be seen in the photos of the wall and floor, it appears there is still leakage occurring from the downspouts where they penetrate the exterior wall and run down the inside face of the exterior wall, which may lead to future damage to the tile if not corrected.

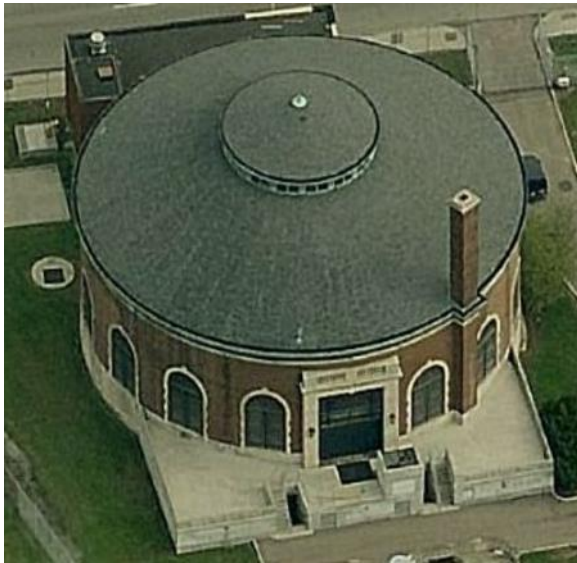
The roof of the Storm Pump Station was replaced in 2016. It appears to be in good condition. The original existing copper gutters and downspouts were preserved in place. GLWA staff informed Arcadis that there is still some leaking into the building, but this may be a result of the downspouts penetrating the exterior wall as opposed to problems with the roof itself.

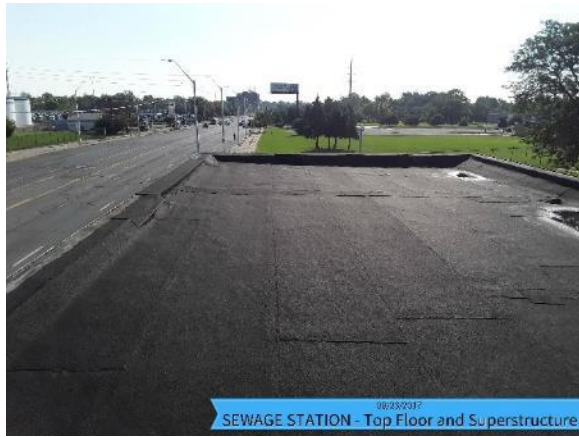
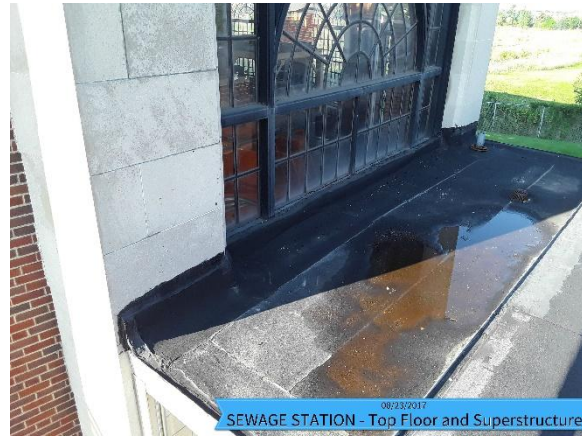
The roof of the Sanitary Pump Station (photos below) appears to be in reasonably good condition with minimal water ponding. There was some evidence on the interior of the building at the roof connecting the Storm Pump Station to the Sanitary Pump Station of water infiltration and it may be desirable to inspect flashing at this location.

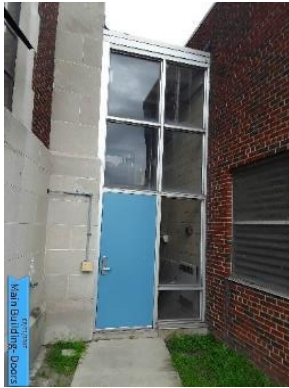
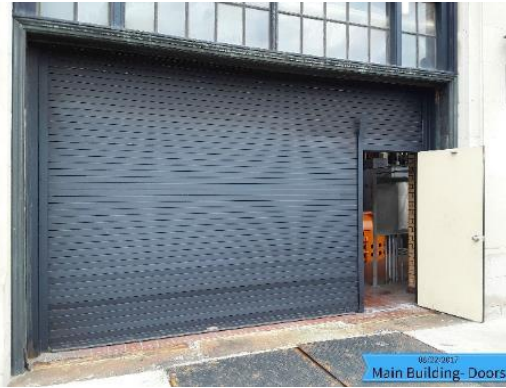
Personnel doors and frames appear to be in good condition. The overhead door and frame at the south of the storm pump structure (circular building) are in a state of deterioration and it may be desirable to replace the door, door frame, and weatherstripping. If replacing the door, insulated door is recommended.

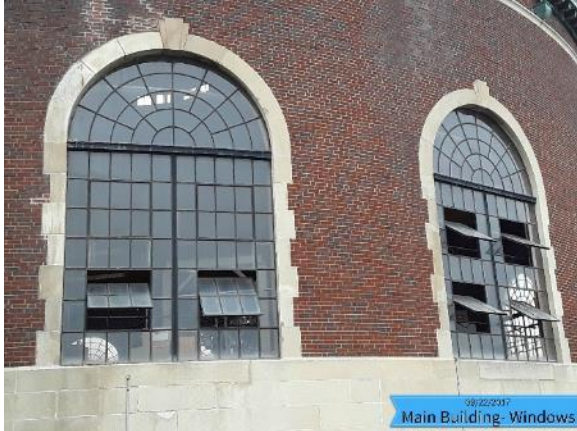
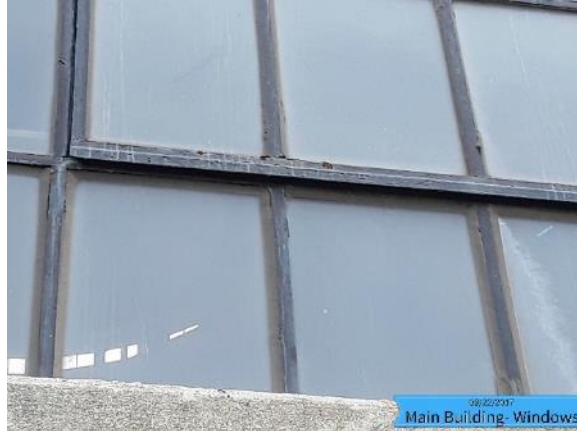
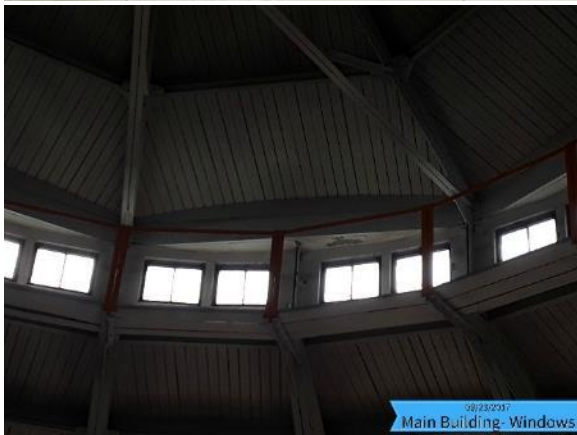
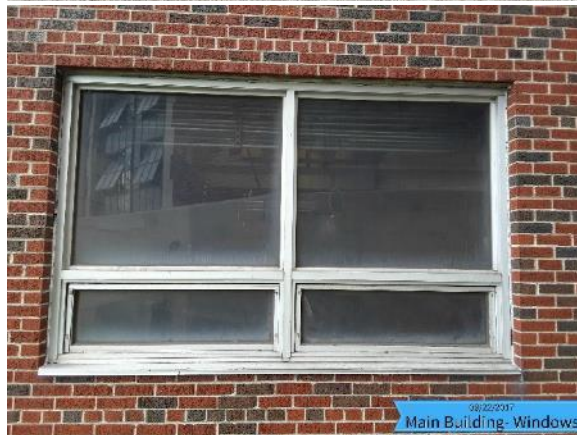
Windows

The window frames appear to be original and are in reasonably good condition, with rusting in some places. The glass was replaced at some point with plexiglass. It may be desirable to replace the window frames with new fiber reinforced plastic (FRP) or other rust proof material. However, this may be cost prohibitive. Arcadis was unable to locate the buildings at Conner Creek on the National Register of Historic Buildings. If the owner is aware of any of these buildings being on the National Registry, this would place restrictions on what can be done with replacement of windows and other building elements.

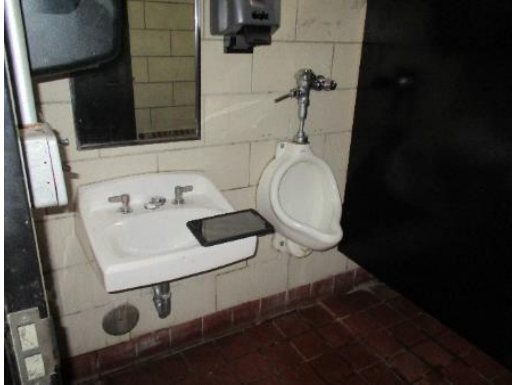
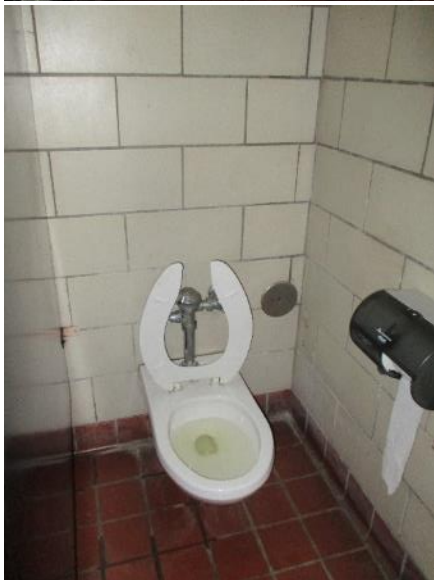
Toilet Room

The toilet room fixtures are in fair condition. It may be desirable to replace these as part of the current work and update them to comply with current ADA requirements. However, it may be noted that the existing toilet room is only accessible by traveling down a flight of stairs. Nevertheless, if the toilet room will receive new fixtures, the new fixtures and toilet room layout will be required to comply with current accessibility requirements.

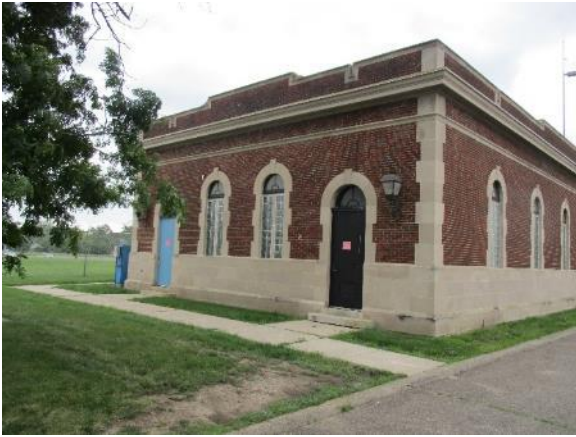
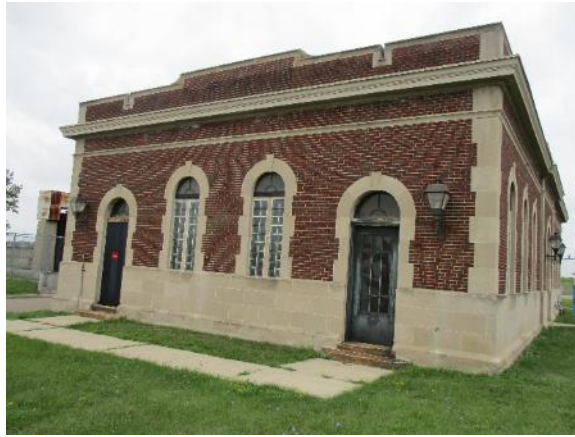
Conner Creek: Primary Switchgear Building

The Primary Switchgear Building was constructed around 1928 and is structurally sound and overall good visual appearance on both the exterior and interior. The structure is comprised of a stone block base, masonry brick upper walls, interior downspouts, and a flat membrane roof. A summary of observations and assessments follow below.

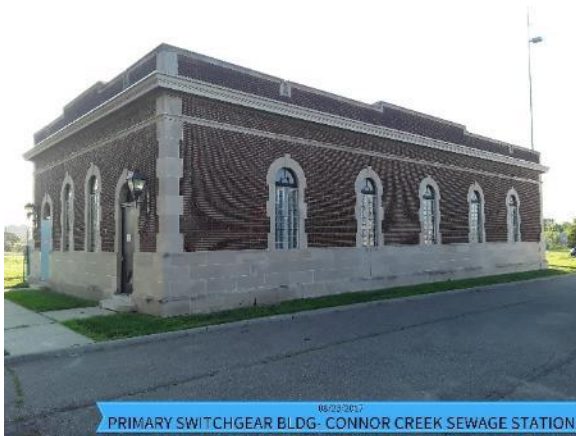
Exterior Walls – exterior side

The masonry brick on the exterior face of the exterior walls is in good condition and does not require repairs or replacement at this time unless minor tucking, pointing, or patching is desired. At this time, the mortar is in reasonably good condition and tucking, pointing, or patching would be for cosmetic reasons only. For bidding purposes, it is recommended to include 20% of wall area for tucking, pointing, or repair work. This can be handled as part of the base bid or an allowance.

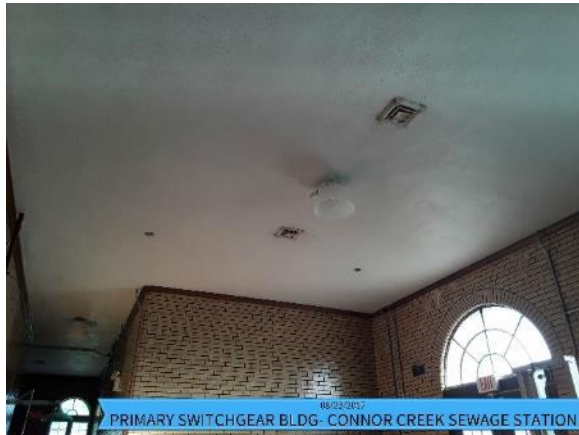
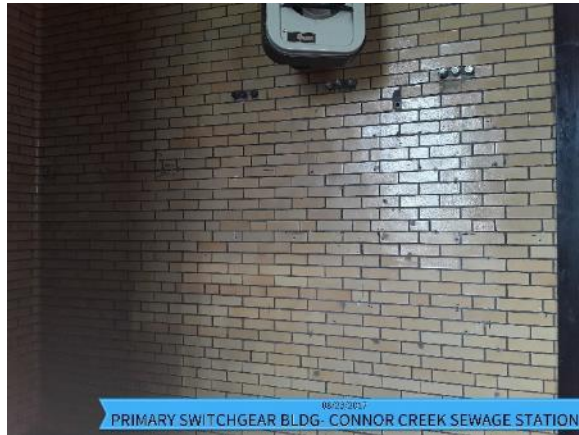
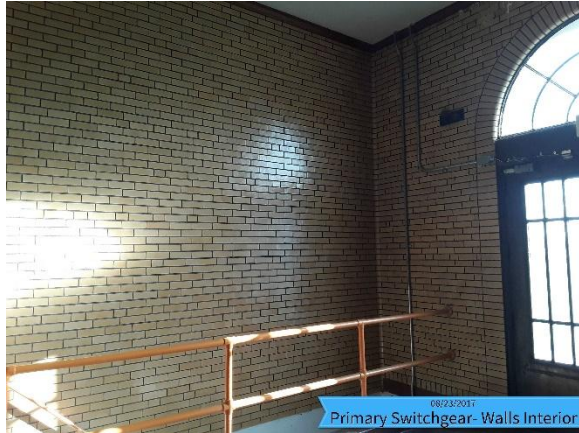
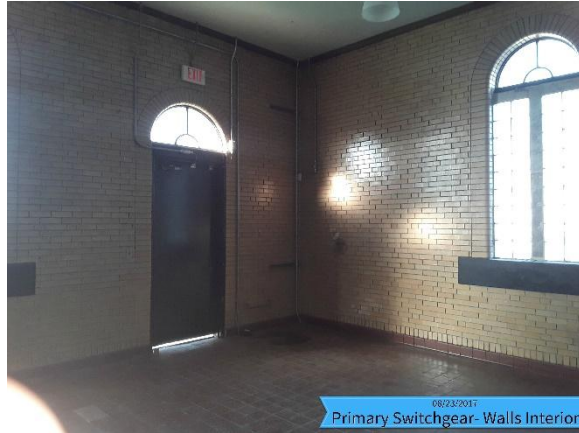
Exterior Walls – interior side

Overall, the glazed masonry on the interior side of the exterior walls is in good condition and does not require major repairs or replacement at this time unless minor patching or replacement of masonry with minor cosmetic damage is desired.

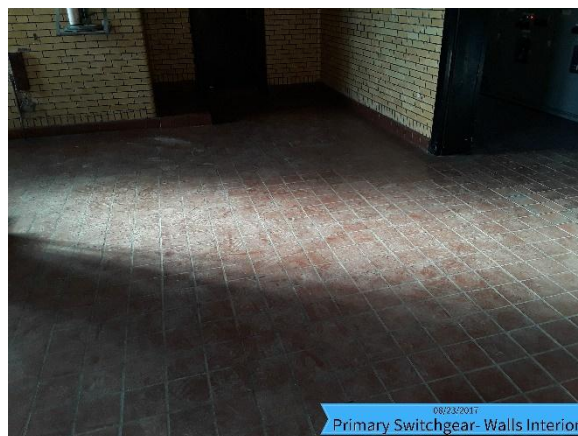
Floors

Overall, the quarry tile in this building is in good condition and does not require repairs at this time. Cleaning and polishing may be desirable.

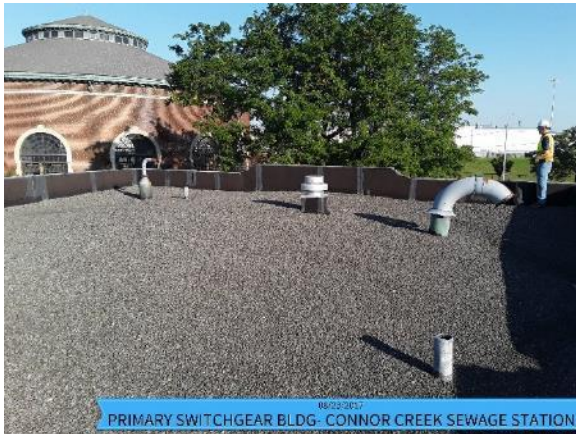
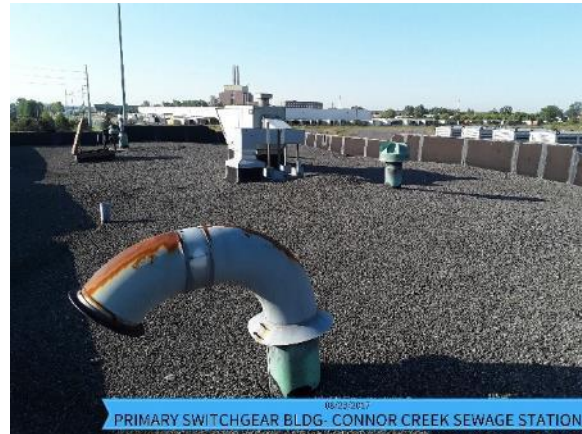
Roof

The roof of this building is a flat membrane system and appears to be in reasonably good condition. There do not appear to be leakage problems at this time.

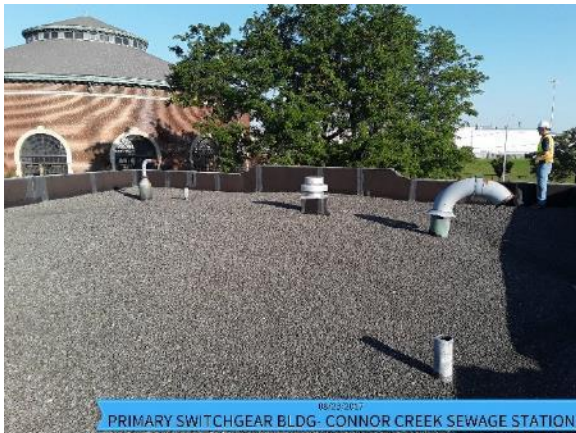
Downspouts

This building has interior roof downspouts which still function without leakage problems. Additionally, there are overflow scuppers that provide a code compliant method for observing if roof downspouts become blocked.
