Great Lakes Water Authority

Freud Pump Station Improvement Project

Project Plan - DRAFT

April 2022

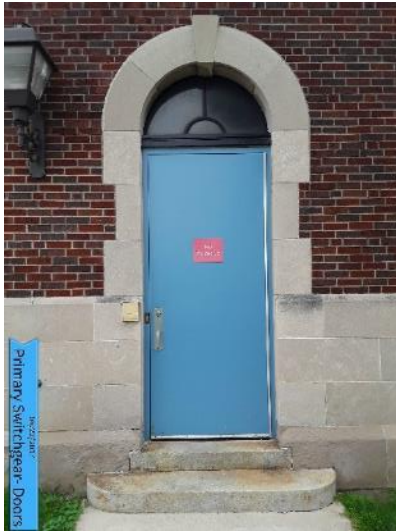
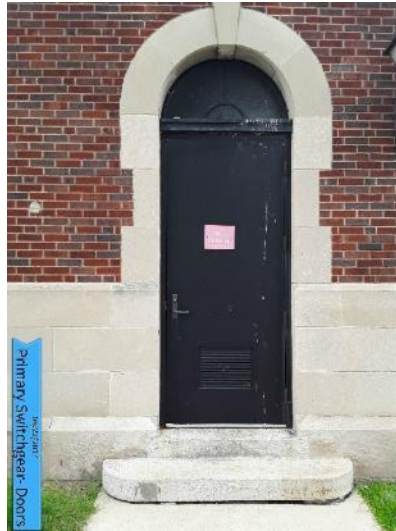
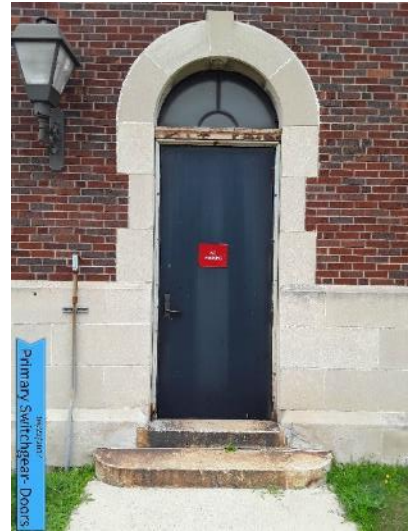
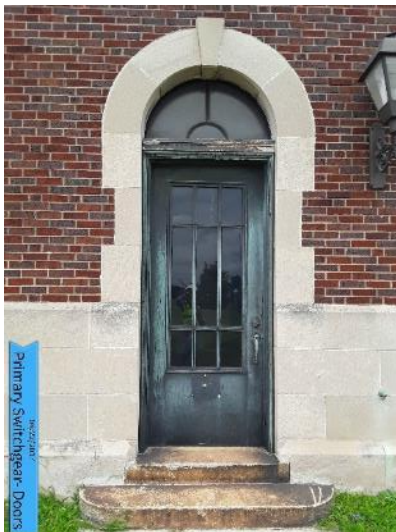
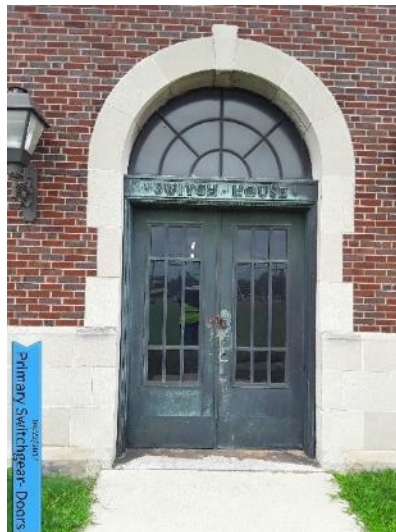
Doors

Newer steel personnel doors and frames (top row) appear to be in good condition with some rust on hinges. It may be desirable to replace the remaining original doors and door frames (bottom row below) which are in fair to poor condition. If replacing doors, insulated FRP doors and door frames are recommended, as is recessing the doors toward the interior of the exterior wall as much as feasible.

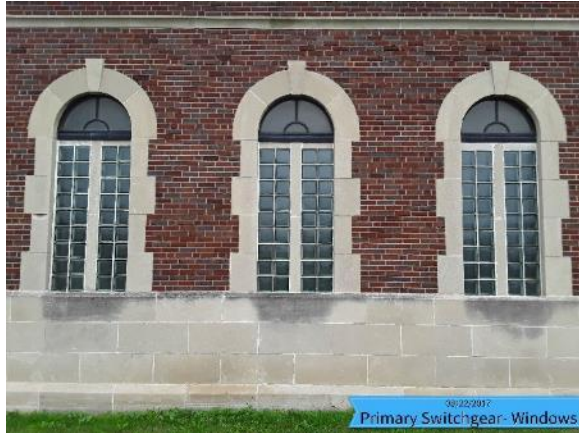
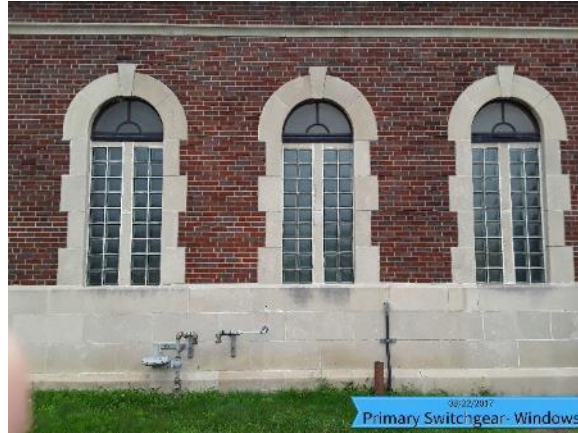
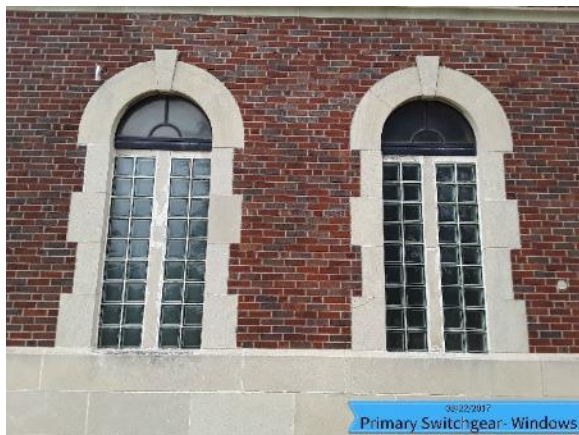
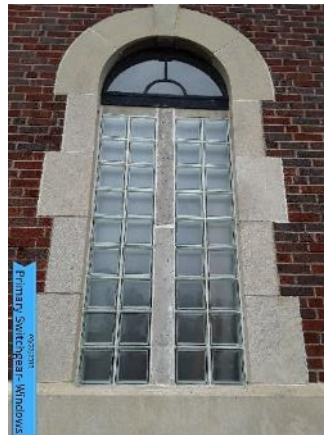
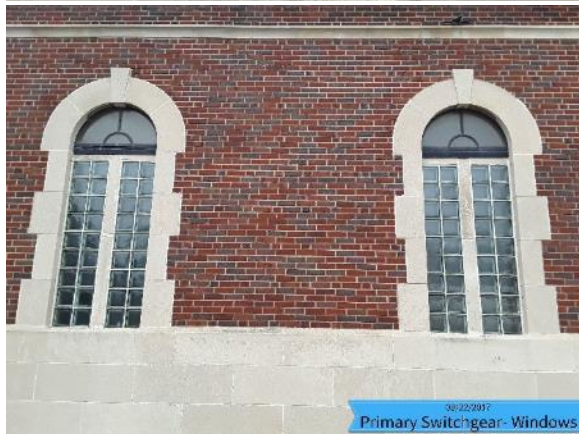
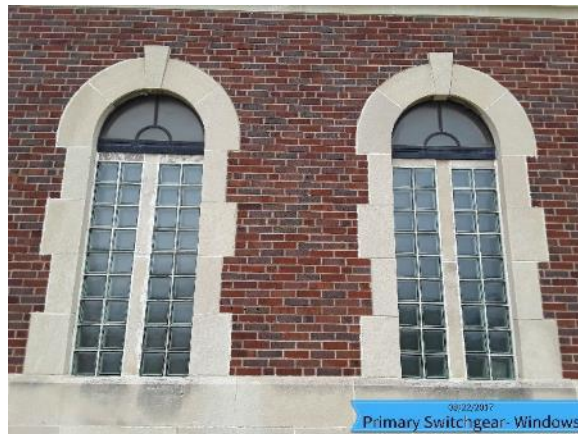
Windows

The upper portion of the windows is original and in fair condition, with rusting in some places. The lower portion of the windows and frames were removed and replaced with glass block. It may be desirable to remove the upper portion and replace with insulated FRP or other rust proof or rust resistant material. Arcadis was unable to locate the buildings at Conner Creek on the National Register of Historic Buildings. If the owner is aware of any of these buildings being on the National Registry, this would place restrictions on what can be done with replacement of windows and other building elements.

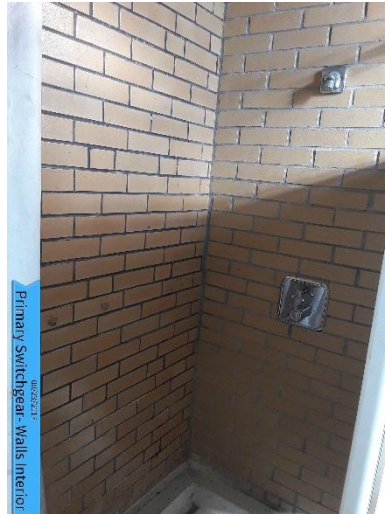
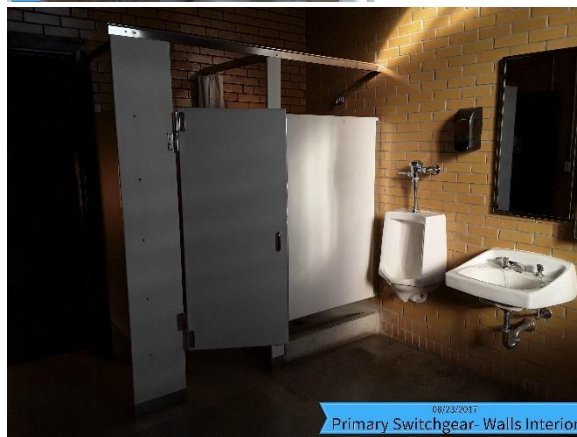
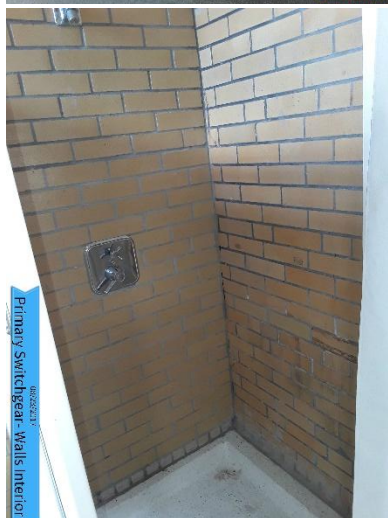
Toilet Room

The toilet room fixtures are in fair condition. It may be desirable to replace the fixtures as part of the current work and update them to comply with current ADA requirements. However, it may be noted that there is currently no accessible entry into this building. Nevertheless, if the toilet room will receive new fixtures, the new fixtures and toilet room layout will be required to comply with current accessibility requirements.

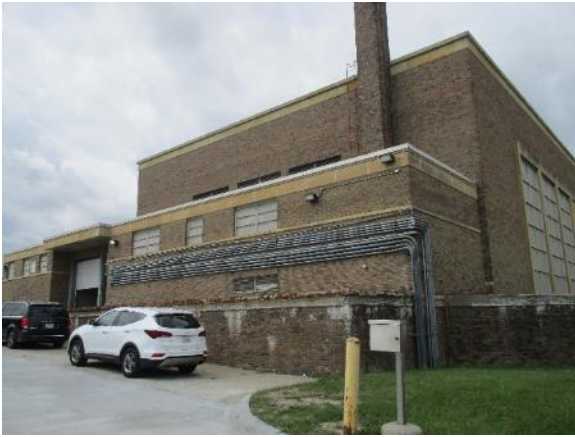
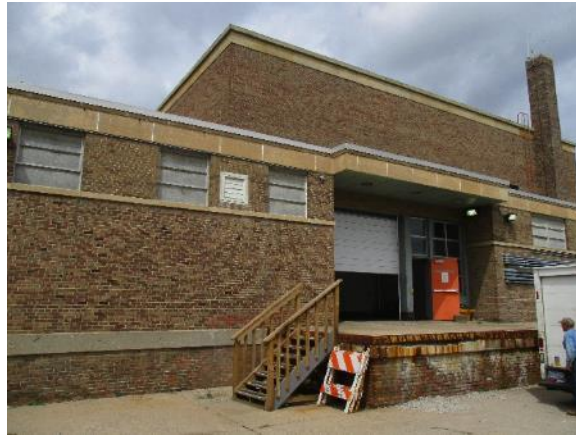
The Freud Pump Station was constructed in 1955 and is structurally sound (see structural), but is in need of some window and finish replacements. A summary of observations and assessments follow below.

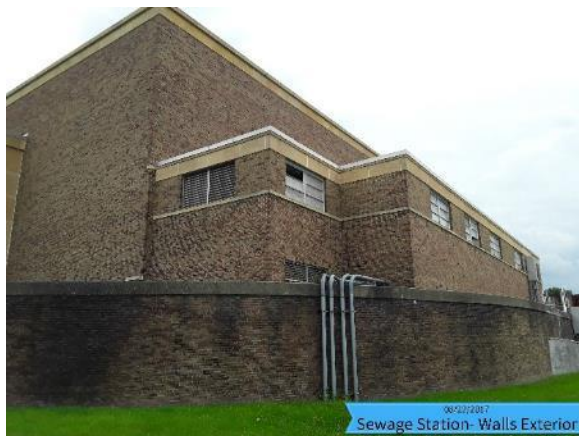
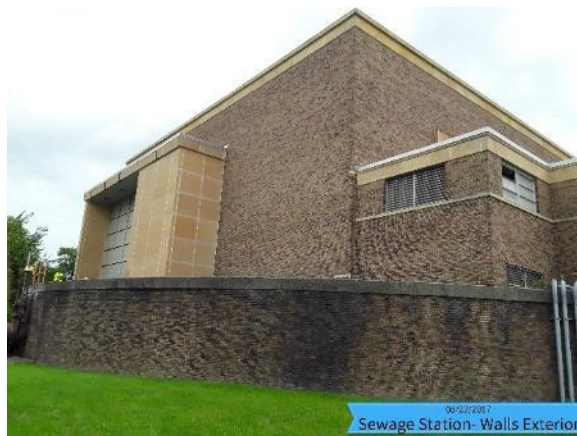
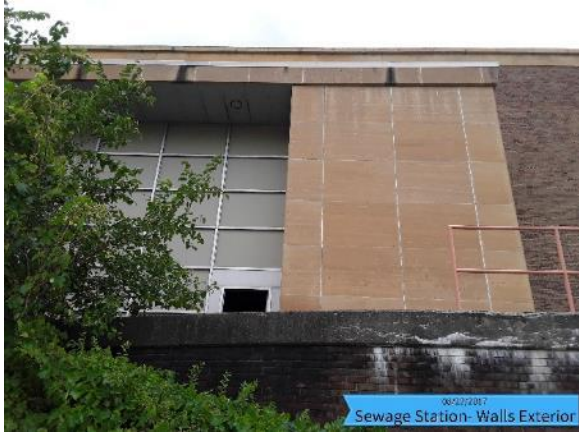
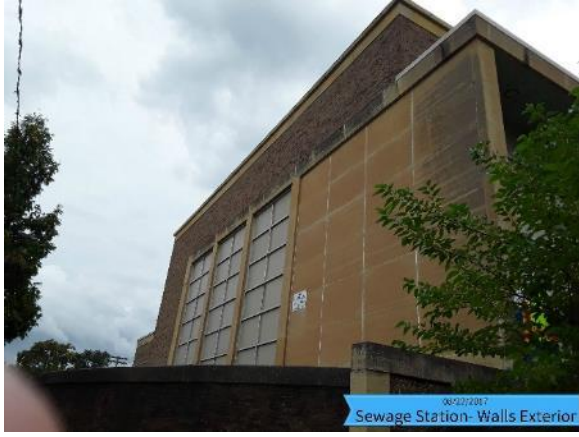
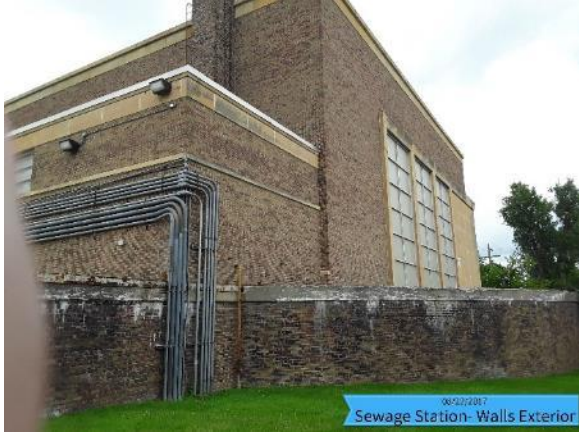
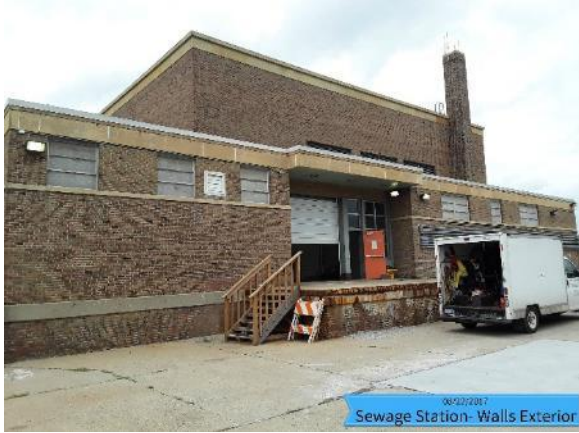
Exterior Walls – exterior side

The exterior masonry brick is in good condition from the main floor level and above. Below the main floor level, there is, in certain areas, efflorescence in addition to deteriorating concrete and rusting metal (see photos). Cleaning, tucking, pointing repair work of masonry as well as cleaning and repairs/replacement of concrete and/or metal support work is needed. At this time, the mortar issues are mostly cosmetic but in some areas, tucking, pointing and repairs are warranted or they may become structural concerns in the future. For bidding purposes, it is recommended to include 20% of wall area for tucking, pointing, or repair work. This can be handled as part of the base bid or an allowance.

The masonry brick on the exterior face of the exterior walls is in good condition and does not require repairs or replacement at this time unless minor tucking, pointing, or patching is desired. At this time, the mortar is in reasonably good condition and tucking, pointing, or patching would be for cosmetic reasons only. For bidding purposes, it is recommended to include 20% of wall area for tucking, pointing, or repair work. This can be handled as part of the base bid or an allowance.

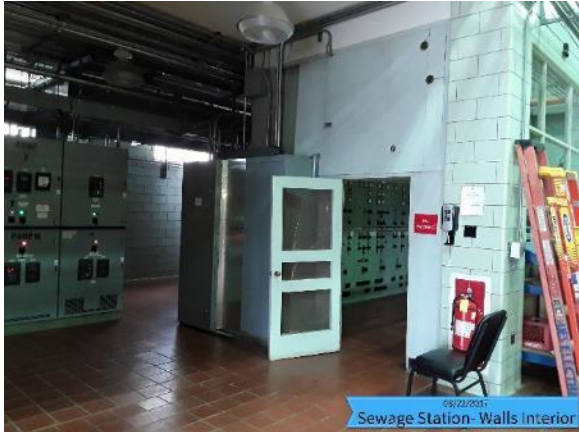
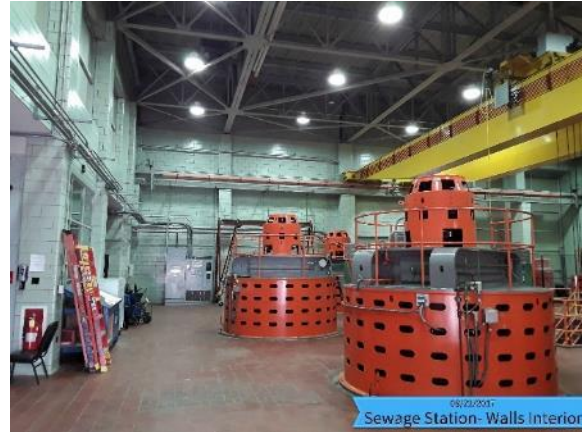
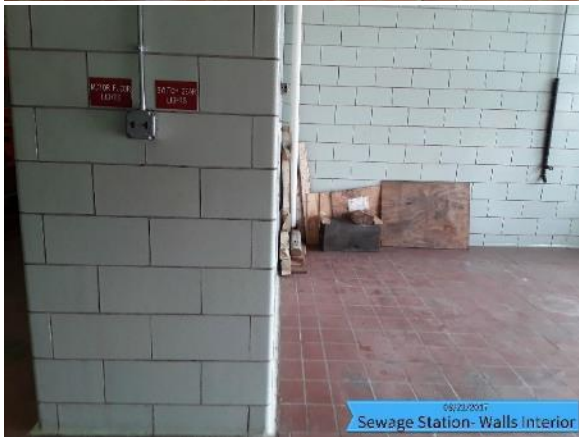
Exterior Walls – interior side

Overall, the glazed masonry on the interior side of the exterior walls is in good condition. It does not appear that repair or replacement are required at this time.

Overall, the glazed masonry on the interior side of the exterior walls is in good condition and does not require major repairs or replacement at this time unless minor patching or replacement of masonry with minor cosmetic damage is desired.

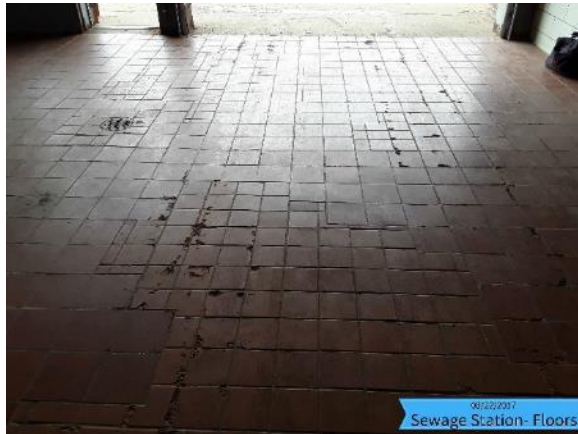
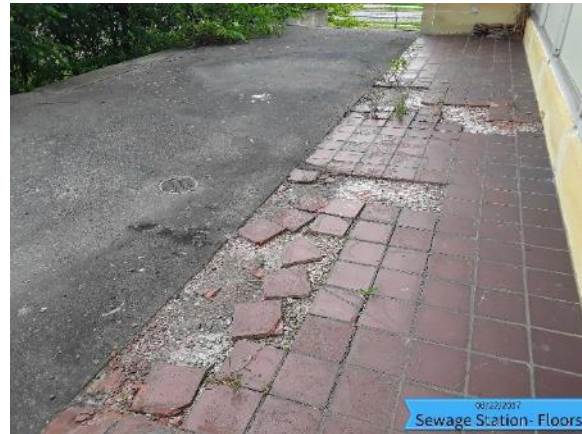
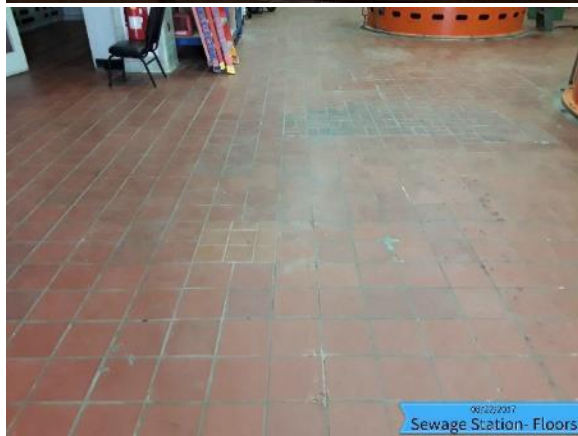
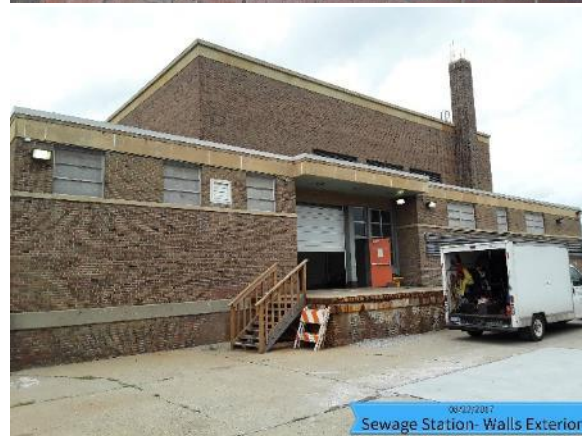
Floors

In most of the building areas, the quarry tile is in good condition. However, certain areas have significant damage or have detached completely from the subfloor and require replacement. This is particularly the case in the loading dock area as well as on the exterior of the North part of the building. GLWA staff requested alternate floor options for the loading area that do not involve tile and that will better withstand the loads and frequent movement in this area. Metal tracks were suggested for moving the heavy equipment from the crane drop off to the exterior dock and vice versa. Arcadis recommends additional investigation into equipment that can better move the pumps into and out of the facility. The existing floor finish (quarry tile) can be removed and replaced with new tile or terrazzo flooring and the metal tracks can be installed. However, Arcadis believes that if it is the intent to continue to use the existing skid in the future to move the pumps, any new flooring will eventually be damaged, regardless of metal tracks. We can help investigate options such as air pallets which utilize compressed air. For the exterior of the North part of the building, we recommend removal of the existing tile, grinding and sealing of the existing concrete beneath the tile, but no replacement tile unless some new floor finish is desired by the owner. It should also be noted that the current stairway up to the loading dock is not code compliant and must be replaced in its entirety. If accessibility is warranted for the facility, a ramp can be designed along with the new stair.

Overall, the quarry tile in this building is in good condition and does not require repairs at this time. Cleaning and polishing may be desirable.

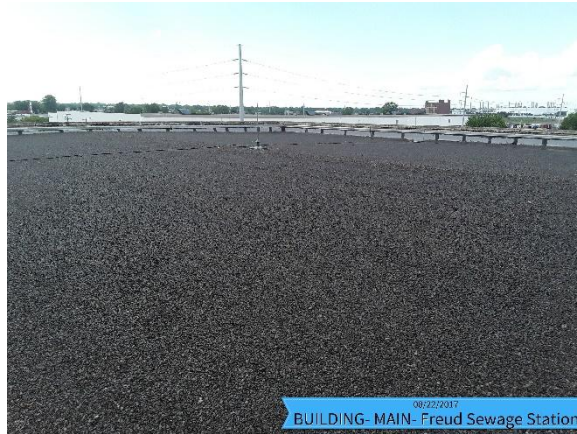
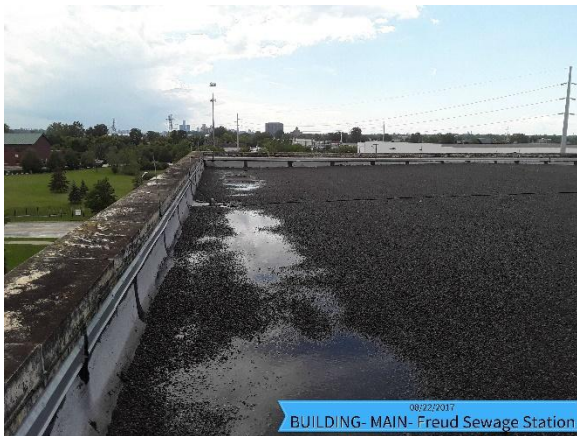
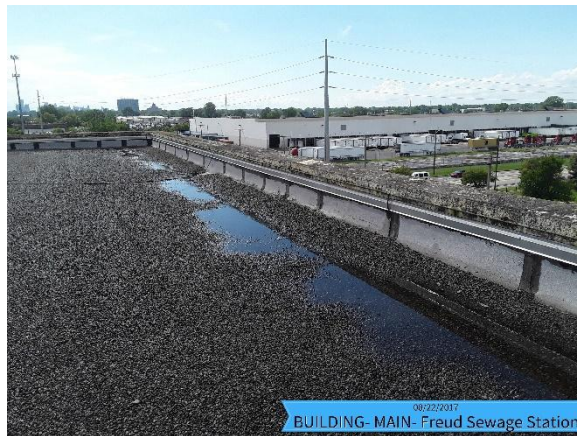
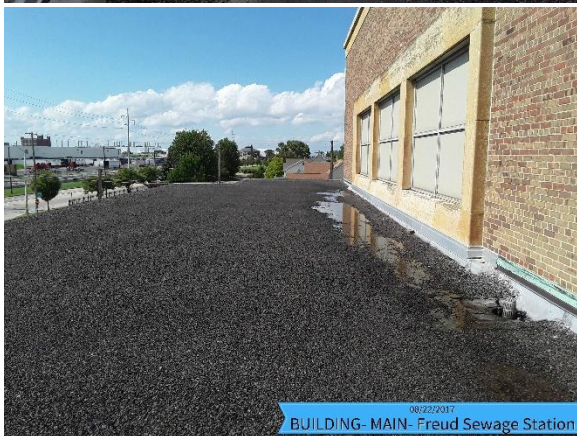
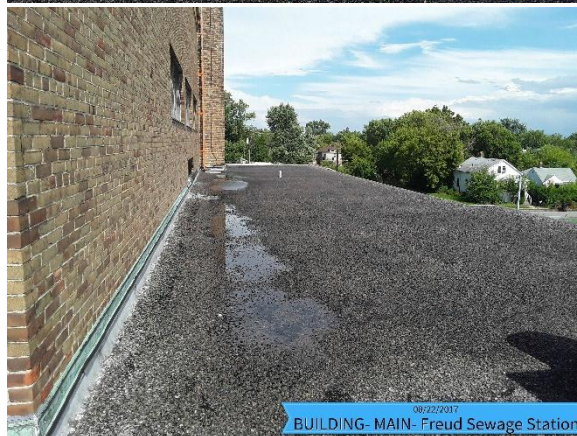
Roof

No leakage problems were observed on the interior or exterior of this building. Minimal standing water. The roof appears to be in reasonably good condition. GLWA staff mentioned that there was some roof repair work above stormwater motor #5 due to leakage (approximate location identified with red oval below).

The roof of this building is a flat membrane system and appears to be in reasonably good condition. There do not appear to be leakage problems at this time.

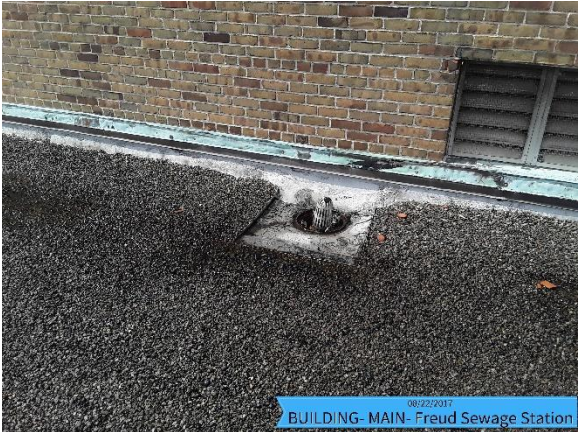
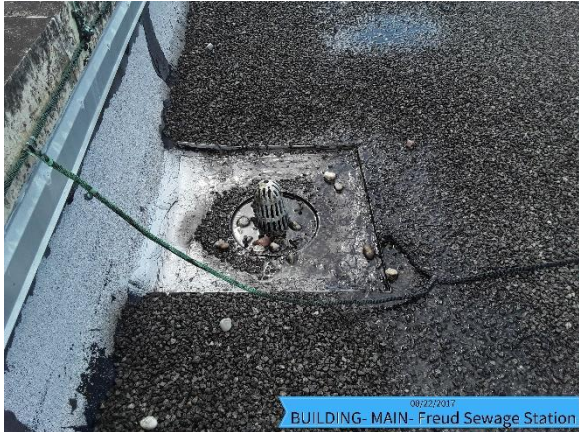
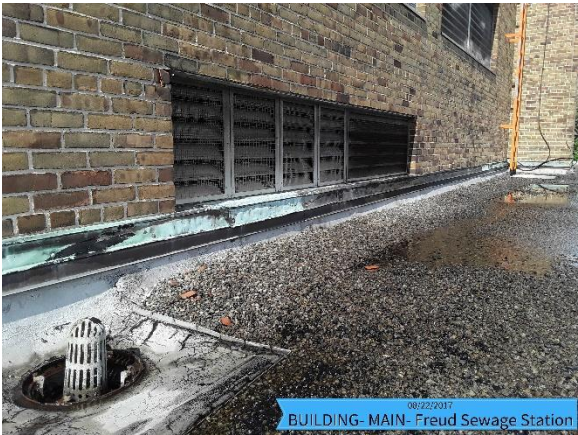
Roof drains

No leakage problems were observed on the interior or exterior of this building. The roof drains appear to be adequately removing water from the roofs.

This building has interior roof downspouts which still function without leakage problems. Additionally, there are overflow scuppers that provide a code compliant method for observing if roof downspouts become blocked.

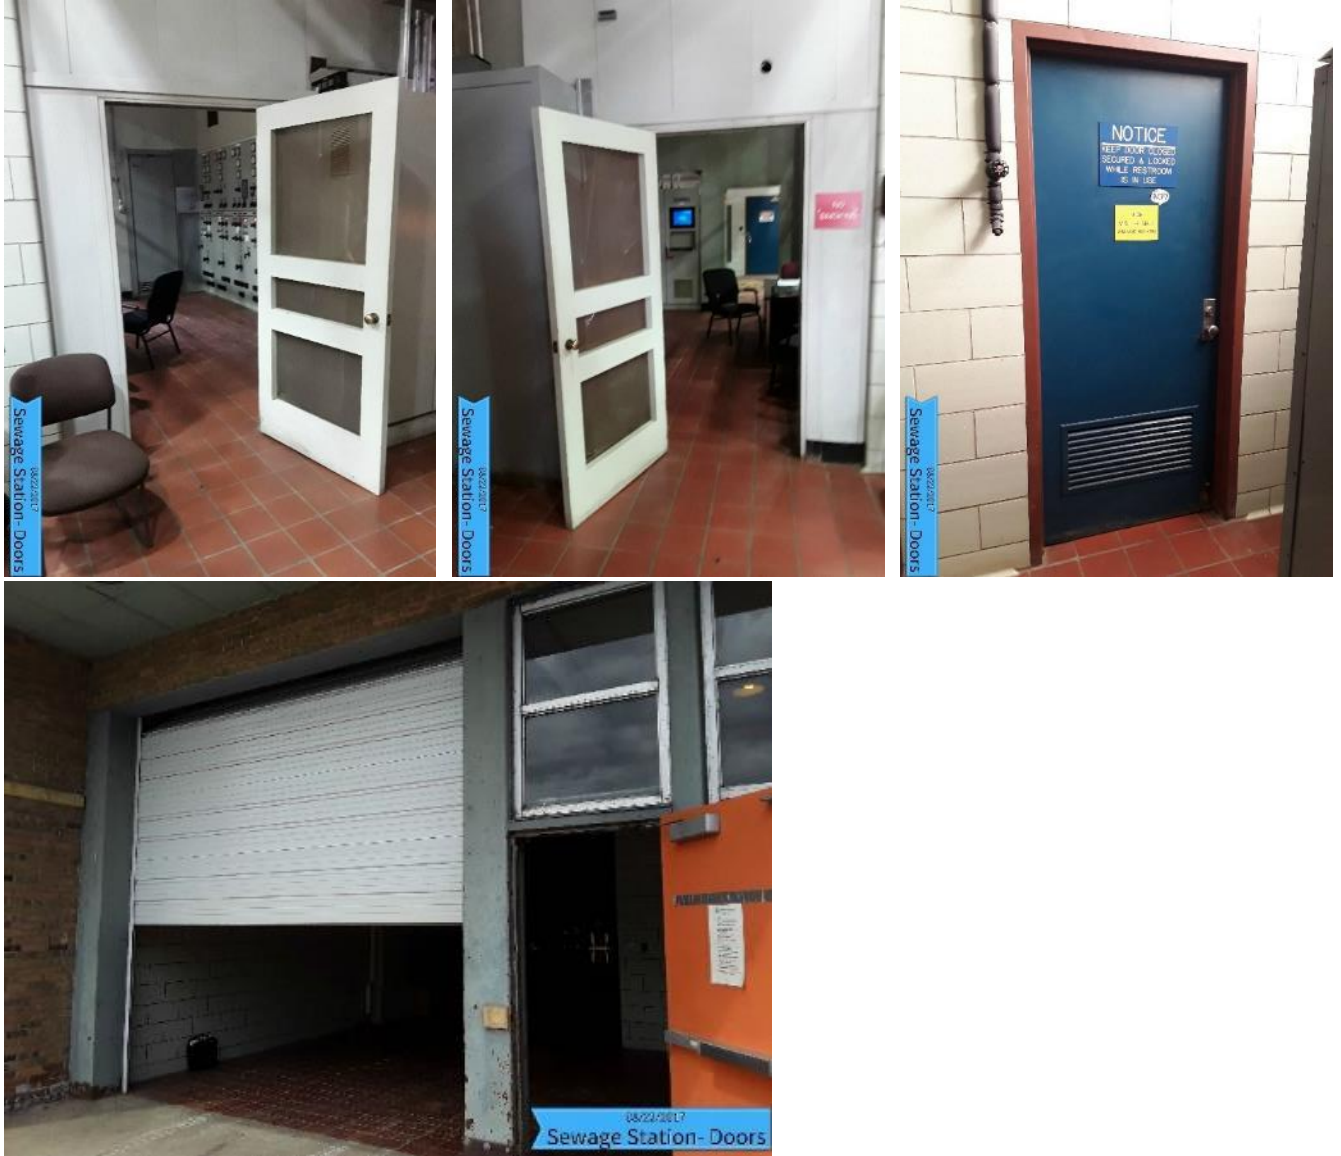
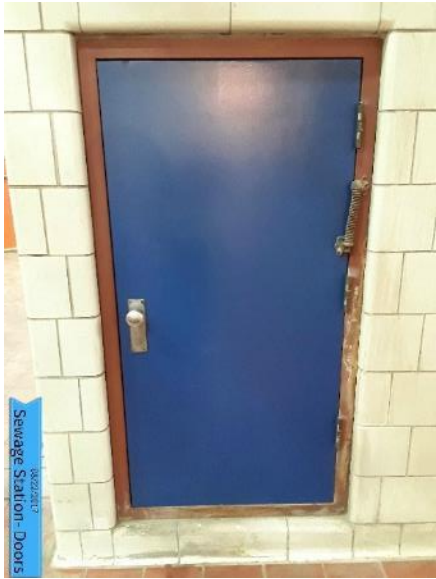
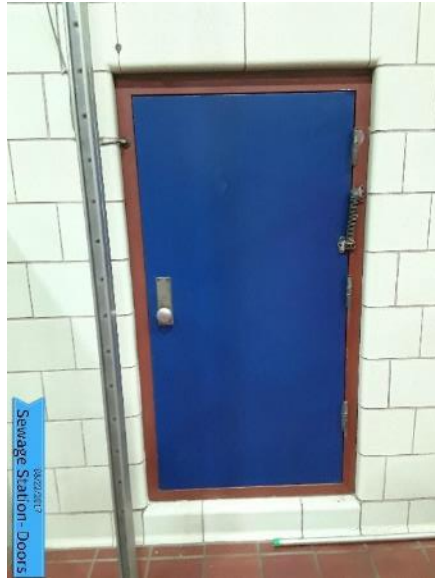
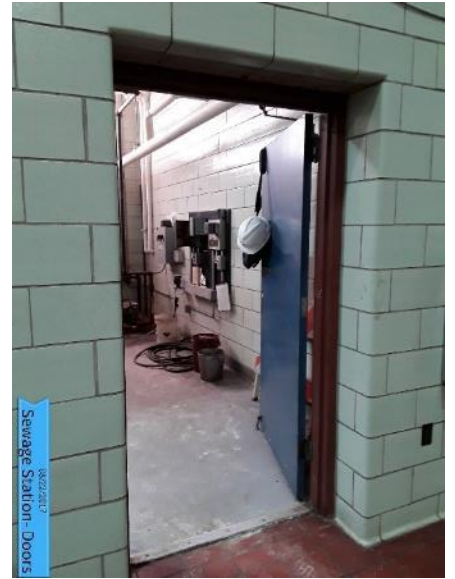
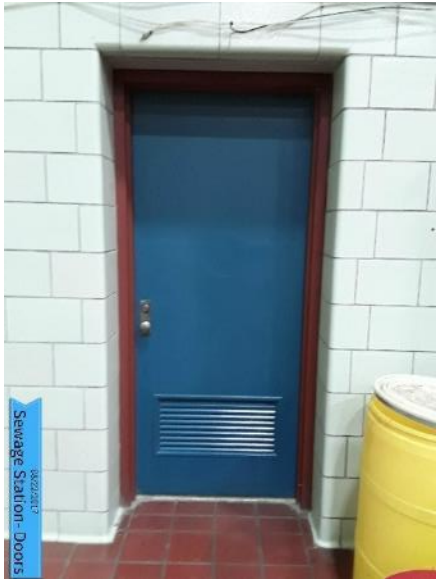
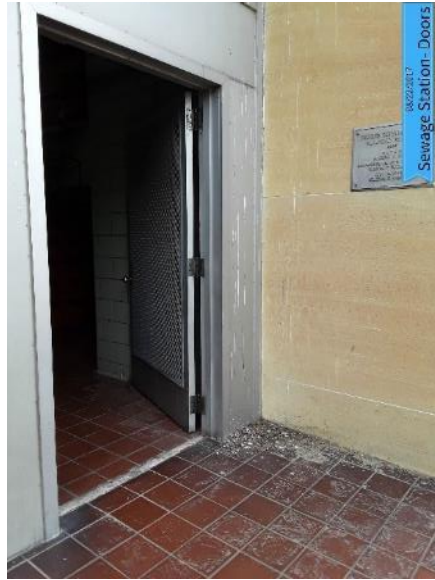
Doors

Personnel doors and frames appear to be in good condition. If door replacement is desired by the owners as part of this work, insulated FRP (fiber reinforced plastic) or insulated metal doors are recommended.

The exterior overhead door and personnel door and window assembly (second row, left) has been modified over the years. It may be desirable by the owner for Arcadis to propose a redesign of this entryway, replacing both doors and the windows to provide a more functional configuration for current use.

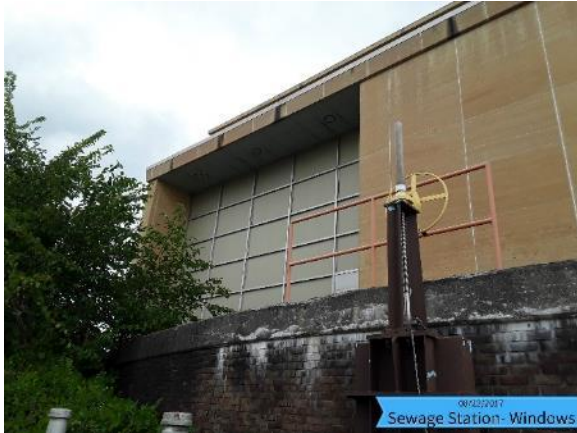
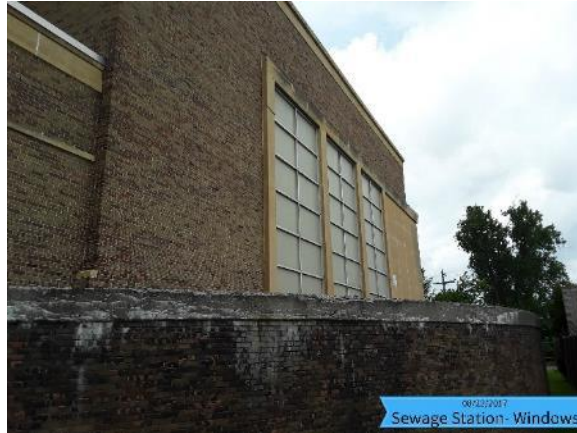
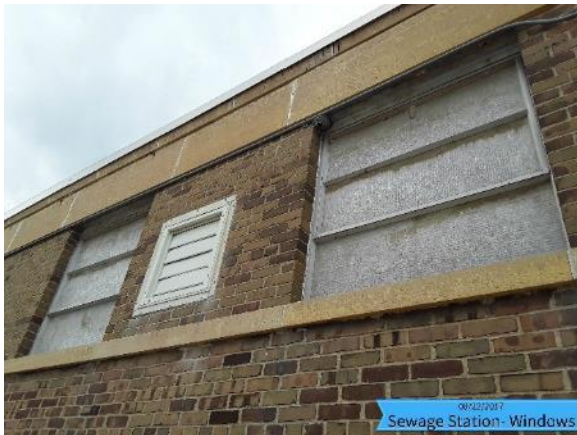
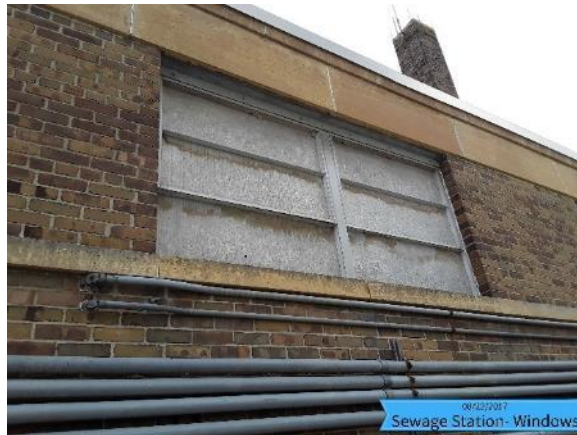
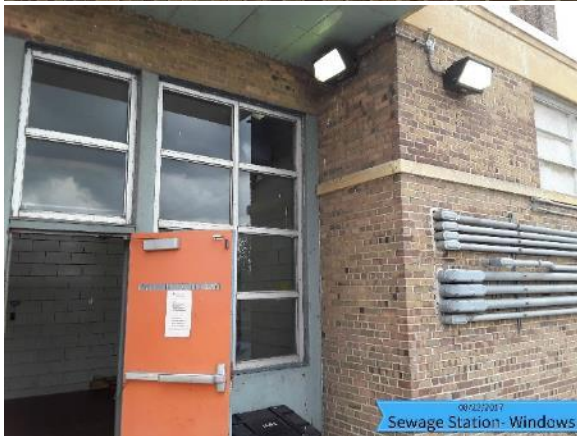
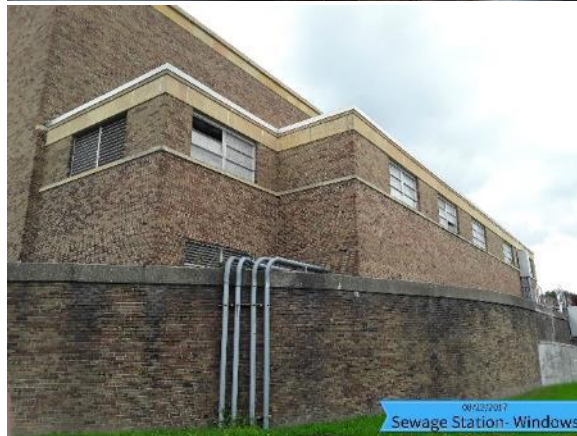
Windows

The window frames appear to be original and are in reasonably good condition. The glass was replaced with an opaque, flexible material to deal with a problem of vandals attempting to break the glass. It is our understanding that the owners would like to replace the opaque material with something transparent (clear glass) or translucent (frosted glass) to permit daylight to enter the facility. The material selected will be resistant to vandalism. If the owners desire operable windows in certain locations, those window frames will require replacement.

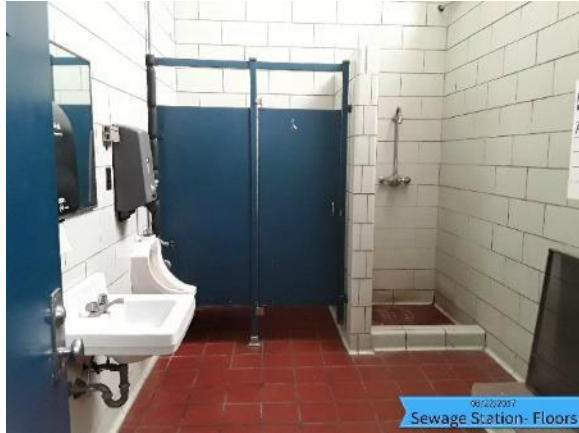
Toilet Room

The toilet room fixtures are in fair condition. It may be desirable to replace these as part of the current work and update them to comply with current ADA (accessibility) requirements. However, it may be noted that the existing toilet room is only accessible by traveling up a flight of stairs to the main building entry (no accessible entry exists). Nevertheless, if the toilet room will receive new fixtures, the new fixtures and toilet room layout will be required to comply with current accessibility requirements, particularly if an accessible ramp to get to the main floor level will be provided as part of this work.

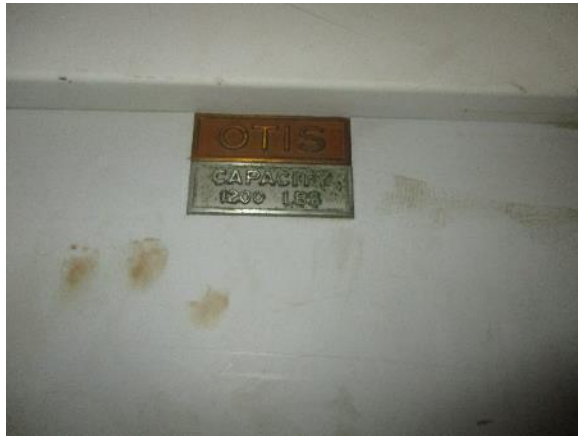
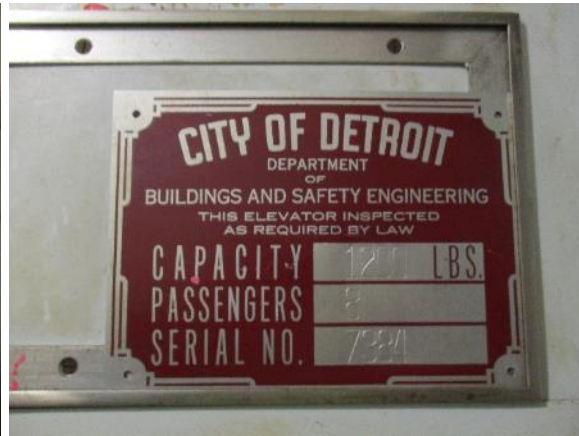
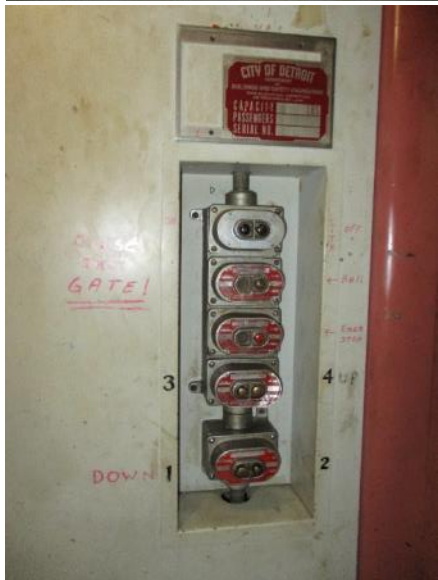
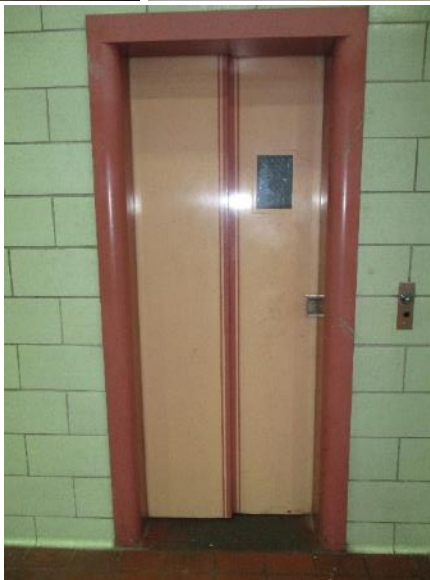
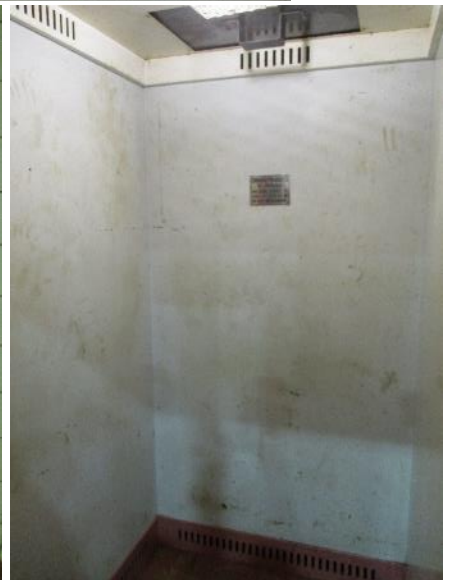
Elevator – personnel

The existing personnel elevator is not functioning properly and requires replacement at this time. A new elevator will be selected as part of the design and specifications of this work.

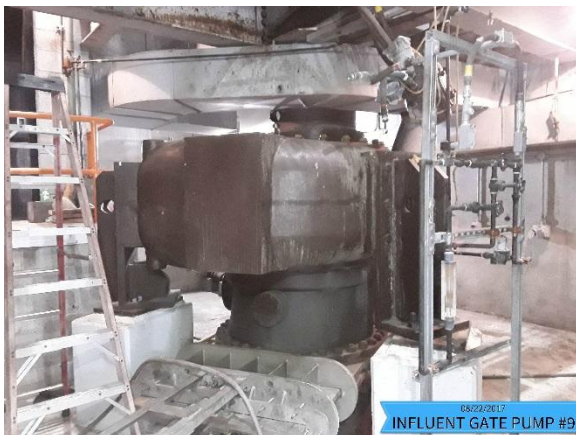
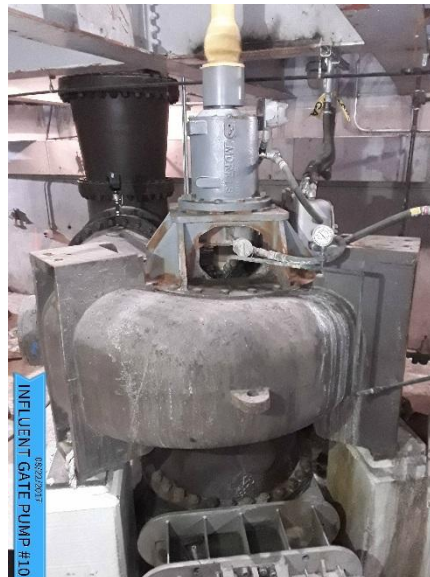
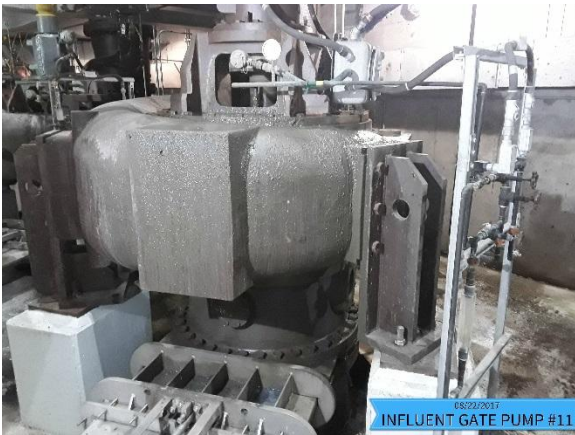
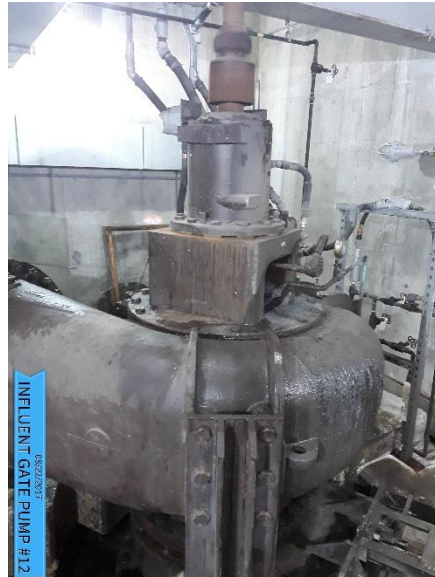
Sanitary Pumps

There are four sanitary pumps which are used to convey dry weather flow. These have experienced maintenance issues due to excessive wear and vibration believed to be caused by poor hydraulic conditions in the wet well. One of the pumps had been physically removed and was out of service at the time of the assessment. The general condition of the pumps is good, likely due to being rebuilt on a regular basis. The capacity of the pumps is questionable, as all four pumps are run on a regular basis to convey flow, leaving no standby pump or redundancy.

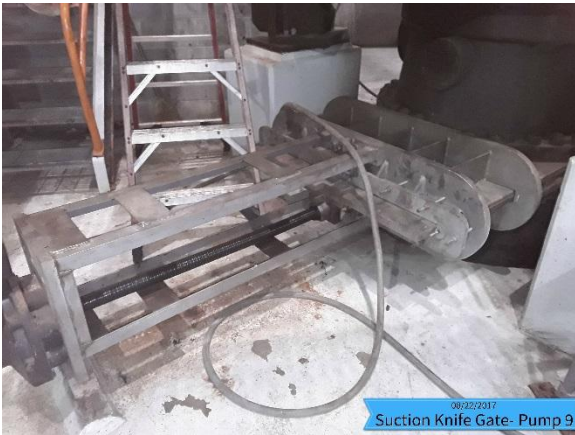
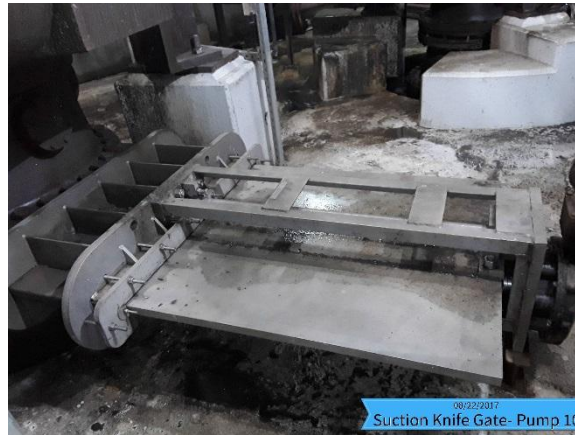
Sanitary Suction Knife Gates

The sanitary suction knife gates are in good condition and are manually operated to isolate each of the four sanitary pumps from the wet well.

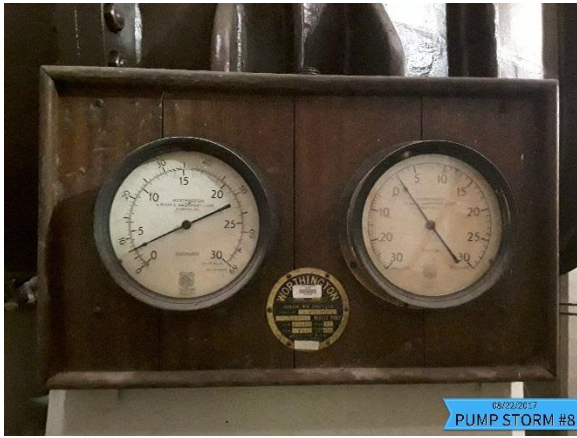
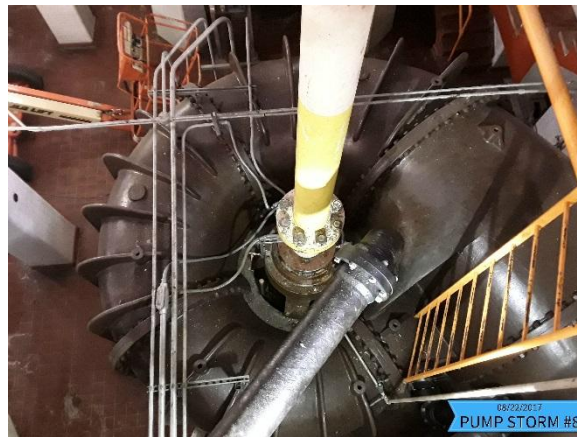
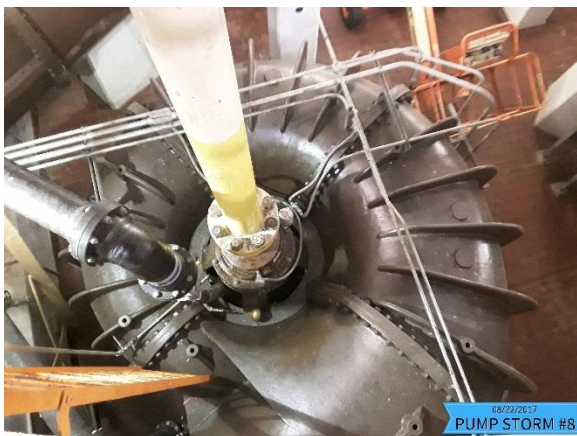
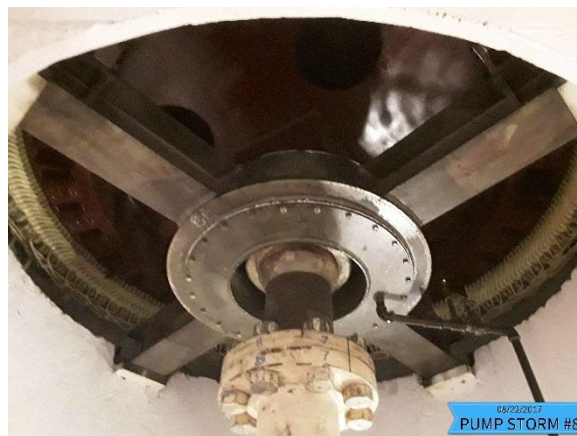
Storm Pumps

The storm pumps are of original construction to the pumping station, installed in phases as capacity was needed over the years, and are in good condition externally. The concrete supports and ancillary piping systems are in good condition as well. Operational issues include problems with priming the pumps to put them in operation, which is addressed in the section on the Vacuum Priming Systems, and an inadequate seal water supply, which is pooled on top of the pumps and drawn into the pump case. Seal water is in short supply when several pumps are running.

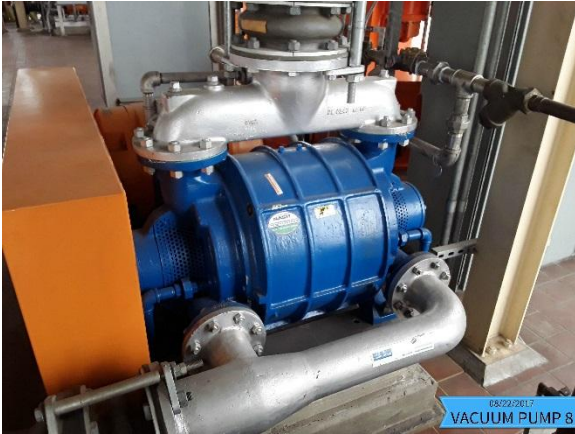
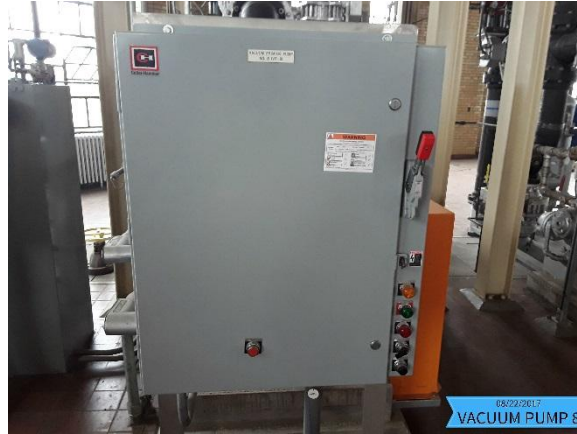
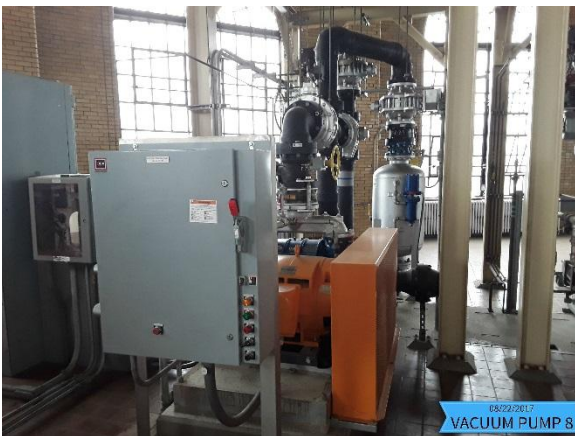
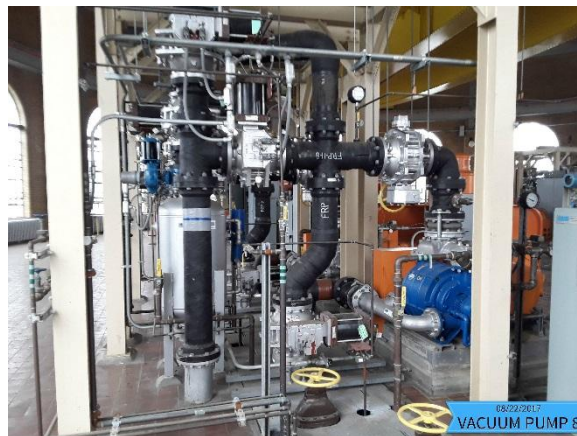
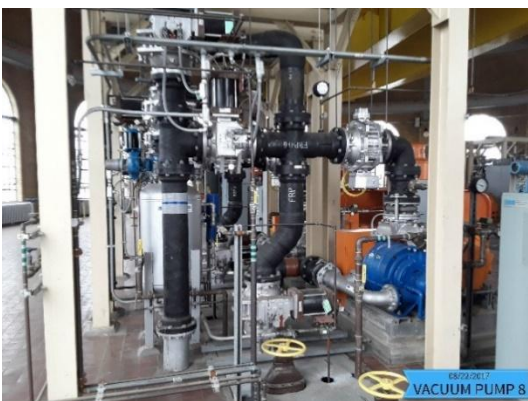
The Vacuum Priming Systems are present as a stand-alone system for each of the storm pumps to fill the pump volutes with water, so that the pumps can be primed to start pumping during wet weather. Once the pumps are primed, they will continue in operation without the priming system running until they are shut down and the pump volute drains back to the wet well. These systems have been problematic and unreliable in the past, although the components and instrumentation appear to be in good condition. The vacuum priming systems are very complex, as they rely on multiple instruments and actuated valves to achieve the proper sequence in filling the pump volute. Any component failure or vacuum leak will leave the associated pump inoperable.

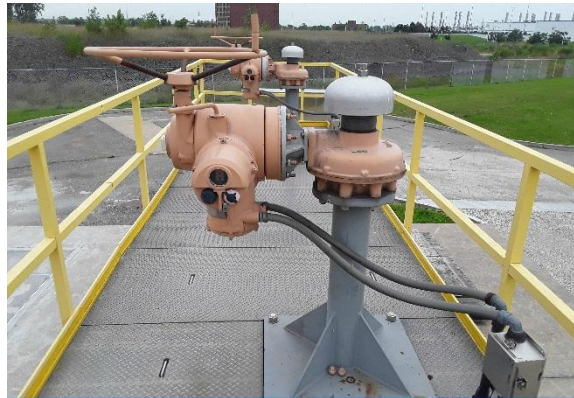
The Conner Storage Gates provide an outlet from the Conner Creek Sewer to the Conner Creek Open Channel. These were installed in 2002 and all nine appear to be in good condition with minimal corrosion, and appear fully operational. One item to note is that several of the motor/control enclosures were tagged with blue tape and marked "Needs 5 kW kit". Damage was also noted on the flexible electrical conduit for one of the actuators.

08/22/2017
 CONNOR STORAGE GATE 2- 204 x 120 RODNEY HUNT - ROTORK IQ70 ACTUATOR

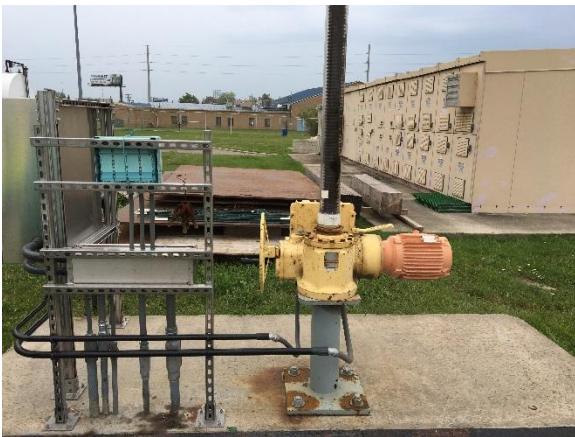
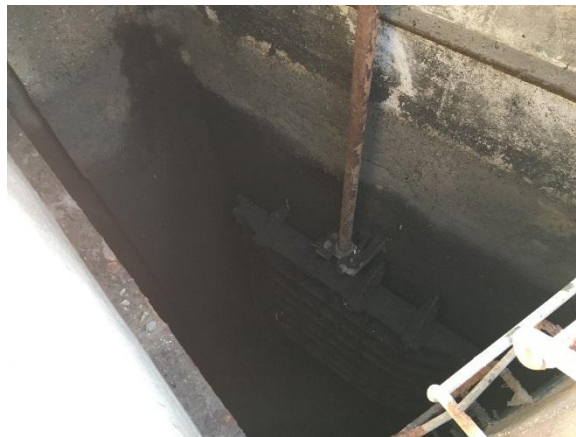
Sanitary Sluice Gates are located in drop shaft manholes located on the east and west side of the sanitary wet well. These gates provide isolation for the wet well along with a third gate connecting the sanitary wet well and the storm wet well. The gates themselves are inaccessible at the bottom of the structures, although the gate operators and actuators are above grade and appear operational.

Sanitary Sluice Gates are located in drop shaft manholes where coarse basket screens prevent large debris from entering the sanitary wet well. There is concern about screen blinding since the coarse basket screens are manually removed and cleaned. To address this and other concerns, the gate separating the sanitary and storm water wet wells is normally open. A previous evaluation noted that the drop at the sluice gate chambers results in entrained air which causes poor hydraulic conditions at the sanitary pumps.

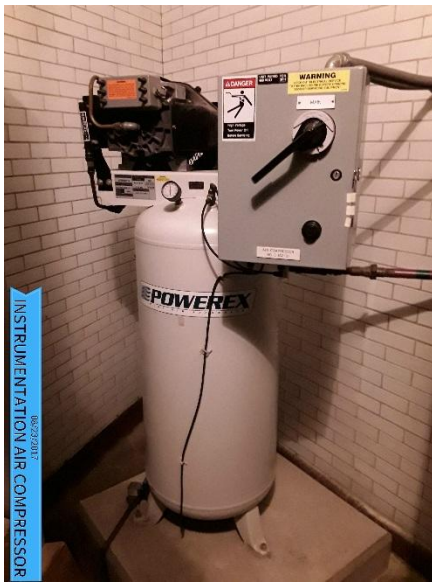
The Air Compressor was installed in 2004 and is in good condition with only minor corrosion around the mounting feet on the concrete pad.
