Great Lakes Water Authority

Freud Pump Station Improvement Project

Project Plan - DRAFT

April 2022

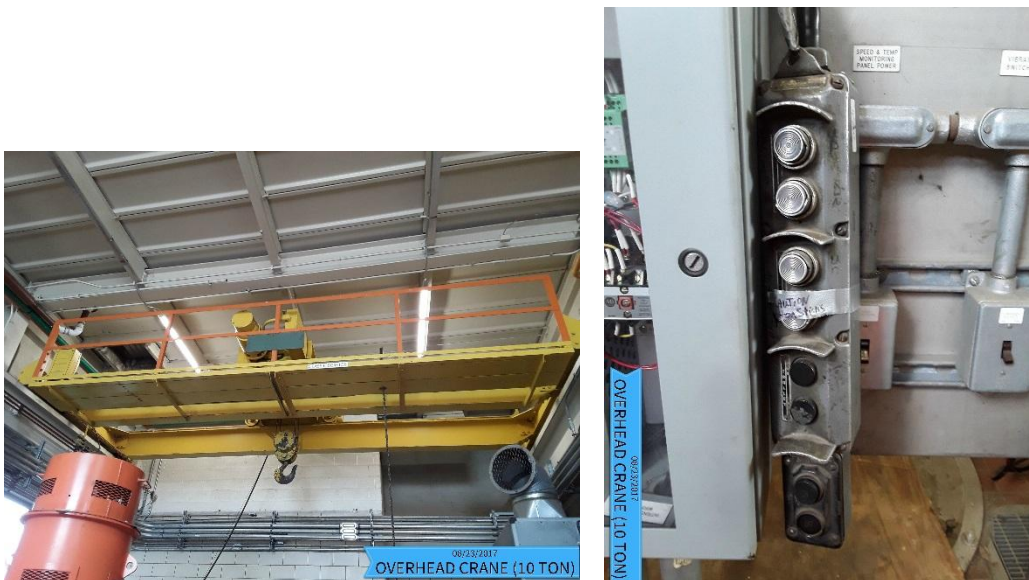
Cranes

The crane in the sanitary pumping station consist of a 10-ton capacity bridge crane, and is likely original to the station, being built in the 1950's. It is in good condition and is functional, although one of the buttons on the pendant control is tagged as "caution button sticks".

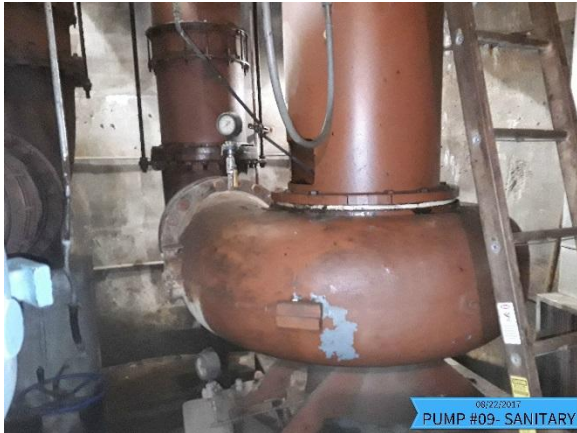
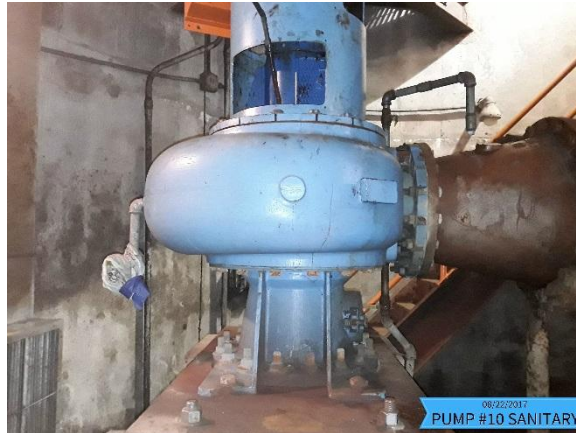
Sanitary Pumps

The two sanitary pumps are located at the lowest level in the station and handle the dry weather sanitary flow. These pumps were originally dewatering pumps for intermittent use but were repurposed for full time use as sanitary pumps and may not be operating within the original design range. The pumps are removed for rebuilding/replacement periodically and are switched with spares that are kept on hand at the station. The condition of the pumps is good with minor corrosion of some of the hardware and the steel supports.

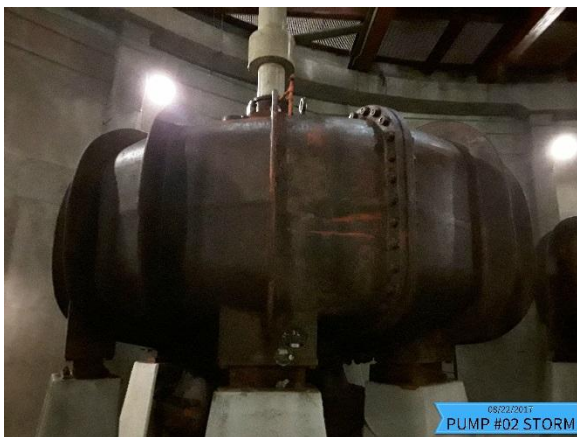
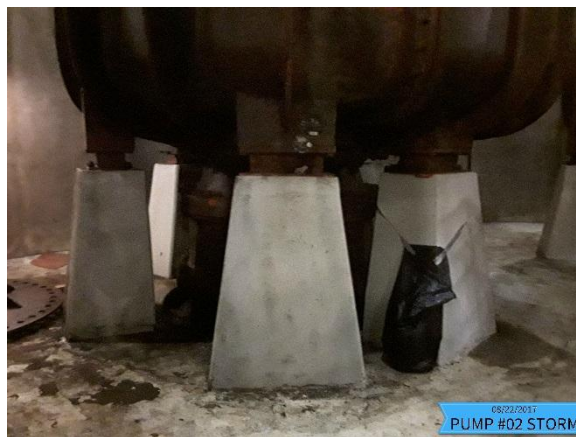
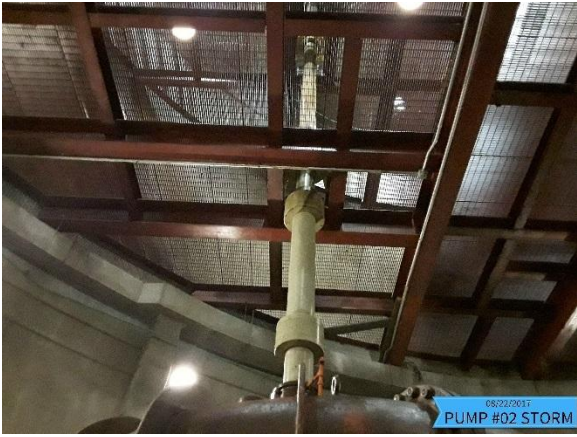
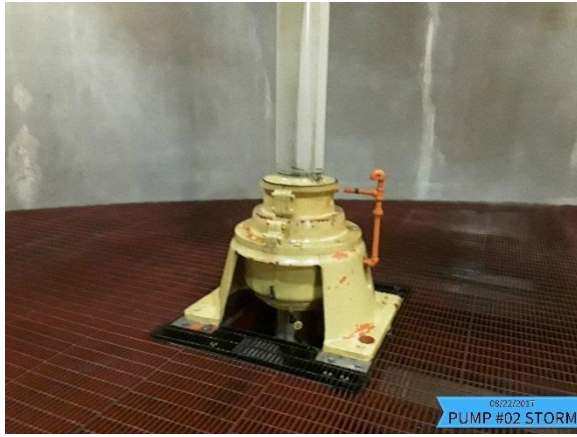
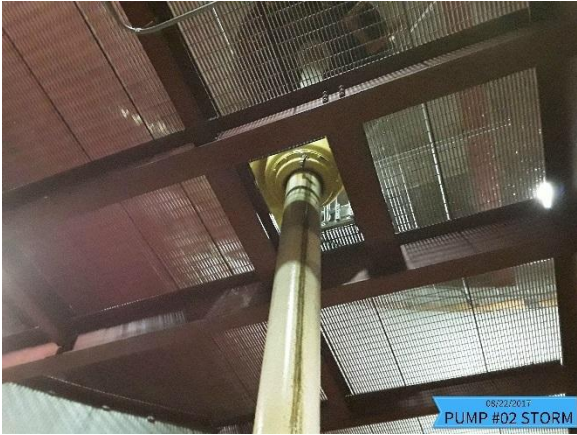
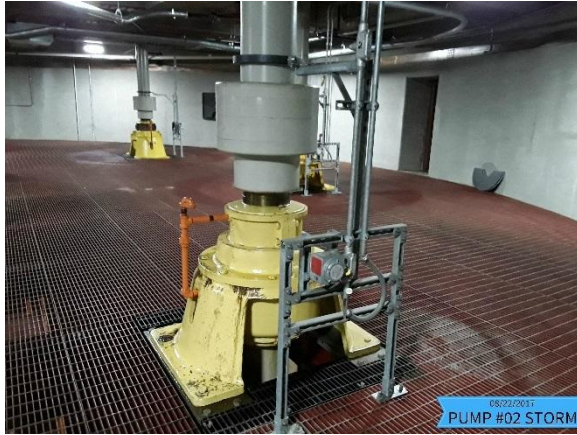
The eight Storm Pumps are original to the station that was built in 1954. The pumps are in fair condition but all have multiple layers of paint, which is peeling over a large portion of the pumps with corrosion covering large portions due to moisture at the lower level in the station. The concrete support piers show various levels of cracking from very minor hairline cracks to major cracks on a couple of the piers, although no pieces of concrete are missing. The discharge piping for the pumps is also showing a significant amount of corrosion.

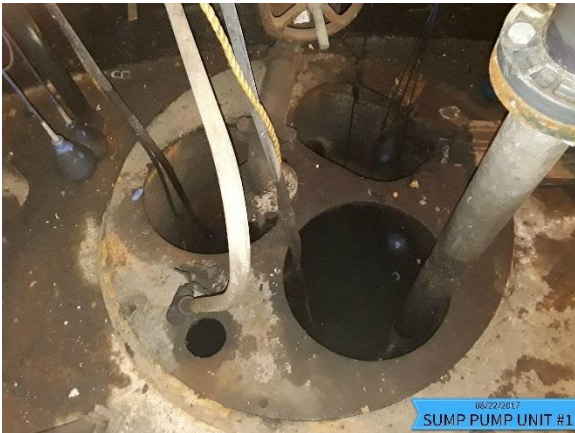
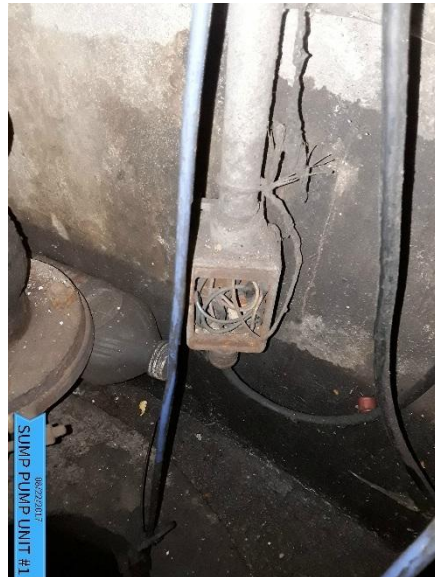
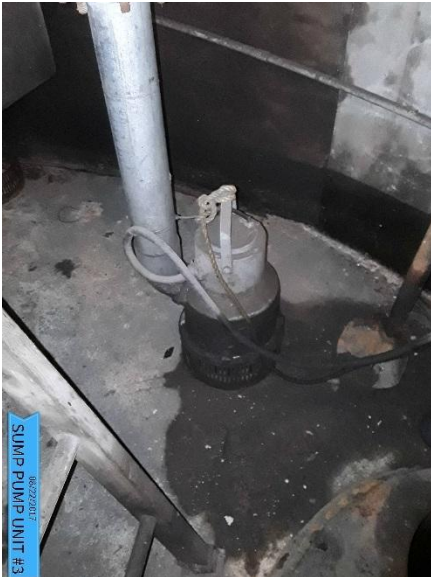
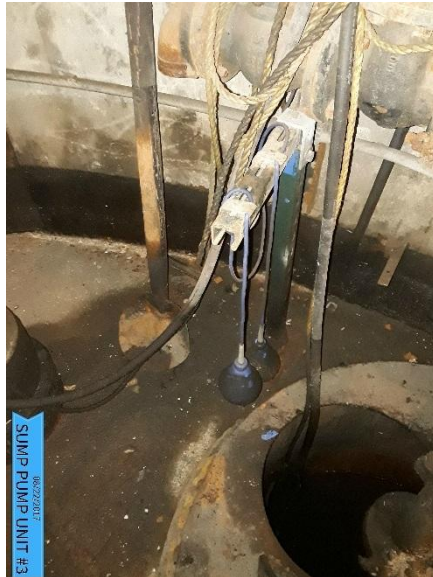
The Sump Pumps consist of two submersible pumps installed in a pit at the lowest level of the station and a third submersible pump, which is sitting on the floor adjacent to the sump. The two pumps in the pit are inaccessible. All the pumps are in service and functioning. The piping for pumps #1 and #2 show corrosion on the steel piping, and some piping has been replaced with PVC piping. Pump #3 appears to have been added later than the others and is piped with PVC piping. There is also an open electrical box for the pump controls that needs a cover.

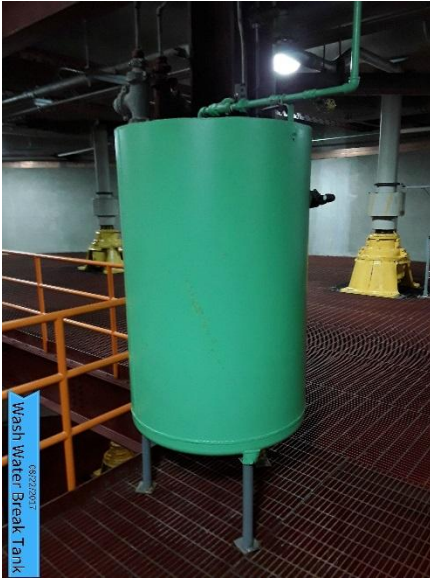
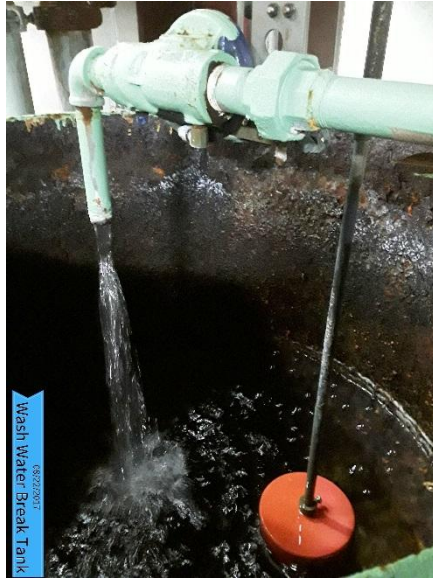
The Seal Water System consists of a break tank and fill valve assembly, which is located on an intermediate level between the motor floor and the pump level. This is in good condition with minimal corrosion and no issues were identified.

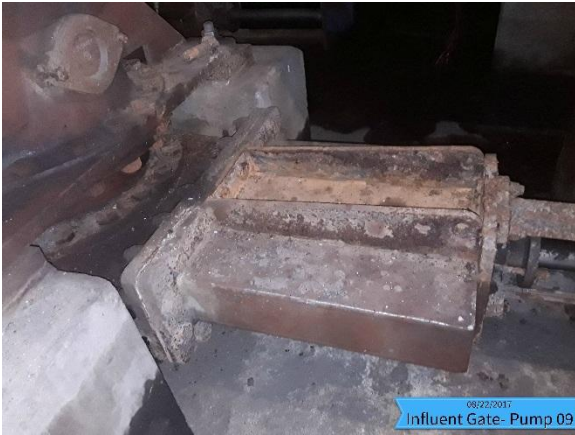
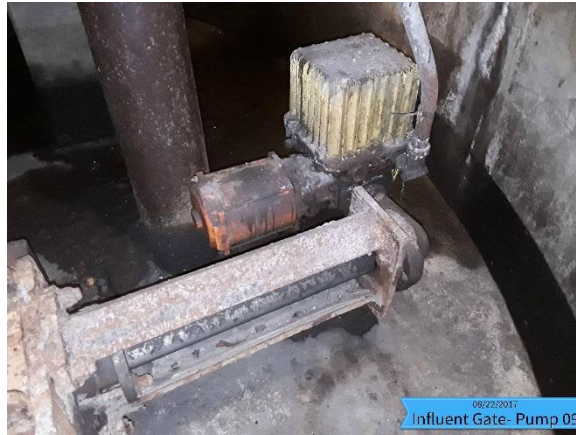
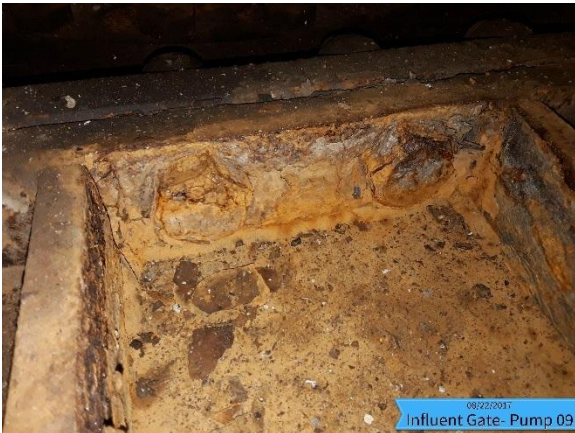
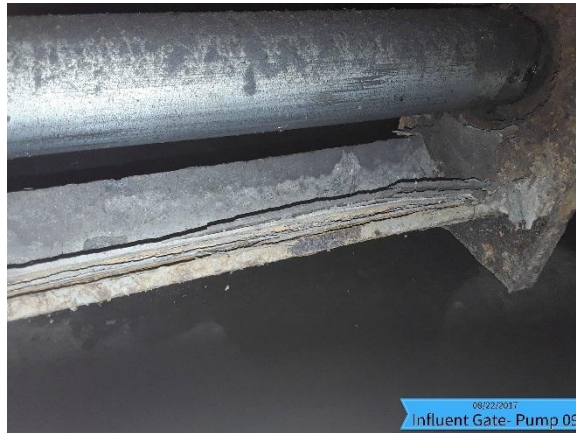
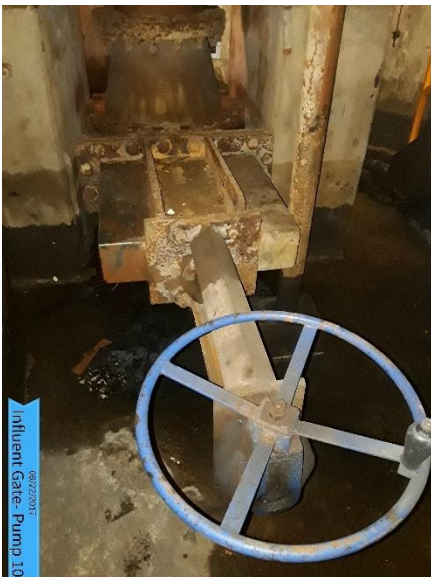
The two Sanitary Pump Influent Gates are located below the sanitary pumps and are a knife gate style valve. These have a significant amount of corrosion and one of the operator supports is delaminating due to the corrosion. The electric actuator for gate #10 has been removed and a handwheel has been installed on the gear operator.

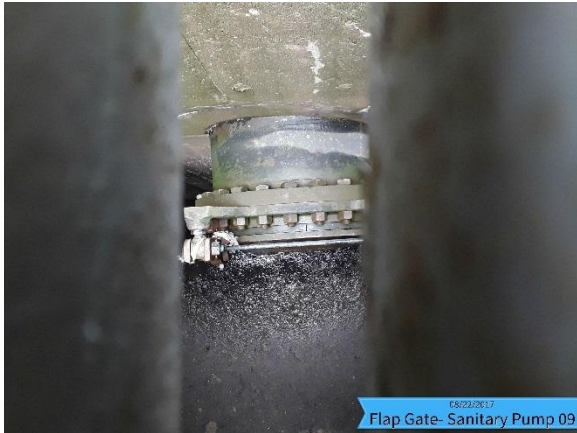
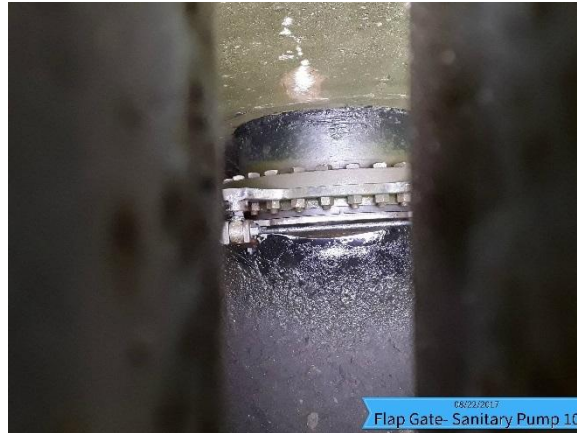
The two Sanitary Flap Gates are installed in the discharge channel on the outside of the station. These are in fair condition with corrosion on both the gates and the hardware.

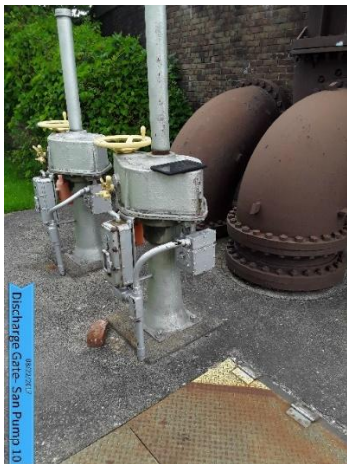
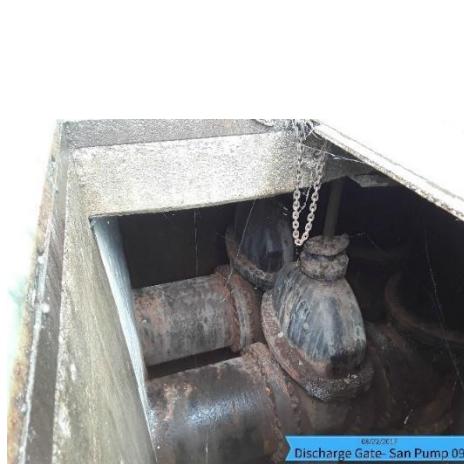
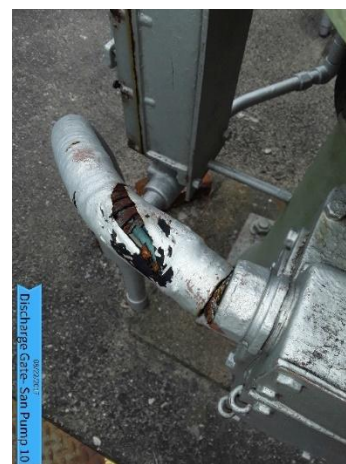
The two Sanitary Discharge Gates are gate valves installed in a pit outside the station along the fence. The gate valves and associated piping have significant corrosion due to moisture in the pit. The valve operators and electric actuators are of an older style and have multiple layers of paint that is peeling in some areas. The flexible conduit for Gate #10 is split and is separating from the junction box, and has exposed wiring. It is not known if this actuator is functional.

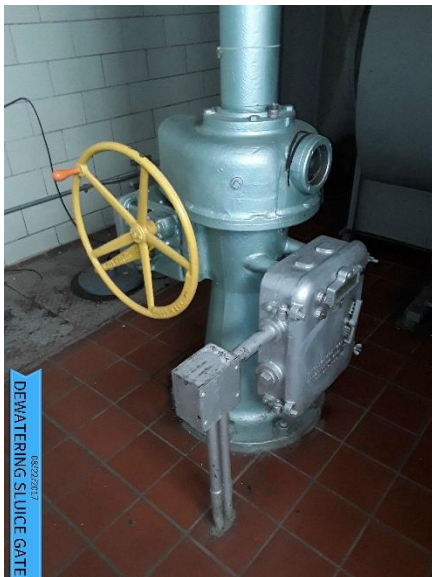
The Dewatering Gate is a cast iron style sluice gate with an electric actuator located just inside the station near the loading dock. The gate and stem appear serviceable, but have some corrosion. The gate operator and electric actuator are in good condition and have minimal corrosion, but are an older style. GLWA staff reports that this gate has never been operated.

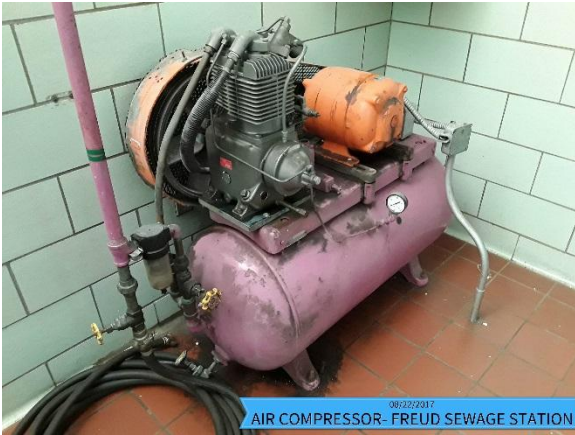
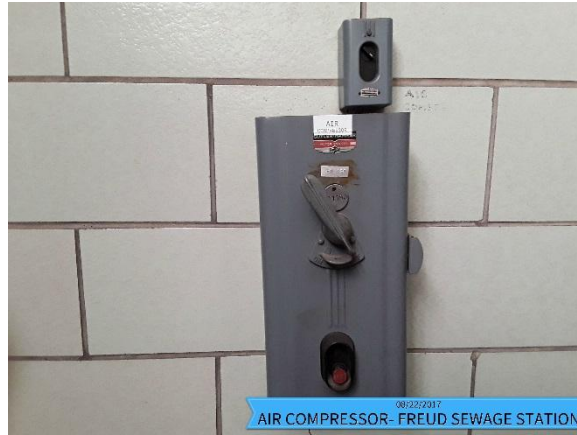
The Air Compressor System is a horizontal tank style with a belt driven compressor pump and is located on the motor floor of the station. The pressure gauge is in poor condition and is missing the glass. There have been reliability issues in the past and the compressor pump may have been rebuilt or replaced at some point, as it appears newer than the remainder of the system.

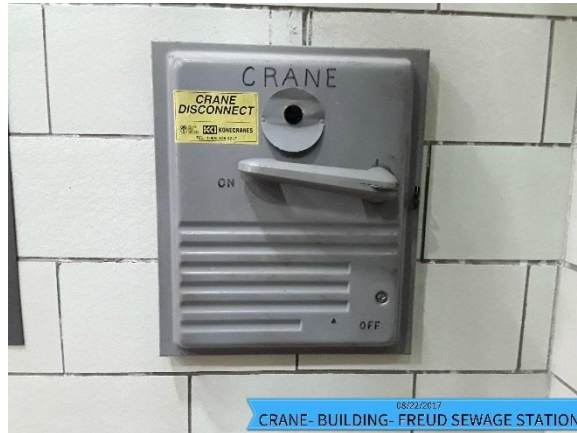
The Bridge Crane has a 20-ton capacity and is likely original to the station construction in 1954. Corrosion is minimal and operation appears to be good, as it was in use during the day of the condition assessment, although it was only used to lift tools from the lower level. Operators noted that the crane does make noise when it is under a greater load lifting pumps.

The Main Building has a 20-ton overhead bridge crane that runs in a circular pattern on runway beams supported from columns located on the exterior walls. The bridge crane was operated during the site visit and it was moved to access ladder above. The crane moved well but no lifting was done. GLWA staff indicated the crane should be inspected and serviced during the upcoming project. Surface corrosion was observed on most of the bottom flanges of the crane runway beams, most likely from past roof and wall leaks (before 2016 roofing replacement project and before exterior brick masonry wall rebuild project).

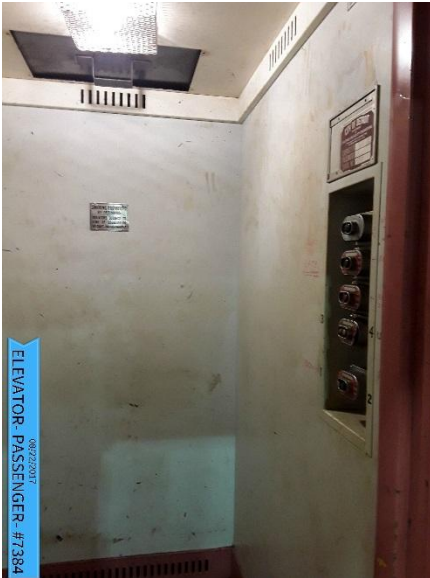
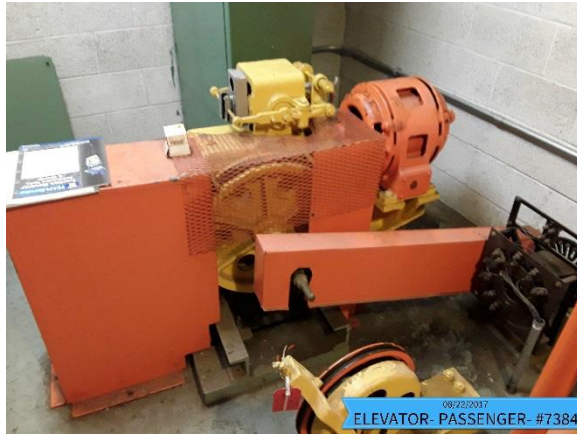
The Elevator is likely original to the pumping station and is in fair condition. The elevator electrical and controls components are mounted on an open rack exposed and the elevator has experienced reliability issues in the past. The elevator has been in use beyond its expected useful life.

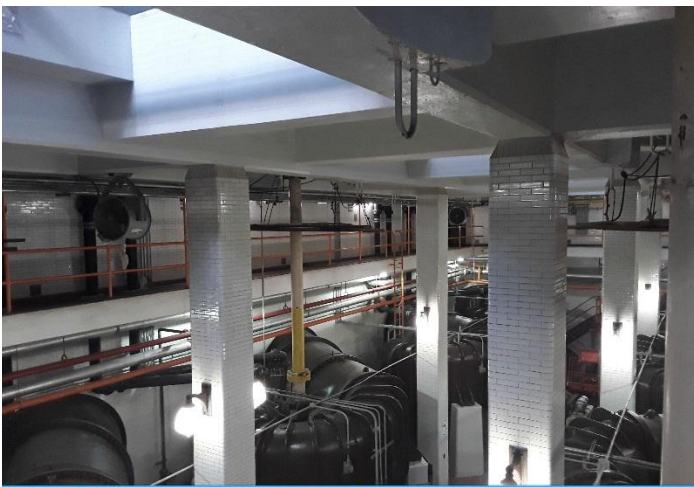
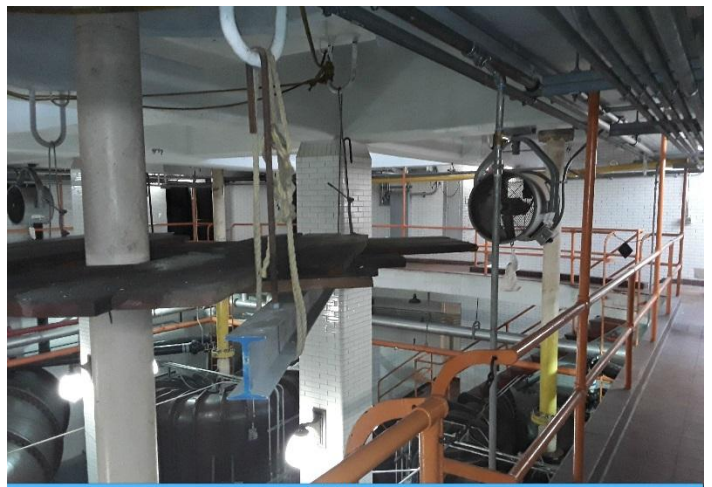
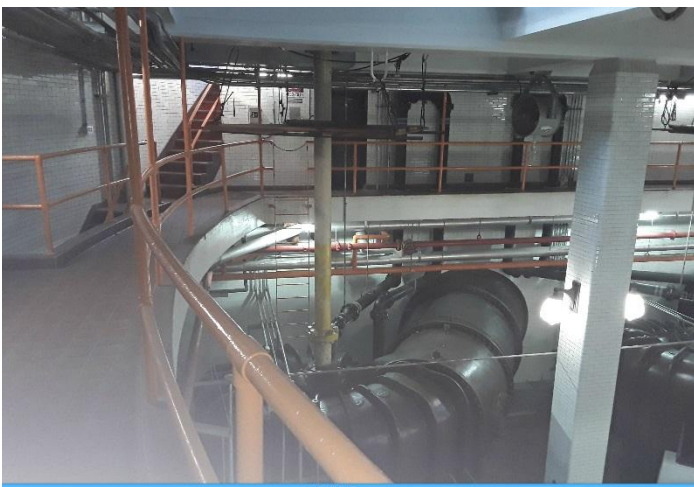
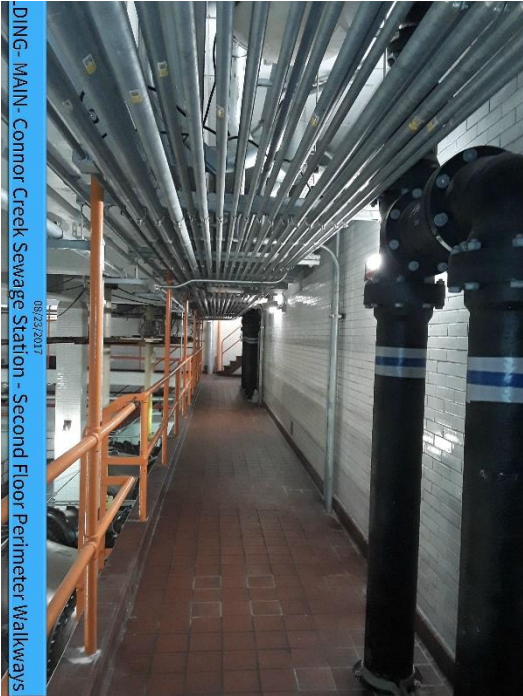
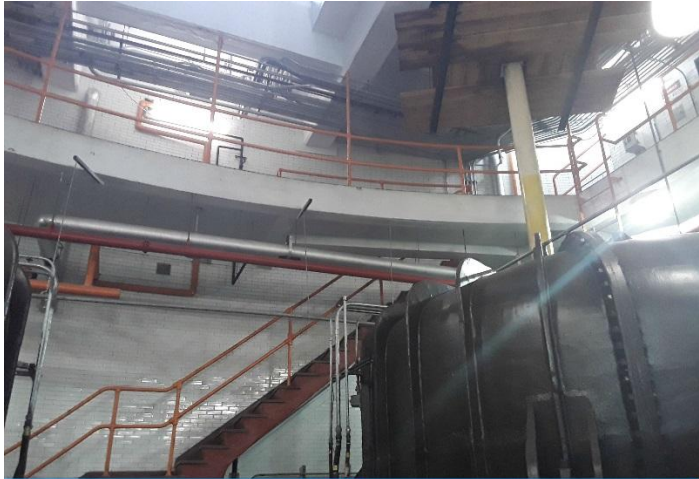
08/23/2017
DING- MAIN- Connor Creek Sewage Station - Second Floor Perimeter Walkways

The Second Floor Perimeter Walkways are reinforced concrete walkways (approximately 5-feet wide) that cantilever out away from the substructure perimeter walls. The walkway slabs have tile flooring, so the reinforced concrete walkway slab could not be observed from above, but the underside of the walkways look to be in good condition with no signs of deflection, deterioration, or exposed resteel. The handrail along the edges of the walkway are in good condition, are of proper height, and have only minor (if any) signs of corrosion.

The reinforced concrete substructure walls are covered with glazed tile so visual inspection could not be done on the concrete walls. However, the glazed wall tiles appear to be in good shape with only very spotty tile and grout cracking. Any major structural cracks would most likely have shown themselves through the glazed wall tiles. No signs of this was observed.

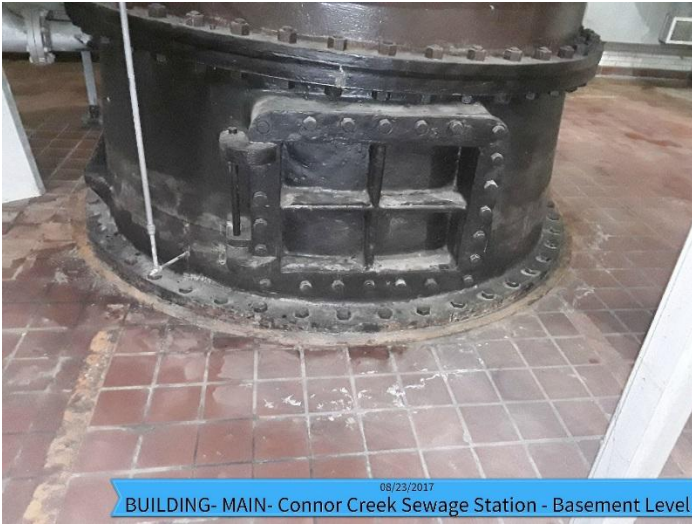
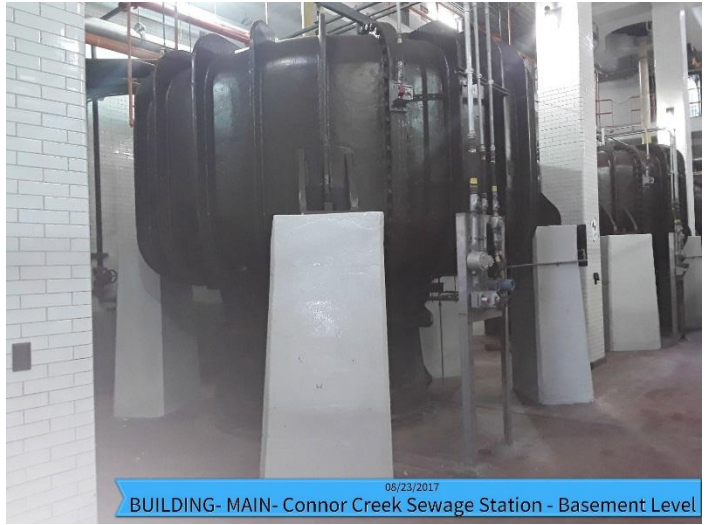
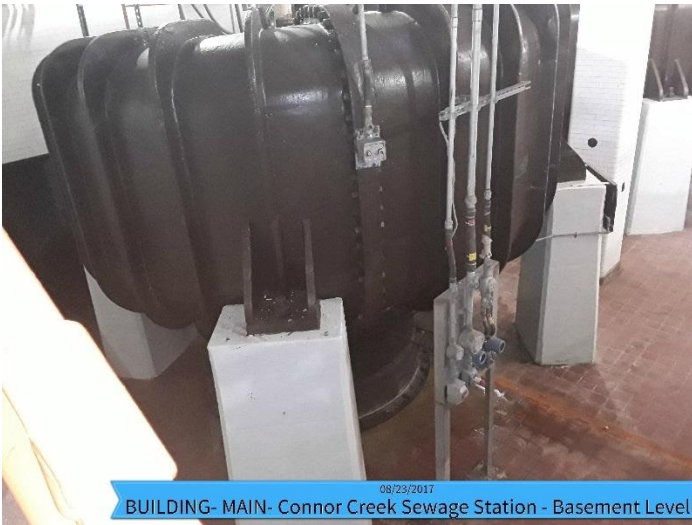
BUILDING- MAIN- Connor Creek Sewage Station - Basement Level

The reinforced concrete substructure walls and concrete columns (supporting the top floor slab and support framing beams) are covered with glazed tile so visual inspection could not be done on these concrete items. However, the glazed wall tiles appear to be in good shape with only very spotty tile and grout cracking. Any major structural cracks would most likely have shown themselves through the glazed wall tiles. No signs of this was observed.

The reinforced concrete floor has tile flooring, so the reinforced concrete slab could not be observed. However, the tile floor appears to be in good shape with only very spotty tile and grout cracking. Any major structural cracks in the floor slab would most likely have shown themselves through the tile flooring. No signs of this was observed. Some puddles of water were observed on the floor between the pump and the wall at the north end of the basement. It could not be determined if these puddles were from the pump leaking or from the substructure concrete wall to floor slab interface. The concrete pump support piers are in good condition.

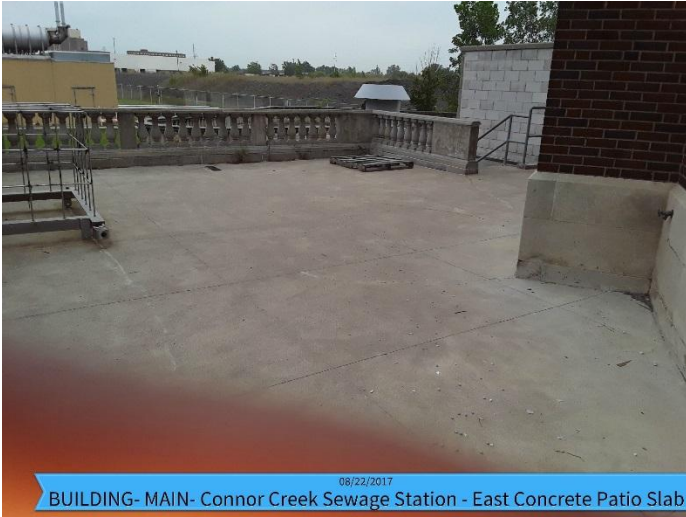
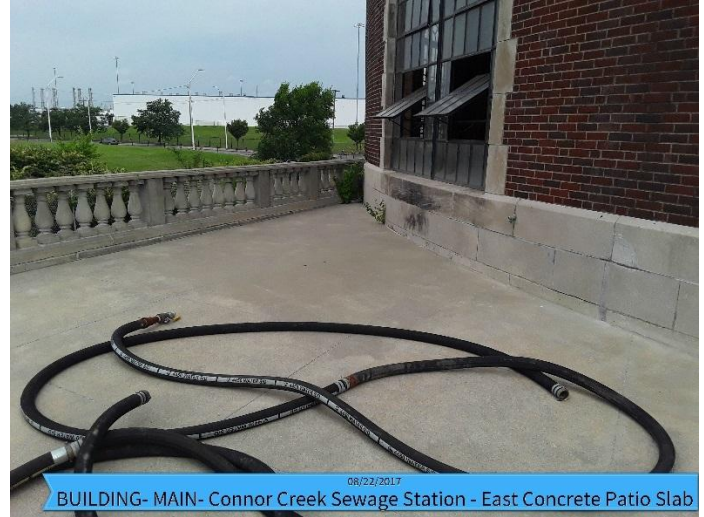
BUILDING- MAIN- Connor Creek Sewage Station - East Concrete Patio Slab

The east exterior concrete patio slab is an extension of the Storm Water Pump Station top floor out to the east of the building. The existing top slab appears to be in good condition with only minor hairline cracks with caulked joints. Some slab joints have lost their joint filler and caulk and now have vegetation growing out of them. The top slab appears to shed water well. The steel floor door just outside the large overhead door to the Main Building has some surface corrosion on it. The decorative concrete railing around the perimeter of the patio slab is only 35 to 37-inches tall. The OSHA code height for fall protection will need to be revisited since this patio slab is approximately 4-feet up from existing grade.

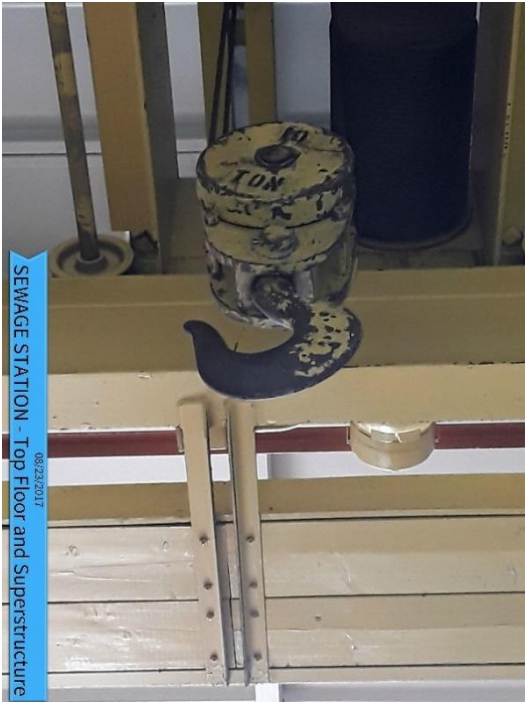
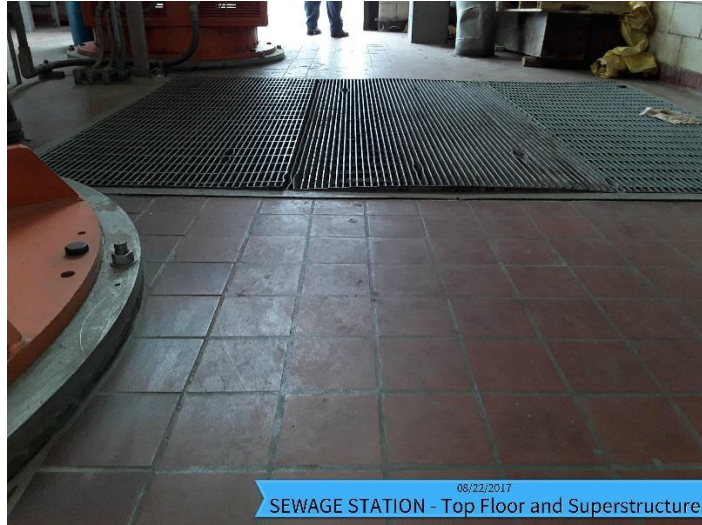
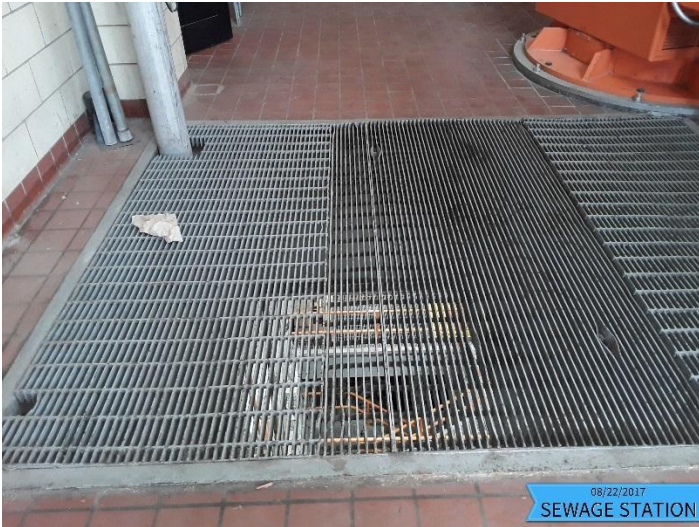
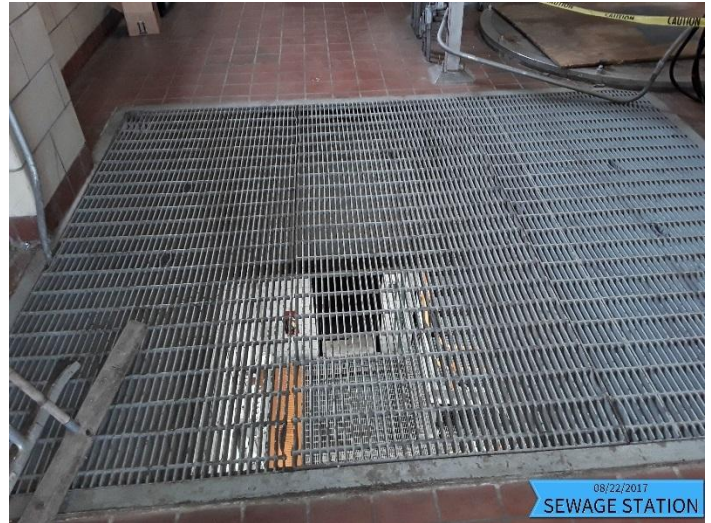
SEWAGE STATION - Top Floor and Superstructure
08/23/2017

The interior glazed concrete block and upper plain concrete block walls are in good condition and the exterior brick walls are also in good condition. There are a few areas of exterior brick that could require some tuckpointing and some exterior brick and interior concrete block mortar joint cracks that were observed (minor joint cracking out of masonry pilasters and at the mid-height of the south wall).

The top slab of the pump station has tile flooring, so it could not be observed from above, but the underside of the slab looks to be in good condition. The embedded steel wide flange framing support beams embedded in the concrete floor and at the grated openings in the floor look to have minimal surface corrosion on them. The steel grating bearing bars have been stressed and warped in numerous locations on this floor (more noticeable on 2nd floor). These grating bearing bars were used as localized lifting points during equipment removal and replacement. It appears lifting lugs and eye bolts were installed between grating bearing bars for lifting and rigging.

The steel roof beams and roof purlins appear to be in good condition with only localized areas of surface corrosion. The precast concrete channel roof deck slabs appear to be in good condition as well with no signs of corrosion, deflection, exposed resteel or water leakage.

good and seems like it had been replaced since the original construction in 1960. Roofing appears to shed water rather well with the only standing water observed along the east side between roof drains. No signs of water leakage (minor wall stains and/or efflorescence) were observed at the top of interior plain concrete block walls. The ladder leading up to the roof should be investigated to see if a cage is required per OSHA code requirements. Also, a short ladder leading between the access hatch roof and the main lower roof of the Sanitary Pump Station should be considered.

The building has a 10-ton overhead bridge crane that runs along runway beams on the east and west walls. The bridge crane was not operated during the site visit, but GLWA staff indicated the crane should be inspected and serviced during the upcoming project.

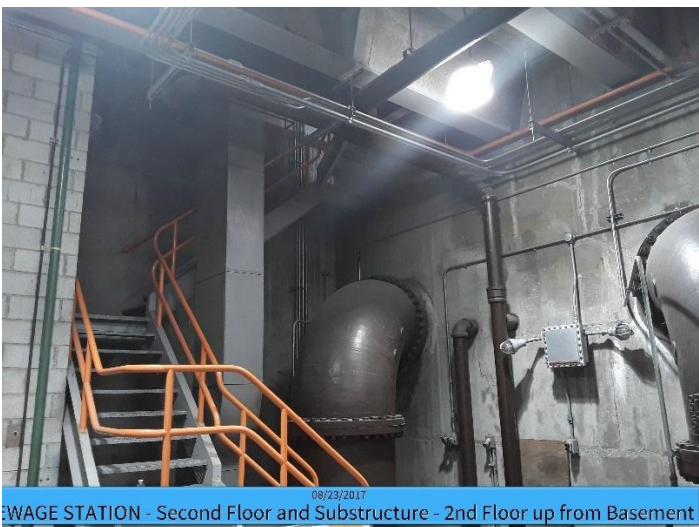
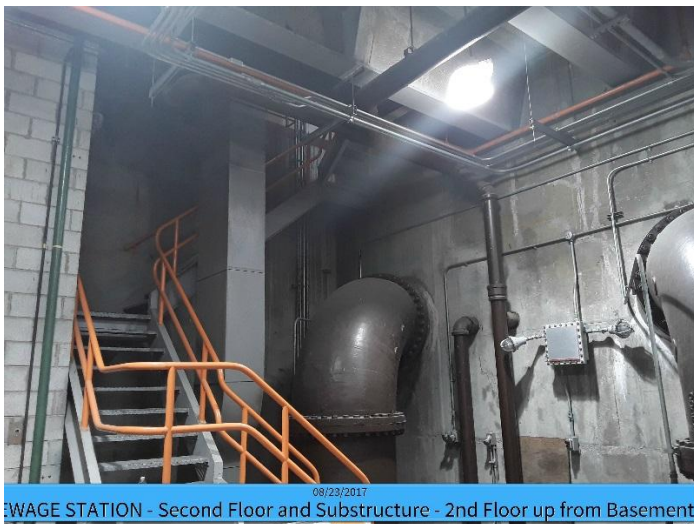
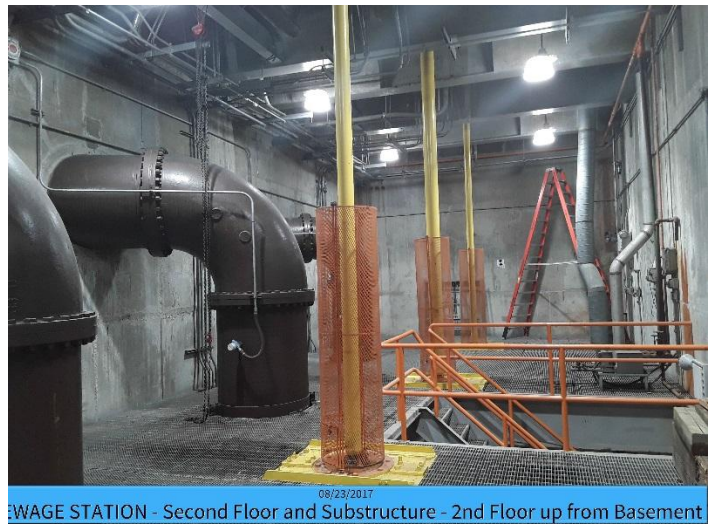
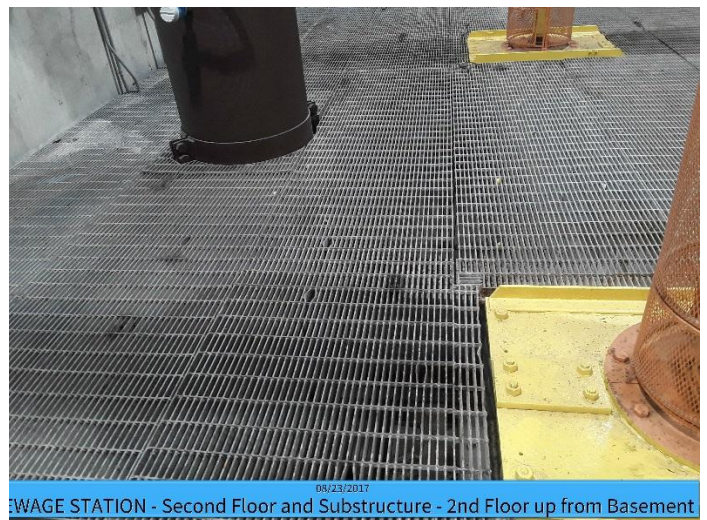
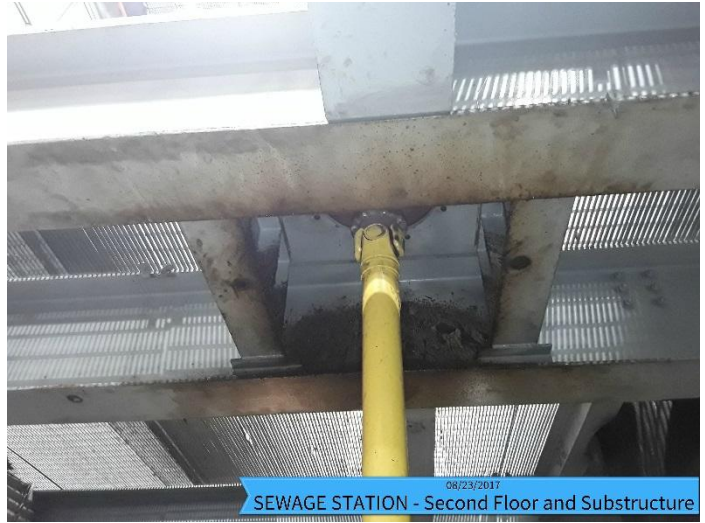
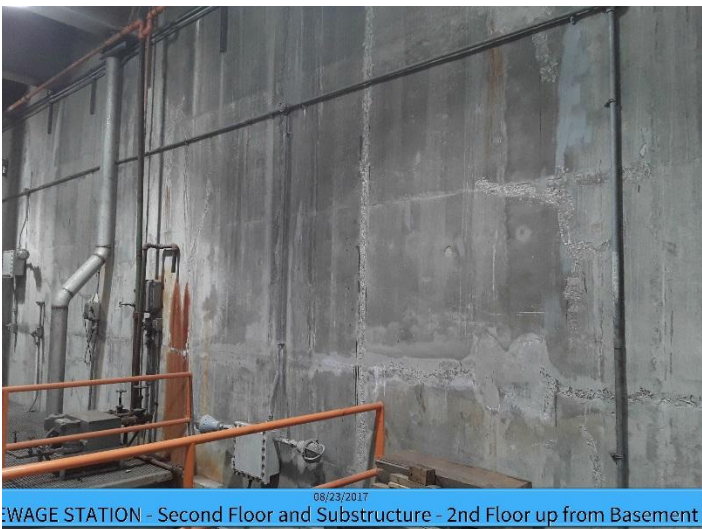
08/23/2017
SEWAGE STATION - Second Floor and Substructure - 2nd Floor up from Basement

The floor consists of galvanized steel bar grating supported from structural steel wide-flange framing beams. The steel framing beams span the entire east-west width of the pump station and are connected to the concrete substructure walls. The grating, handrails, and steel wide-flange beam framing are in good condition with very little steel surface corrosion observed. However, a good amount of steel corrosion was observed from the underside when looking at the bottom flange and webs of the steel framing beams around the pump shafts. Steel grating bearing bars have been stressed and warped in numerous locations on this floor since they were used for localized lifting and rigging during equipment removal.

The reinforced concrete substructure walls were in good condition. Numerous hairline cracks and concrete cold joints (and/or rough form finish) from the original construction were observed. It also appears as though repair mortars and pastes have been applied to a few small, localized areas of the walls in the past to resolve minor leakage. These repairs appear to have resolved the minor leakage that was occurring. No exposed rebar was observed.

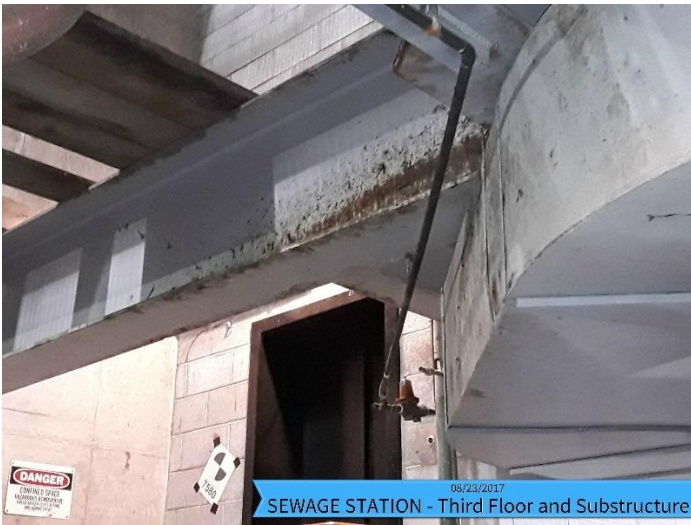
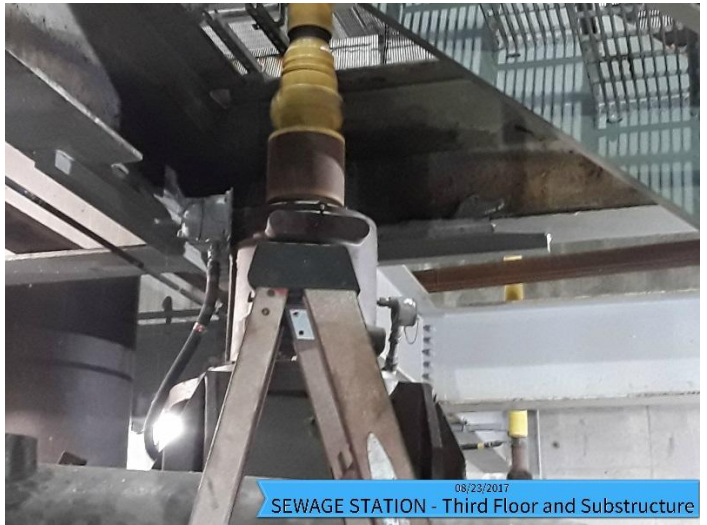
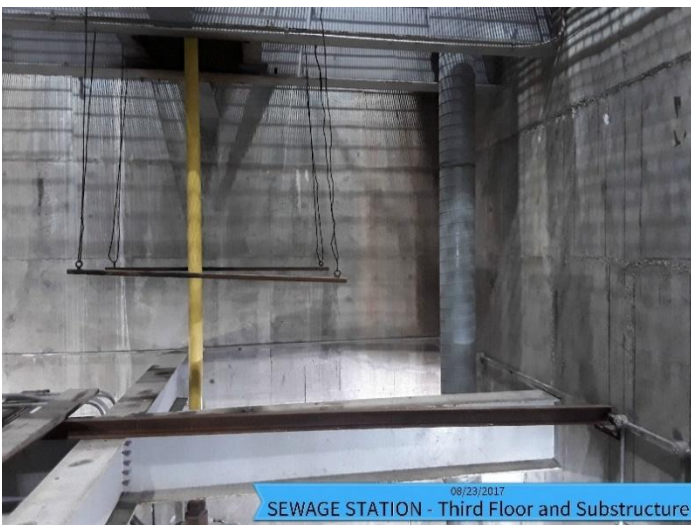
SEWAGE STATION - Third Floor and Substructure

The floor consists of structural steel wide-flange framing beams, but no grating. The steel framing beams span the entire east-west width of the pump station and are connected to the concrete substructure walls. The handrail, stairs, and steel wide-flange beam framing are in good condition with some steel surface corrosion observed. However, steel surface corrosion was observed on the bottom and top flanges of the steel framing beams. And, a good amount of steel corrosion was observed from the underside when looking at the bottom flange and webs of the steel framing beams around the pump shafts. Portions of the steel framing beam bottom flanges have been removed in certain areas to allow for equipment and conduits. At these areas, it appears steel tubing was added adjacent to the bottom flange cutout to replace the flange area removed (a structural steel method to remedy cutouts).

No grating was ever placed on this floor during its original construction. According to GLWA staff, maintenance personnel must utilize this floor for lifting/rigging of equipment and maintenance of equipment. Consequently, loose wooden boards have been laid across various portions of the steel framing beams. GLWA staff requested steel grating be added to this floor level to allow for proper and safe maintenance and lifting/rigging operations.

The reinforced concrete substructure walls are in good condition. Numerous hairline cracks (one showing signs of past leakage) and concrete cold joints (and/or rough form finish) from the original construction were observed (cold joint just below 2nd floor level doesn't show signs of past leaking). It also appears as though repair mortars and pastes have been applied to a few small, localized areas of the walls (on east wall near south end) in the past to resolve minor leakage. These repairs appear to have resolved the minor leakage that was occurring. No exposed rebar was observed.

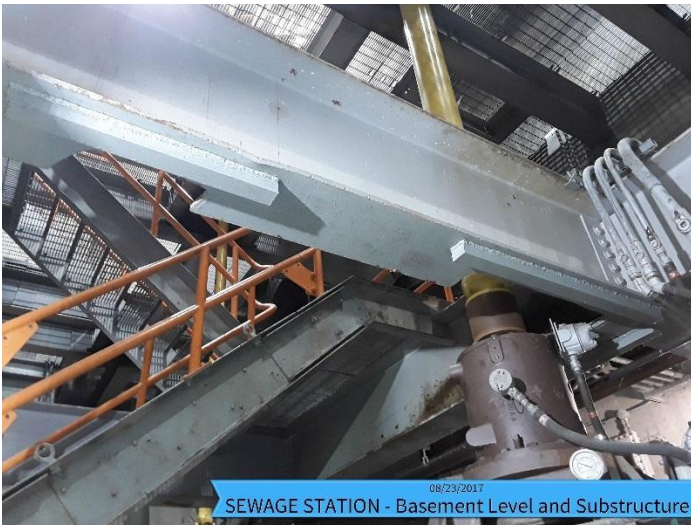
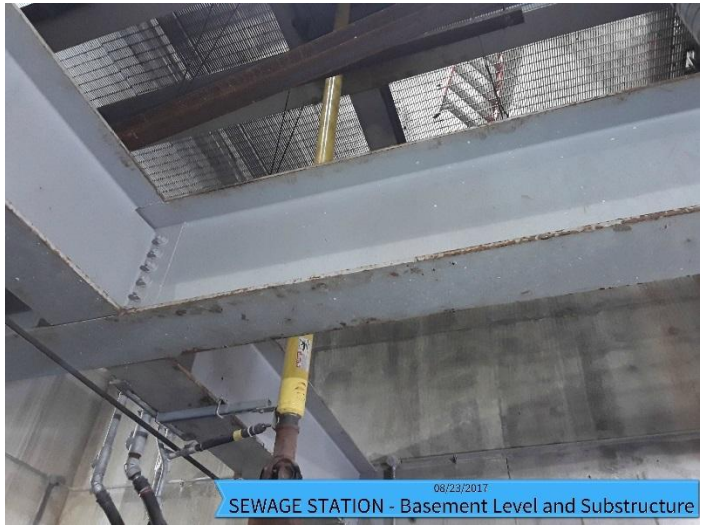
SEWAGE STATION - Basement Level and Substructure

The reinforced concrete substructure walls are in good condition. Numerous hairline cracks (none showing signs of active leaking) were observed. No exposed resteel was observed. The concrete block framed elevator shaft walls appear to be in good condition. Concrete pump support piers are in good condition.

The reinforced concrete floor appears to be in good condition with only minor hairline cracks and no signs of leakage. Some puddles of water were observed on the floor, but these seem to be from the pumps since the puddles are away from walls.

Structural steel stairs and handrails look to be in good condition with minor surface corrosion.
