Great Lakes Water Authority

Freud Pump Station Improvement Project

Project Plan - DRAFT

April 2022

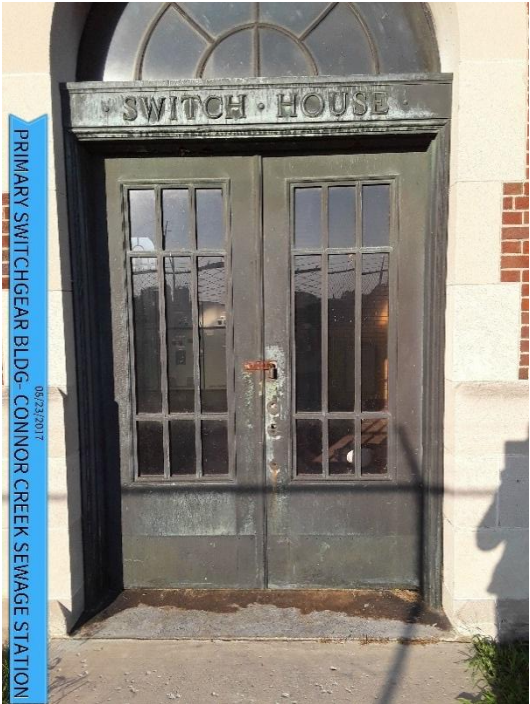
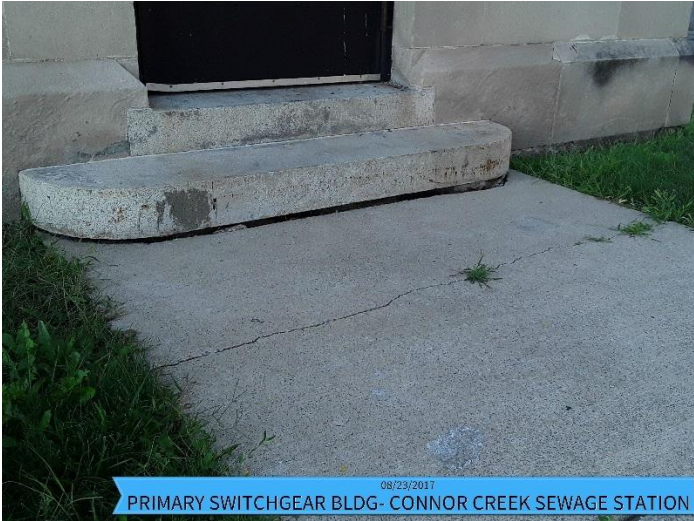
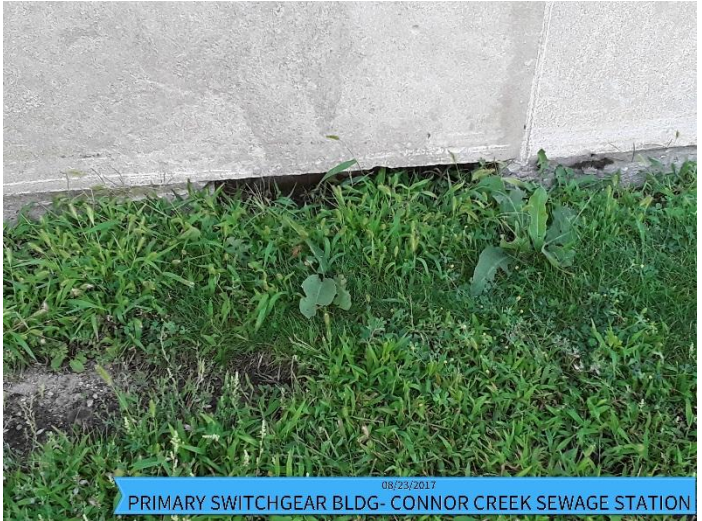
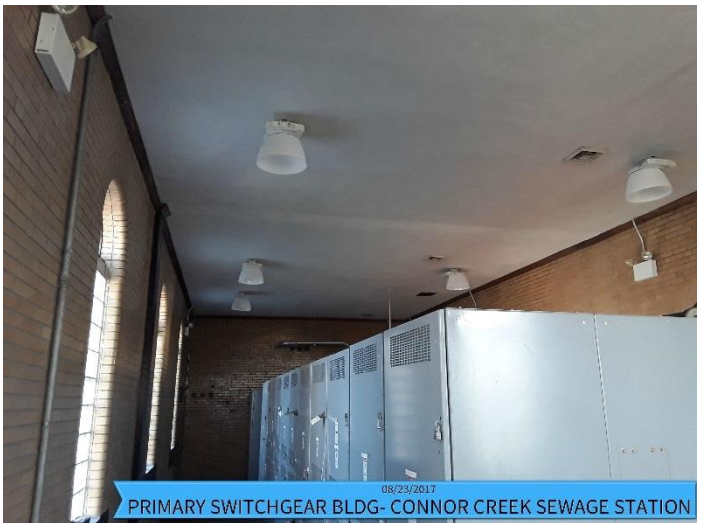
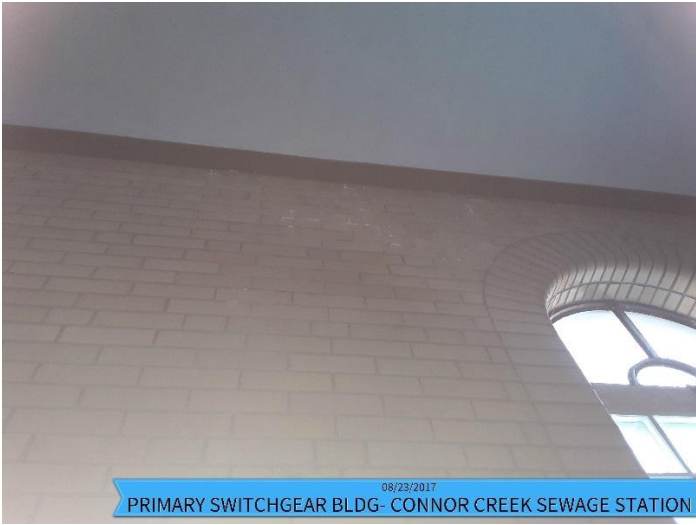
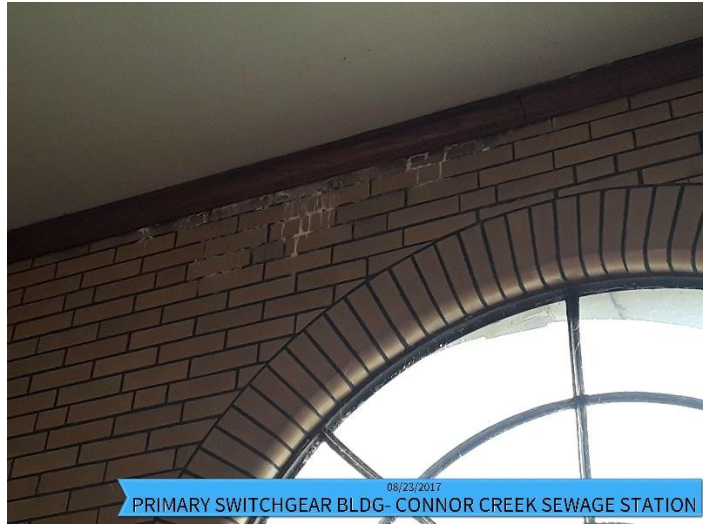
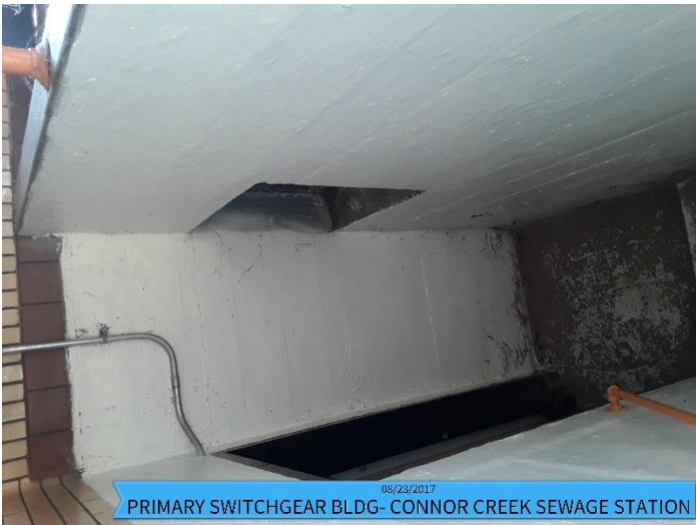
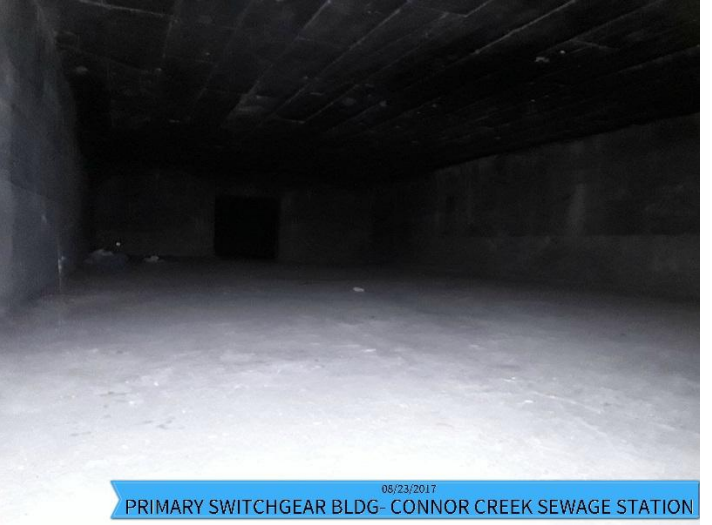
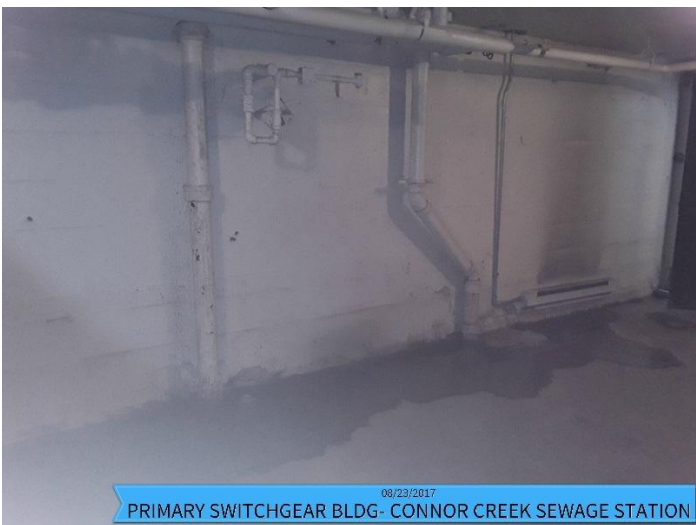
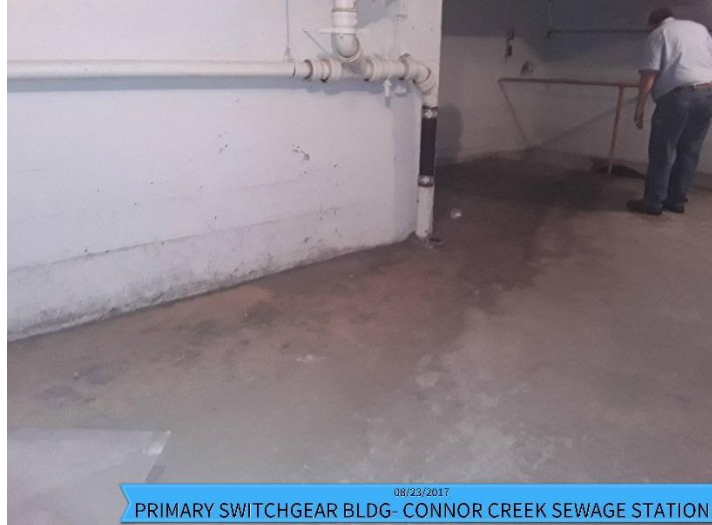
Conner Creek: Primary Switchgear Building

08/23/2017
PRIMARY SWITCHGEAR BLDG- CONNOR CREEK SEWAGE STATION

The Switchgear Building was constructed in 1925 at the same time as the Storm Water Pump Station. The superstructure of the building is constructed of a multi-wythe masonry wall system (brick exterior face and glazed brick interior face) with cast stone units at the base and corners of the exterior walls. The masonry walls support a reinforced concrete roof deck slab. The floor slab of the building is a reinforced concrete slab and there is a reinforced concrete basement under one half of the structure with a crawl space (reinforced concrete foundation walls) under the other half of the structure.

The interior glazed brick walls are in good condition and the exterior brick walls are in good condition. Areas of exterior brick and mortar joint cracks were observed. Some of the mortar joints on the cast stone units and under the concrete step into the building have weathered. Abandoned wall anchors and holes from previously wall supported equipment were observed in numerous locations on the interior walls. Some minor maintenance activities such as brick tuck-pointing, will be needed to keep further mortar joint deterioration from occurring and causing larger masonry wall issues in the future.

The floor slab of the building has tile flooring, so it could not be observed from above, but the underside of the slab looks to be in good condition (observed from the basement and the crawl space). The reinforced concrete basement walls are in good condition with only 2 minor hairline cracks observed. Ponding water was noticed along the north wall of the basement at the floor to wall interface. It had rained the day before.

The roof was accessed and observed on a dry and sunny day the morning after it had rained. The reinforced concrete roof deck appears to be in good condition with no signs of corrosion or deflection. GLWA staff indicated roofing should be considered for replacement as part of a future project. The roofing appears to shed water well and no standing water was observed. All mechanical equipment appears to be more than 10-feet away from roof parapet walls. Signs of water leakage (minor wall stains and efflorescence) were observed at the top of interior glazed brick walls in 3 locations under the plaster ceiling (just above the windows).

Exterior grade slopes away from structure on all sides of the building except for the north side. This might explain some of the minor water leakage that was observed in the basement along the basement wall to basement floor slab interface.

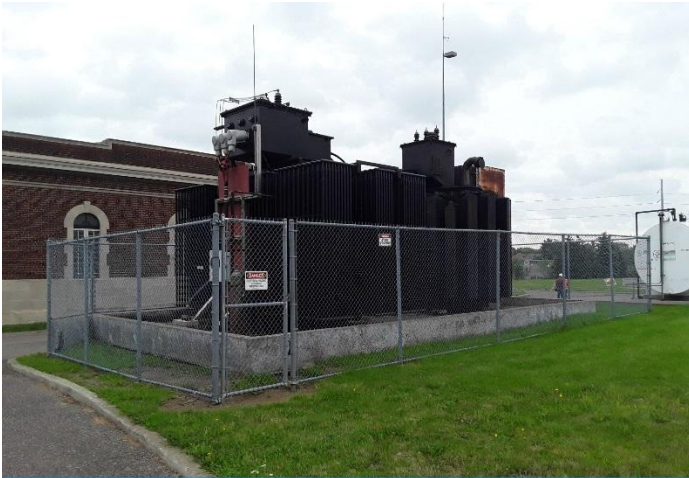
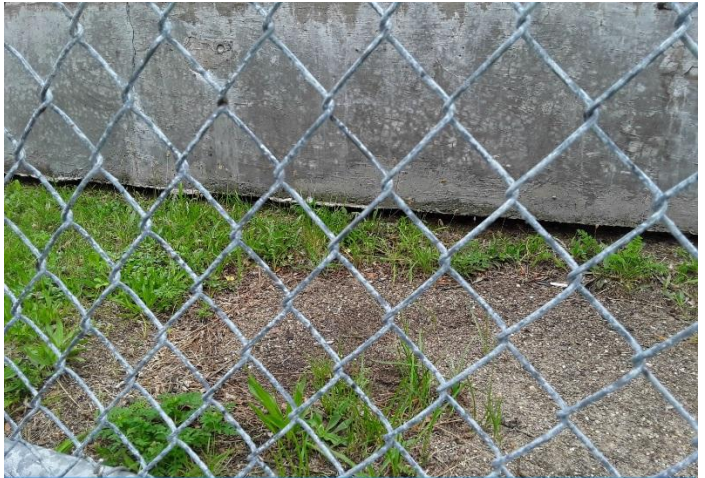
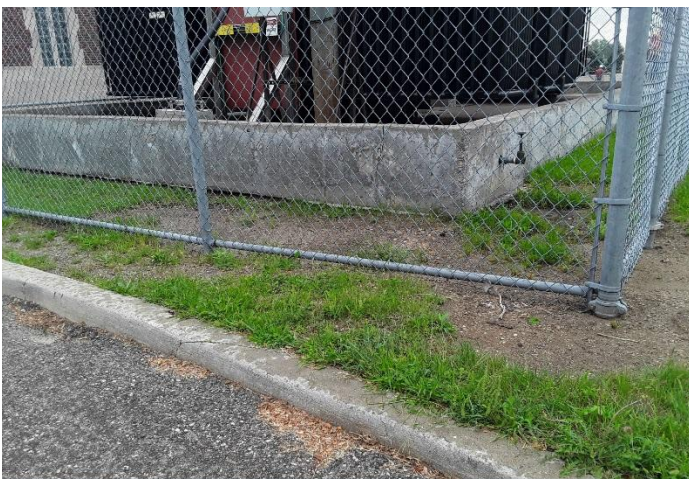
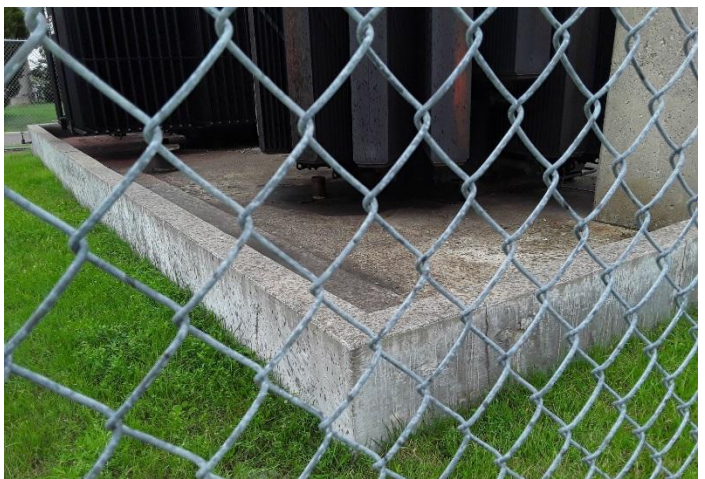
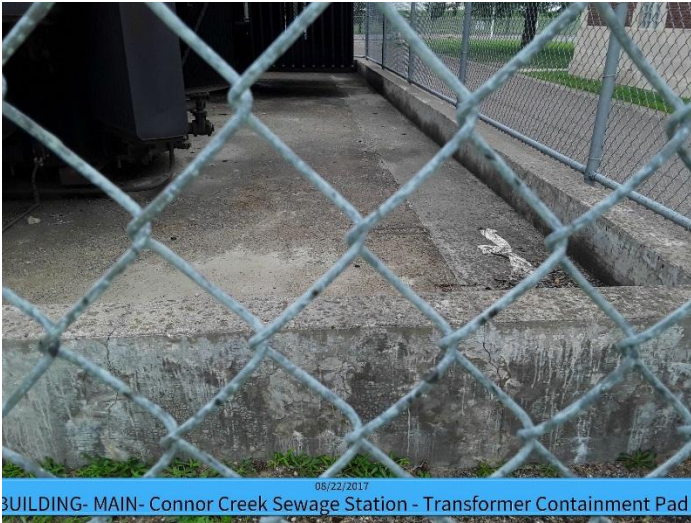
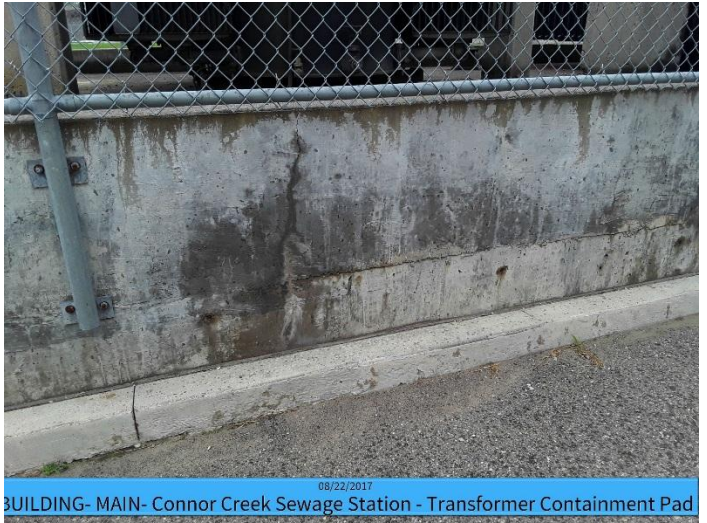
BUILDING- MAIN- Connor Creek Sewage Station - Transformer Containment Pad

The transformer containment pad consists of a concrete slab-on-grade with a perimeter concrete curb and chain link fencing. The date of construction of this containment pad is unknown. The existing concrete slab-on-grade appears to be in good condition with only minor hairline cracks at quarter points of the curb lengths. Portions of the west and south slab edges are starting to be undermined from lack of soil cover around the perimeter of the concrete-slab-on-grade. There does not appear to be a drain or sump inside of the containment curb, so not sure how rainwater gets out of the containment area. Debris has collected in the corner of the containment area. Containment requirements of the transformer fluids on this concrete slab-on-grade will need to be determined.

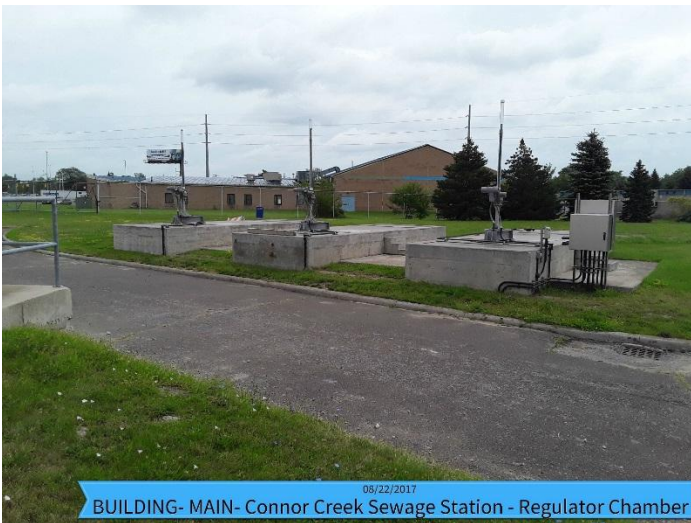
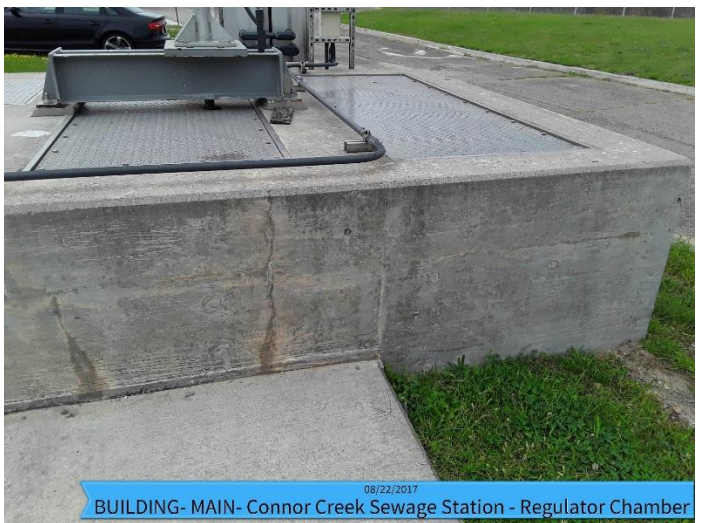
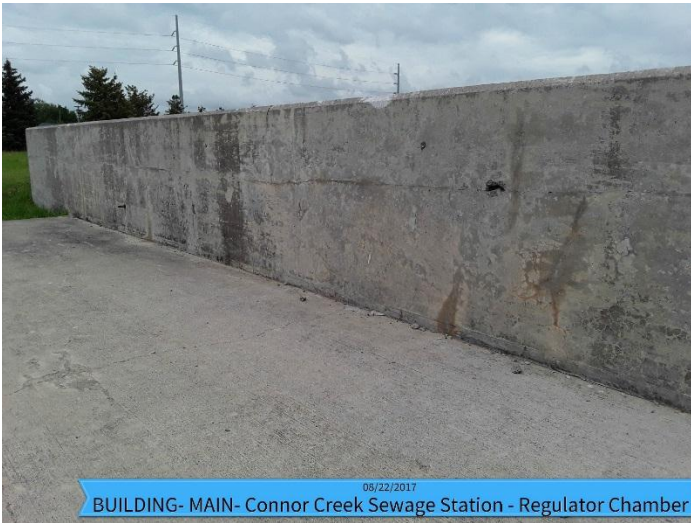
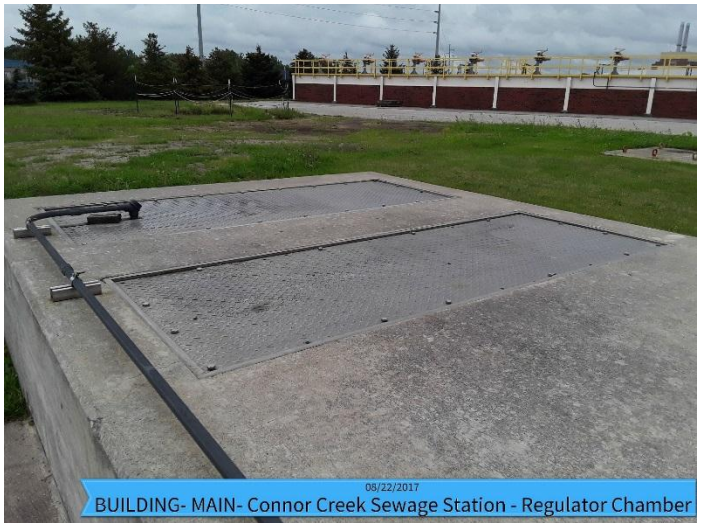
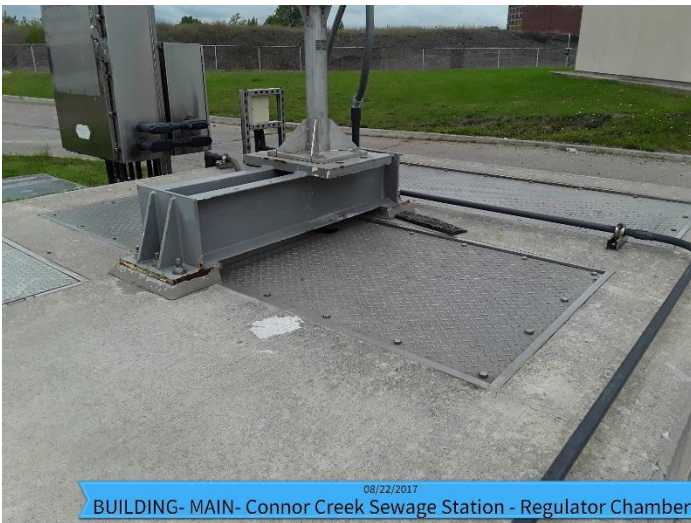
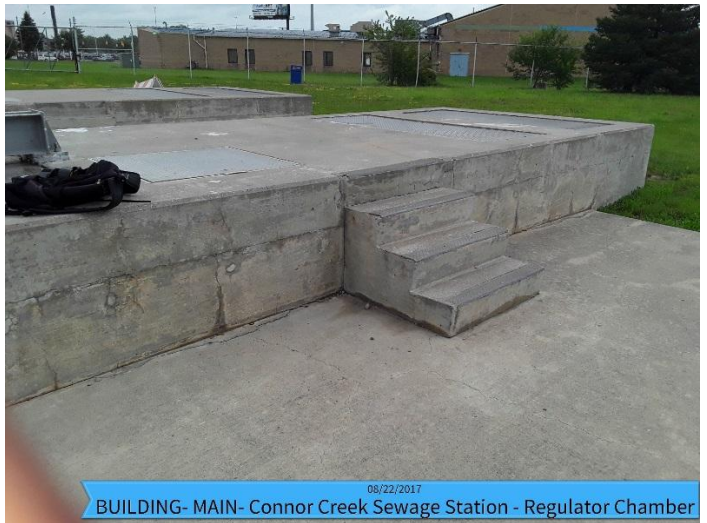
BUILDING- MAIN- Connor Creek Sewage Station - Regulator Chamber

08/22/2017
BUILDING- MAIN- Connor Creek Sewage Station - Regulator Chamber

The Regulator Chamber consists of three below-grade reinforced concrete structures whose concrete walls and top slab extend above grade by approximately two and a half feet with concrete walk slabs between them. The date of construction of this structure is around 1999. The concrete walls and top slab are in good condition with only hairline cracks in the top slab at the corners of the floor doors and vertical hairline cracks in the walls every 6 to 8 feet on center. A cold joint (construction joint) was observed at the top slab to wall pour joint. The top slab appears to be sufficient since no standing water was visible on the top slab. The aluminum floor door and frames look to be in good condition with only mild surface weathering.

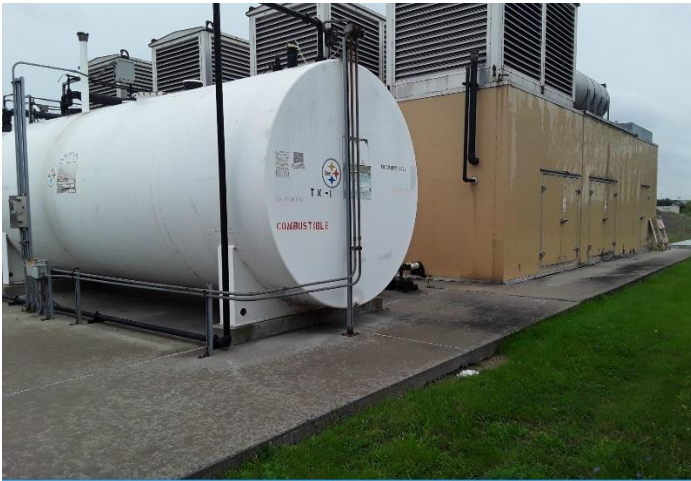
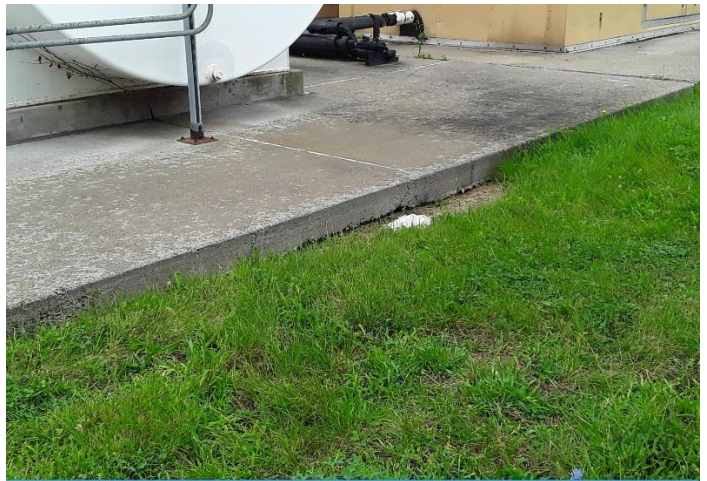
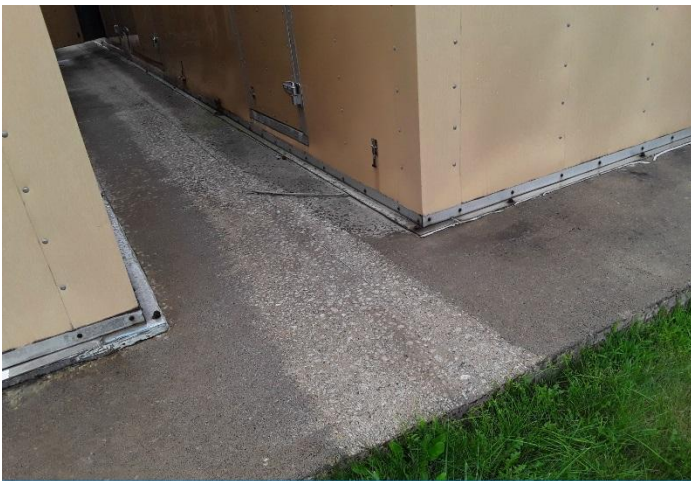
08/22/2017
G- MAIN- Connor Creek Sewage Station - Generator and Diesel Fuel Storage Pad

The generators and diesel fuel storage tanks are supported from a concrete slab-on-grade that was constructed in 1999. The existing slab-on-grade appears to be in good condition. GLWA staff indicated the original contractor did not properly slope the top surface of the concrete slab for drainage. Therefore, the contractor grinded portions of the slab between the enclosures to intentionally create some slope. This explains why the top surface appears eroded slightly in areas (to allow for water drainage between electrical enclosures). Portions of the slab edges are starting to be undermined from lack of soil cover around the perimeter of the concrete-slab-on-grade. A two-inch wide gap (with loss of joint filler and caulk) was observed in the joint between the concrete slab-on-grade under the generators and diesel fuel storage tanks.

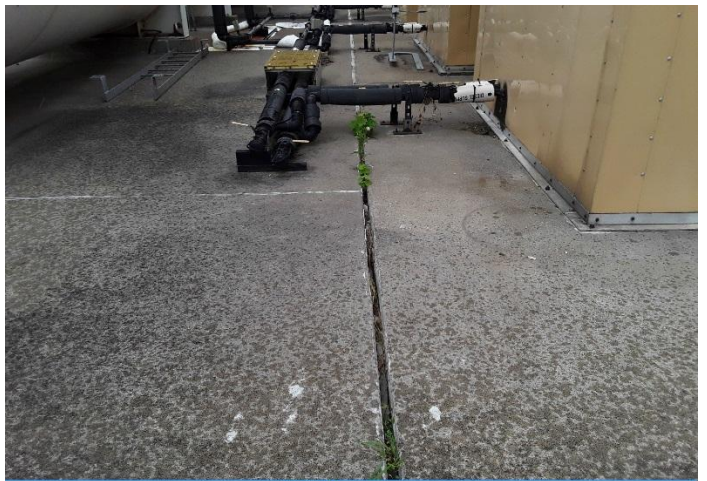
08/22/2017
G- MAIN- Connor Creek Sewage Station - Generator and Diesel Fuel Storage Pad

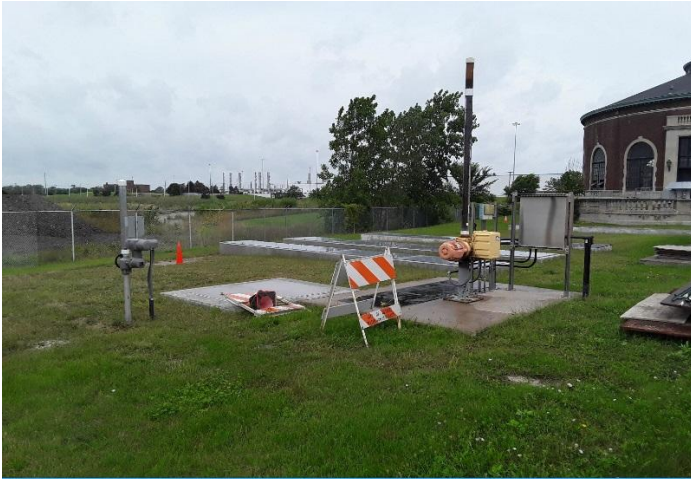
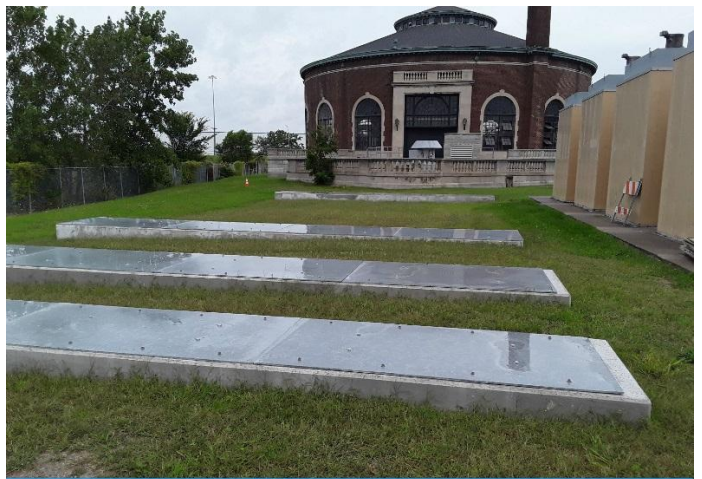
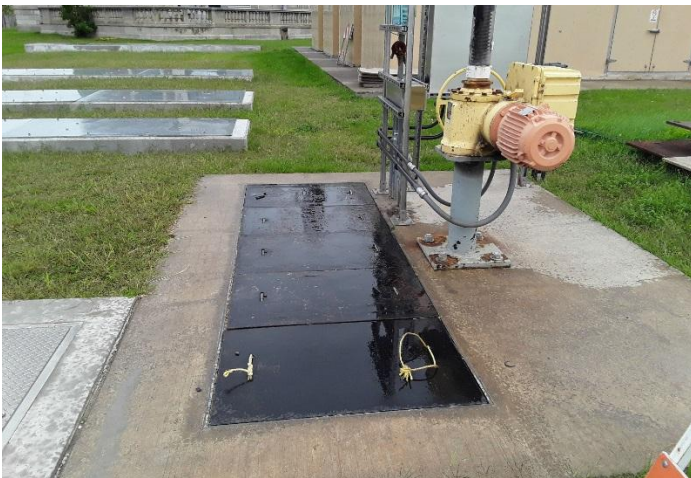
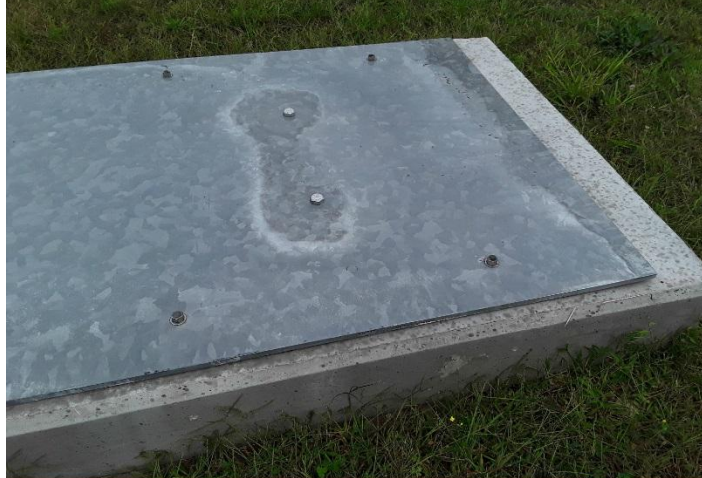
Connor Creek Sewage Station - Gate Structure and Raised Stop Log Structures

The gate structure and raised stop log structure consists of one below-grade vault structure and four below grade stop log structures. The construction date for the below-grade vault structure is unknown but the four stop log structures were constructed in 2006. All structures extend six inches to one-foot above grade. The below grade vault structure concrete is in good condition with some surface corrosion on the top slab cover plates. The stop log concrete structures are in great condition and the aluminum cover plates are in great condition with no signs of weathering.

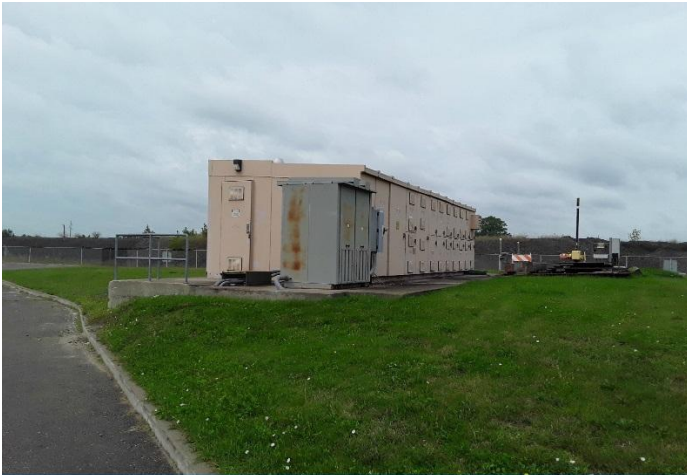
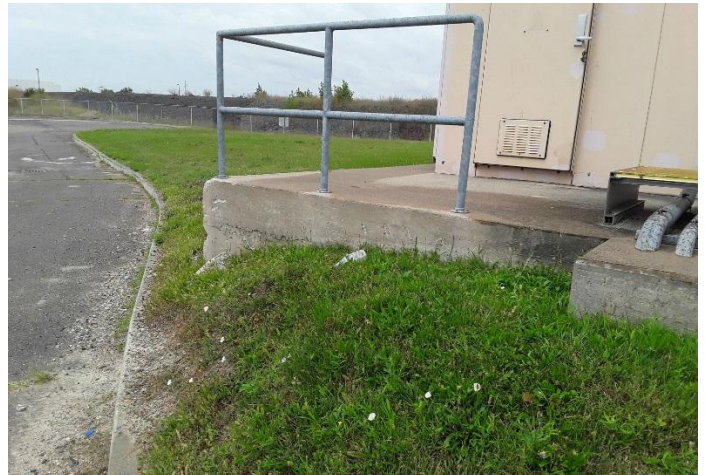
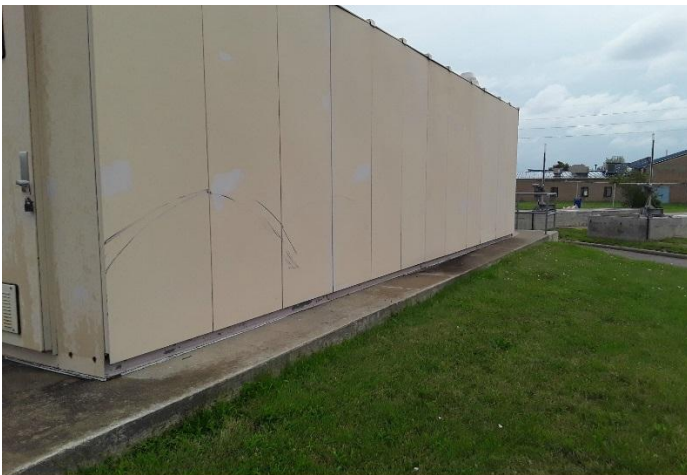
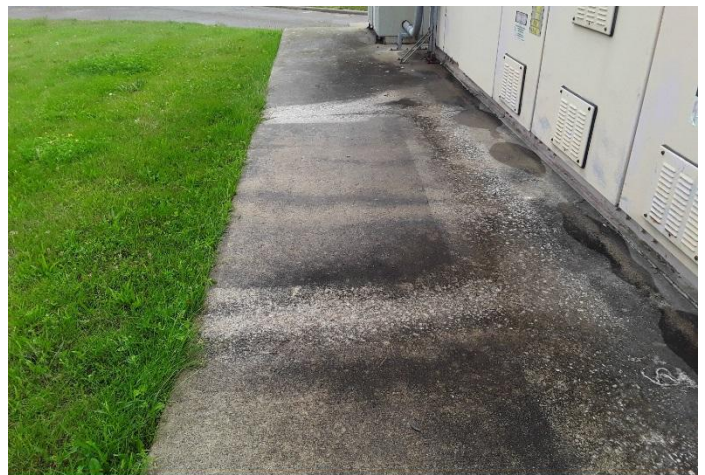
ING- MAIN- Connor Creek Sewage Station - Transfer Switch Electrical Enclosure

The transfer switch electrical enclosure is supported from a concrete slab-on-grade. The structure was constructed in 1999, at the same time as the generator and diesel fuel storage pad. The existing slab-on-grade appears to be in fair condition with very few minor hairline cracks. GLWA staff indicated the original contractor did not properly slope the top surface of the slab for drainage. Therefore, the contractor grinded portions of the slab to intentionally create some slope. This explains why the top surface appears eroded slightly in areas. In some areas where the slab is flat or sloping back to the enclosure, concrete stains were observed (where water ponding is occurring).

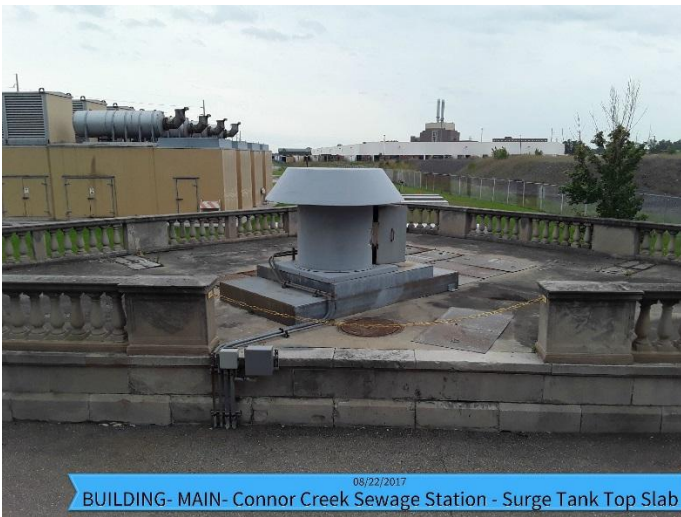
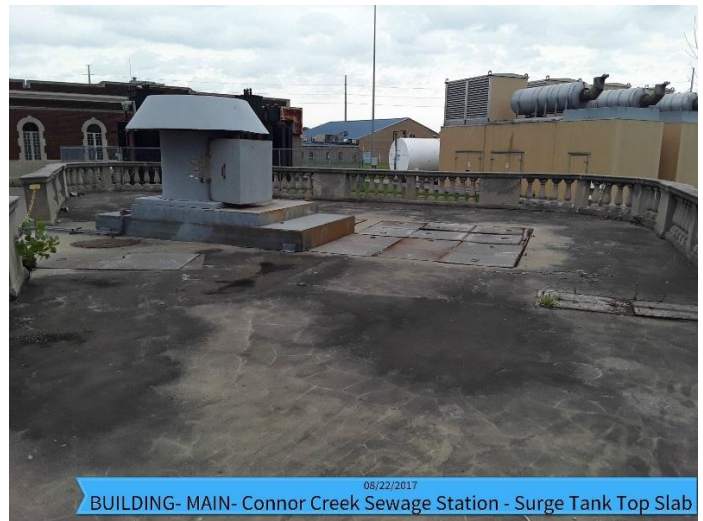
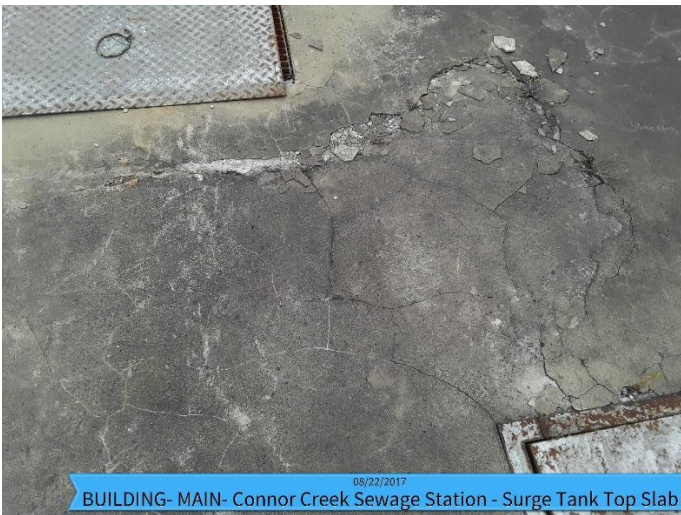
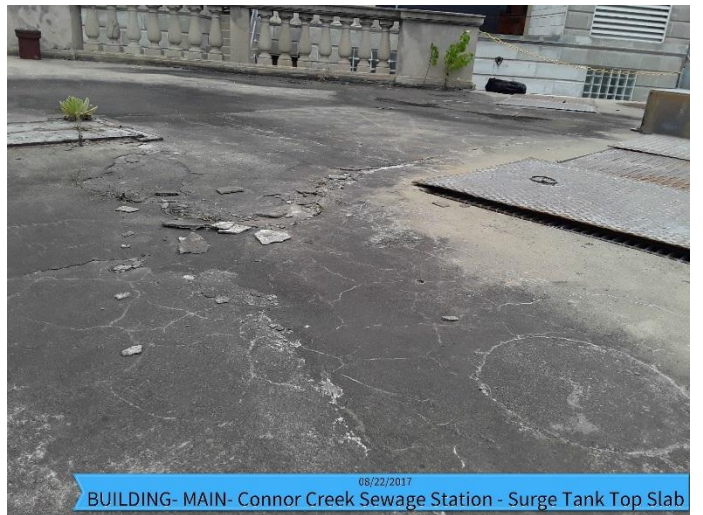
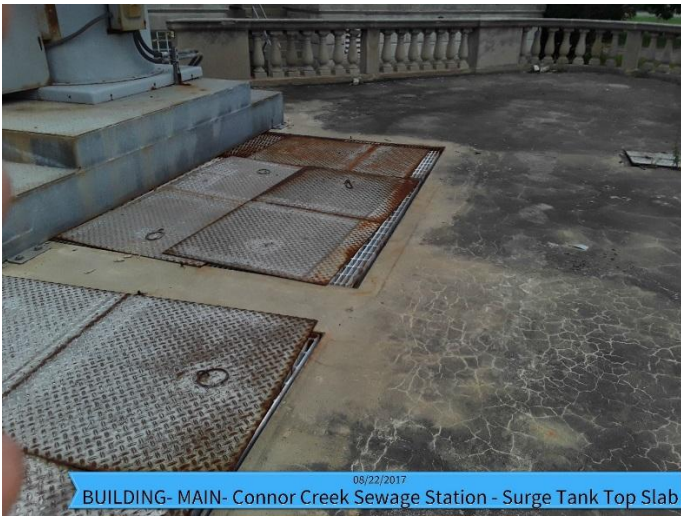
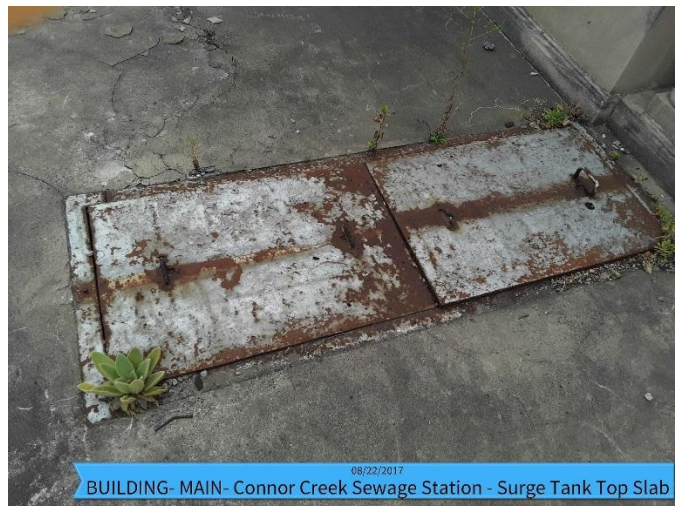
Surge Tank

The surge tank structure is a below-grade reinforced concrete tank structure that extends approximately 3-feet above grade. The surge tank was constructed at the same time as the Storm Water Pump Station (1928). The reinforced concrete tank walls are covered by decorative cast stone pieces so they were unable to be viewed. The cast stone units along the perimeter walls are generally in fair condition. The reinforced concrete top slab of the surge tank is in poor condition. Numerous spider cracks, raised portions of slab, and hollow sounding portions of slab were observed. However, no exposed rebar was seen from the top slab. It appears the top slab of the surge tank was placed in multiple slab pours based on the construction joints seen. The top slab does not appear to drain well. Since no floor drains were found and not much slope on the top slab is available, the top slab may drain to the grated covers on the top slab. Dirt and concrete debris was observed in numerous places on the top slab. There are numerous steel floor plates covering the grating pieces on the top slab. Most of these steel floor plates are deformed and all show signs of surface corrosion. There is also no stair provided for accessing this top slab. The need for access to the top slab will need to be considered during the upcoming project.

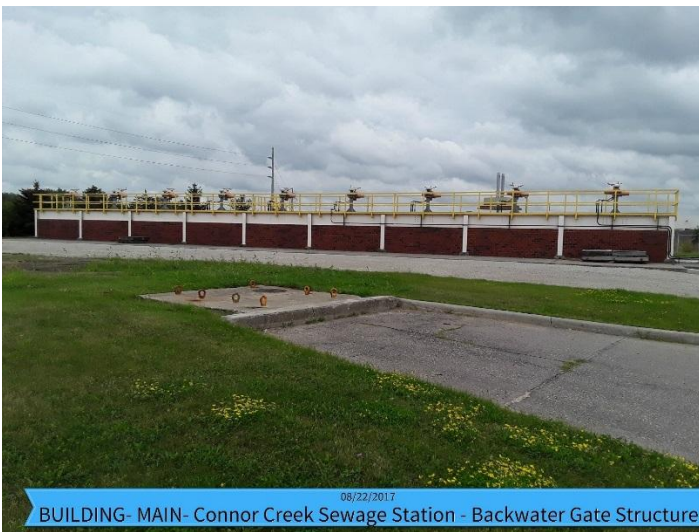
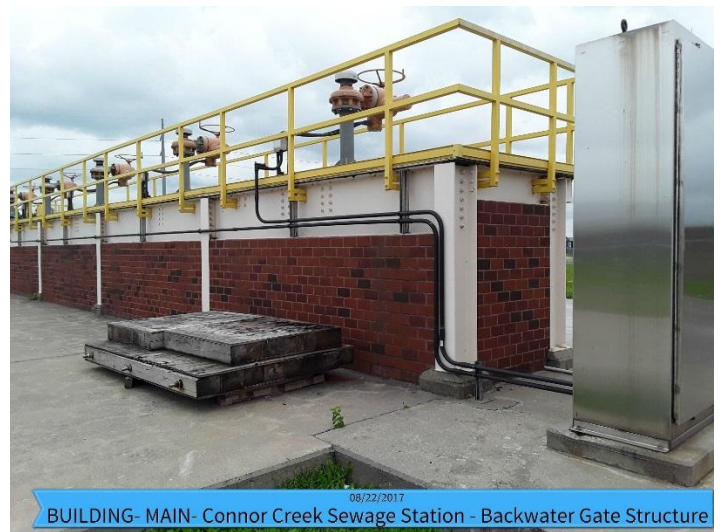
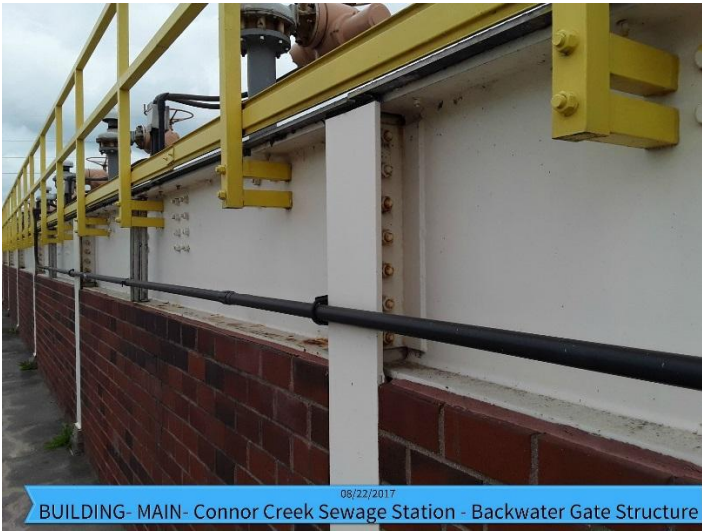
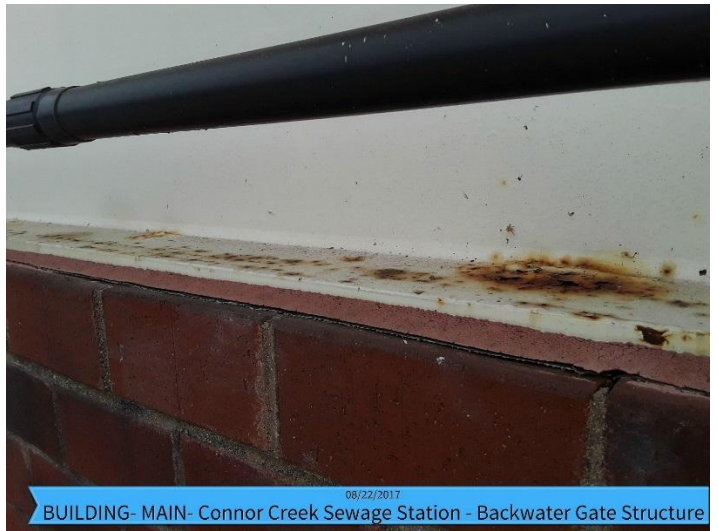
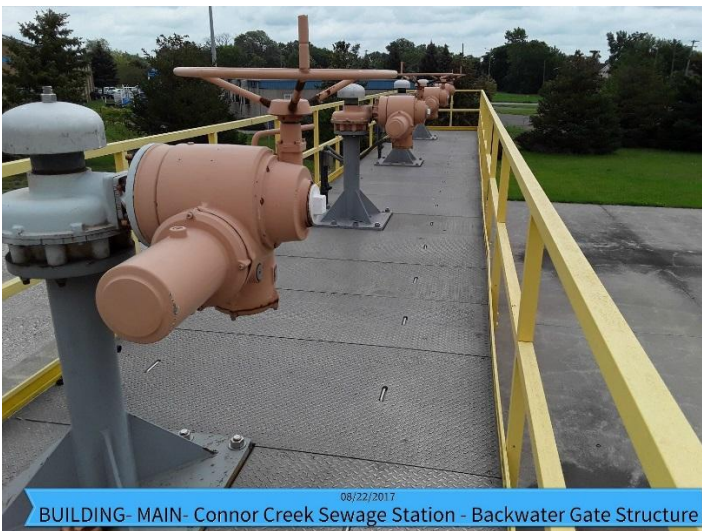
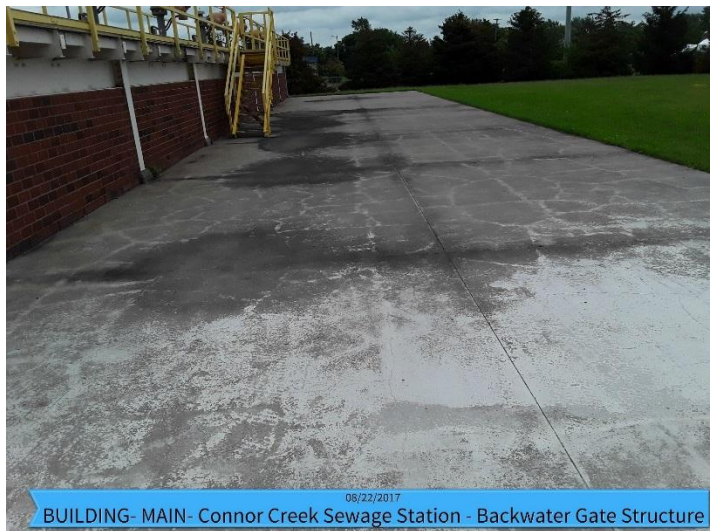
08/22/2017
BUILDING- MAIN- Connor Creek Sewage Station - Backwater Gate Structure

The backwater gate structure is a structure that extends both above and below-grade. The walls of the structure consist of oversized brick on the exposed face with structural steel frame columns and beams supporting an upper walkway on top of the structure. The upper walkway consists of aluminum plates and fiberglass handrail. The date of construction of this structure is around 1999. Numerous hairline spider cracks were observed in the 20-foot wide concrete slab-on-grades on both the east and west sides of Backwater Gate Structure. These slabs do not appear to drain surface water well based on the dark stains and dirt piles on various portions of these slabs. Minor surface corrosion was observed on the bottom of the steel beam flanges in some stretches of east and west side top walkway support beams (at the top of the brick wall). The aluminum cover plates appear to be in good condition. The fiberglass handrails and stair treads are in good condition, however, in spots, the fiberglass railing feels “sharp” and “abrasive” to bare hands.

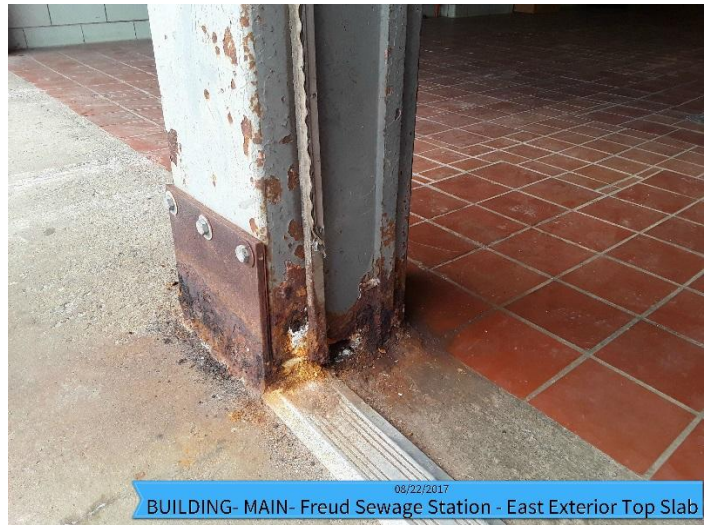
08/22/2017
BUILDING- MAIN- Freud Sewage Station - East Exterior Top Slab

A temporary steel column base repair was observed at the overhead door adjacent to the east exterior top slab (loading dock). A more permanent repair for this steel column base is needed.

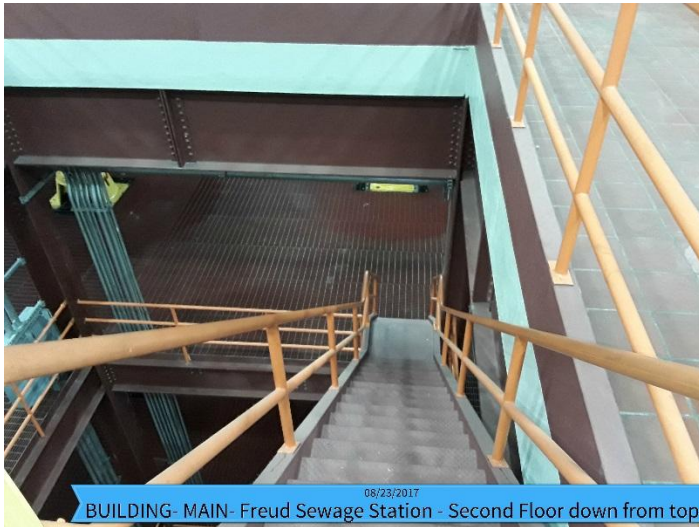
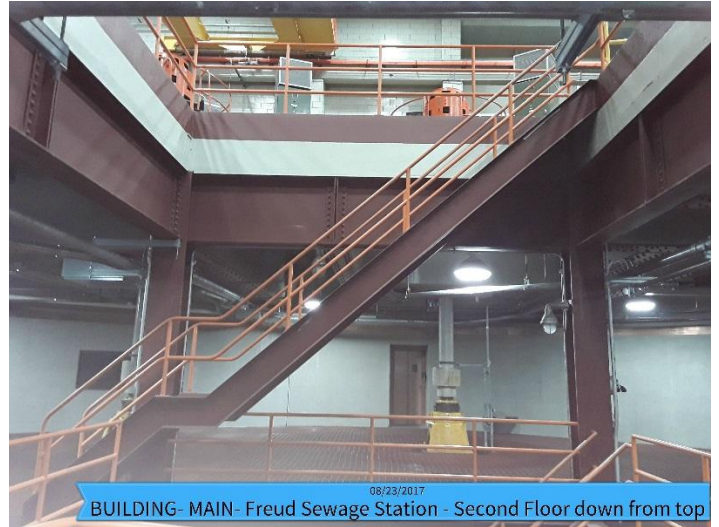
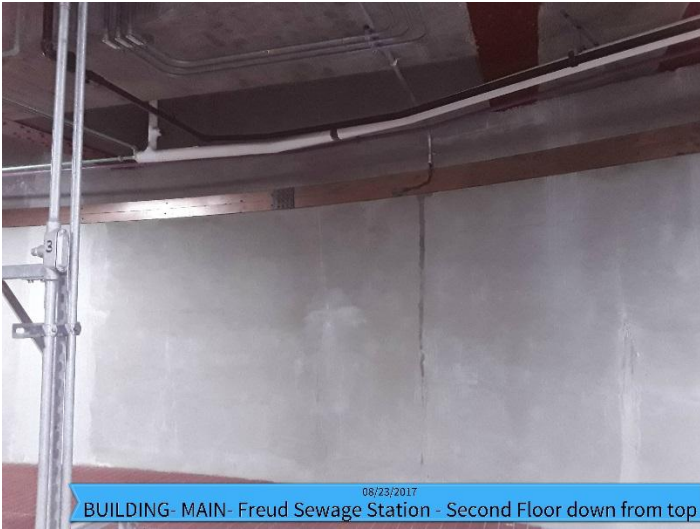
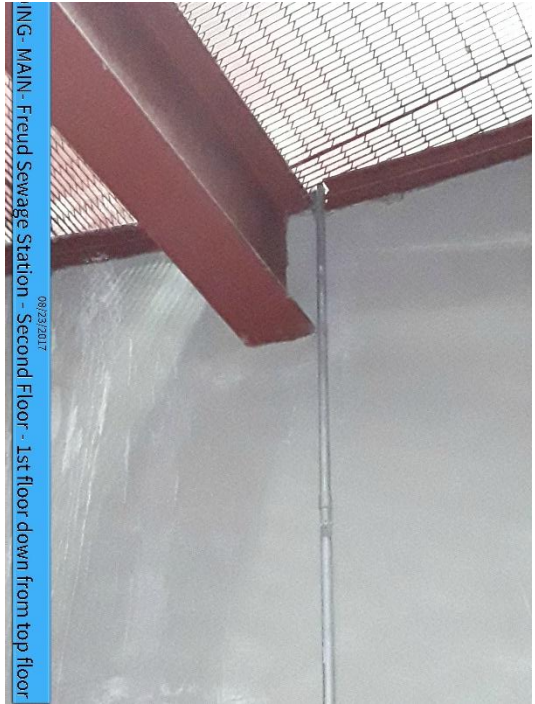
Second Floor and Substructure (1st Floor down from Top)

The floor consists of painted steel bar grating supported from structural steel wide-flange beam framing. The framing is supported at the center of the pump station by four columns (that also frame the stair and pump removal shaft) and by the circular concrete caisson walls around the perimeter of the Pump Station. The grating, handrails, and steel wide-flange beam framing are in great condition with very little steel surface corrosion observed. Some minor paint bubbling was found on the southeast column of the center shaft just below 2nd floor.

The perimeter reinforced concrete caisson walls were in great condition and looked like they were just built. Only a few hairline cracks with very minor signs of past leakage were observed.

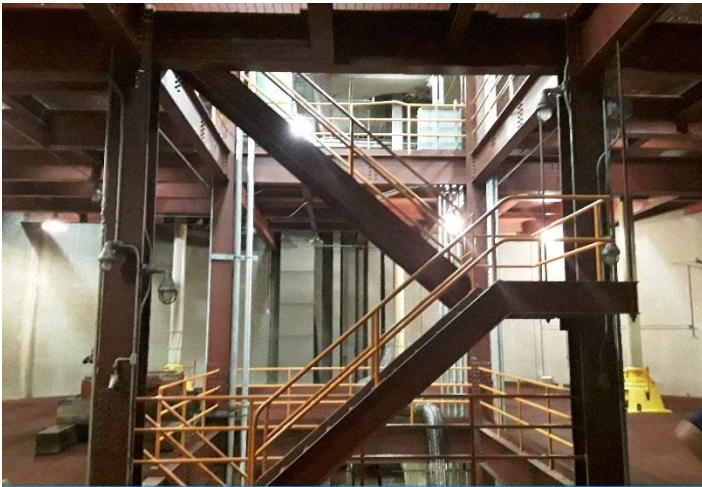
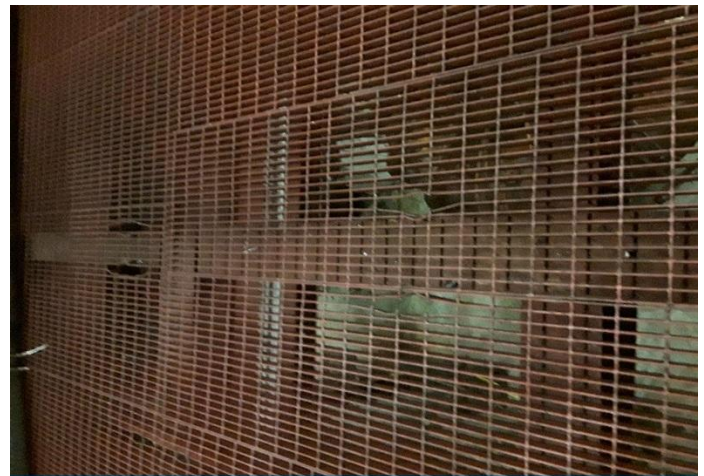
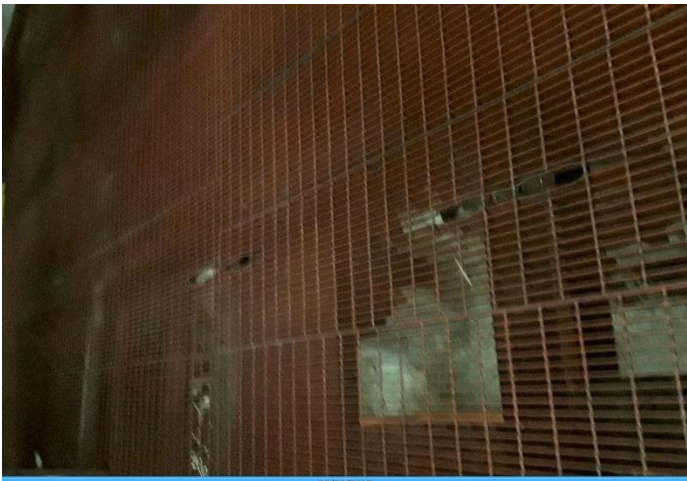
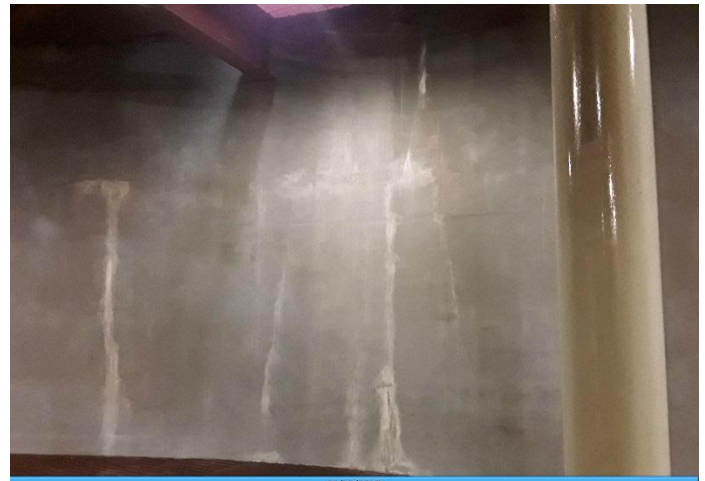
Third Floor and Substructure (2nd Floor down from Top)

The floor consists of painted steel bar grating supported from structural steel wide-flange beam framing. The framing is supported at the center of the pump station by four columns (that also frames the stair and pump removal shaft) and by the circular concrete caisson walls around the perimeter of the Pump Station. The grating, handrails, and steel wide-flange beam framing are in good condition. Very little steel surface corrosion was observed on the grating and handrail. The structural steel wide-flange beam framing has some steel corrosion, specifically noticed on bottom flange when looking up at underside of framing. Steel grating bearing bars have been stressed and warped in numerous locations on this floor (more noticeable on 3rd floor than 2nd floor). These grating bearing bars were used as localized lifting points during equipment removal and replacement.

The perimeter reinforced concrete caisson walls are in good condition with some hairline cracks and signs of past minor leakage in north and northwest portions of the walls. More cracks with past leakage were observed above 3rd floor level than compared to the 2nd floor level above.
