Great Lakes Water Authority

Freud Pump Station Improvement Project

Project Plan - DRAFT

April 2022

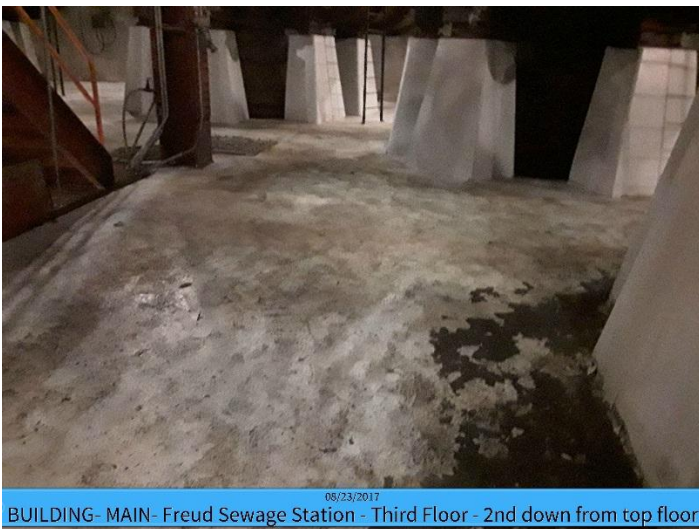
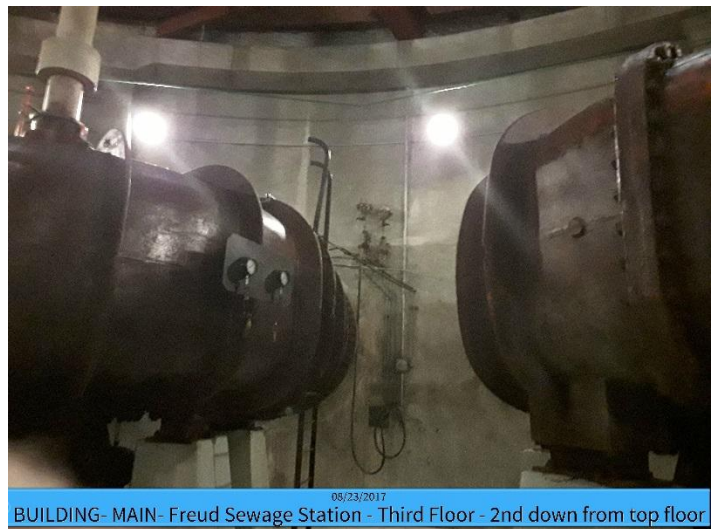
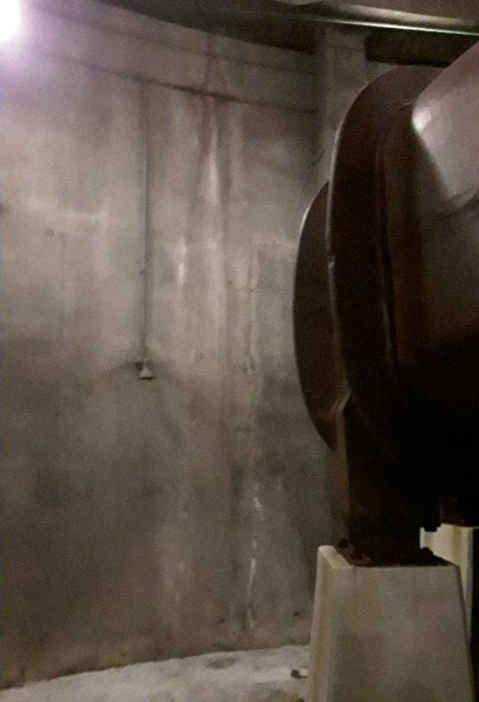
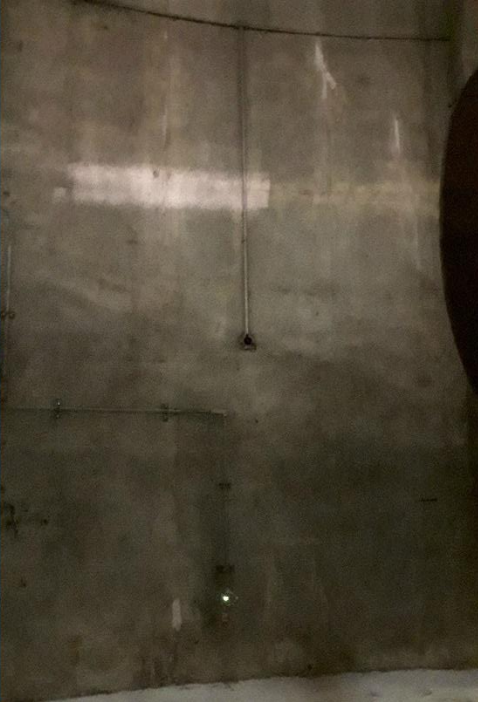
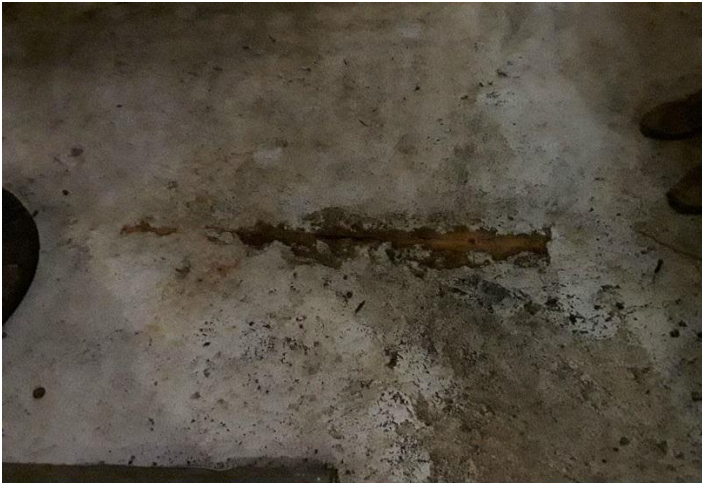
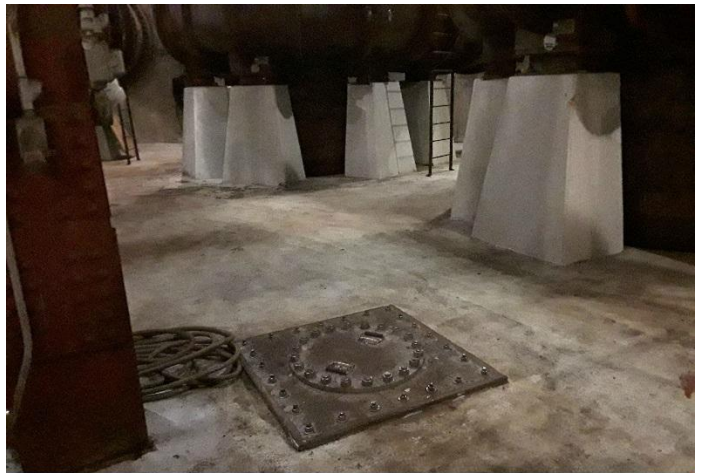
The perimeter reinforced concrete caisson walls are in good condition with numerous hairline cracks and signs of past minor leakage (efflorescence) of the walls observed. There were more cracks with past leakage noticed at and above the basement floor level than compared to 3rd floor level (above) and much more than compared to 2nd floor level (further above).

The reinforced concrete floor is painted so hard to see the top surface for cracks. Exposed rebar, maybe insufficient cover during original placement, was noticed in one area on the north side of center shaft. There are two bolted-down floor access hatches for access to the storm well. The construction of these floor hatches and the bolts used to restrain the access hatches poses a tripping hazard since plates and bolts stick up from floor.

The only structural steel framing at this elevation is grating and support framing over the center lower sump level shaft. The support framing has surface corrosion on both flanges and webs. The handrails and grating look to be in good condition with very minor surface corrosion.

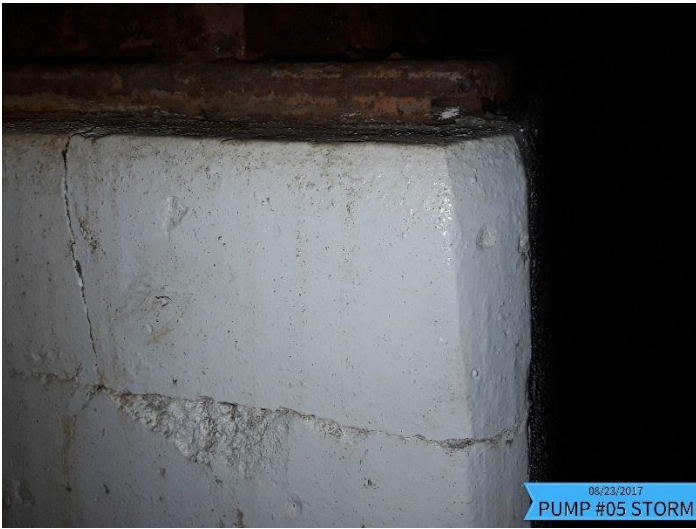
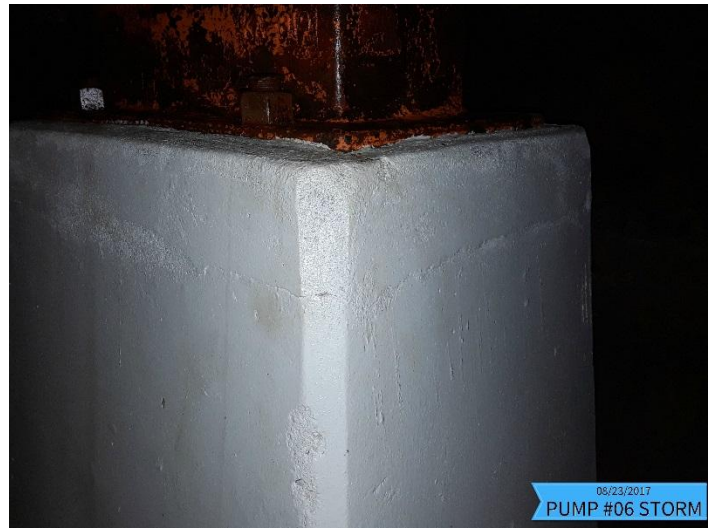
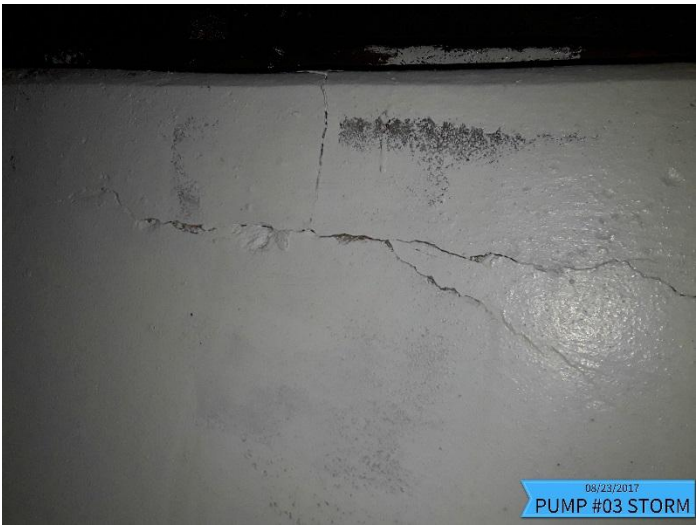
Lowest Level (Sump) and Substructure (4th Floor down from Top)

The perimeter reinforced concrete walls are in fair condition with numerous hairline cracks (with signs of active minor leakage and efflorescence), areas of concrete deterioration and spalls (on west wall and northwest corner), and numerous locations of exposed horizontal rebar in walls were observed. The walls of this lowest sump level are by far the poorest condition of any of the substructure walls observed in the Pump Station, and will require repairs in the future project.

The stair stringers, stair treads, intermediate walkway framing, and grating has significant surface corrosion. The handrail on the intermediate platform at the northwest end has lost its connection to the wall (connection corroded through). The upper and lower stairs to the intermediate platform are steep and narrow, and OSHA code requirements should be revisited to ensure stairs meet code.

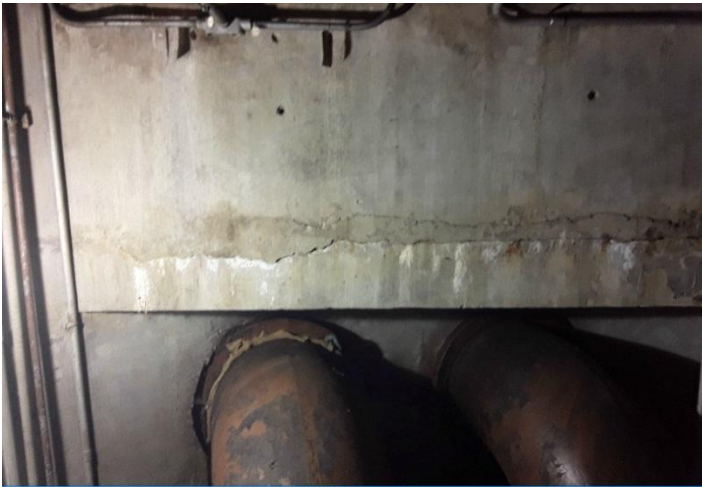
08/23/2017
G- MAIN- Freud Sewage Station - Lowest Level - Sump - 4th down from top floor

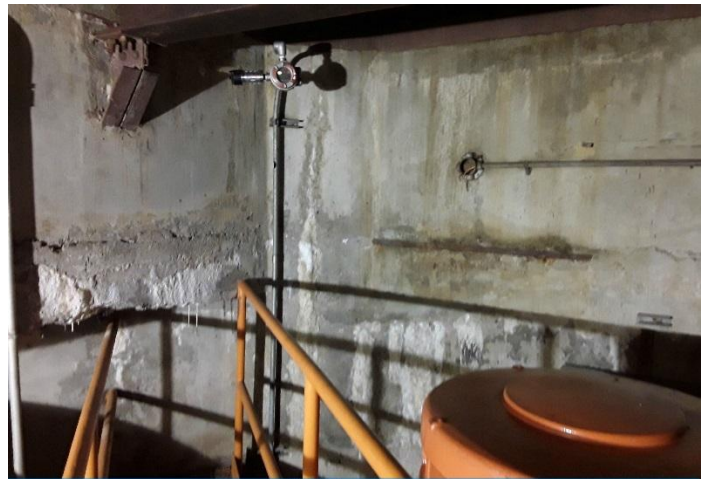
08/23/2017
G- MAIN- Freud Sewage Station - Lowest Level - Sump - 4th down from top floor

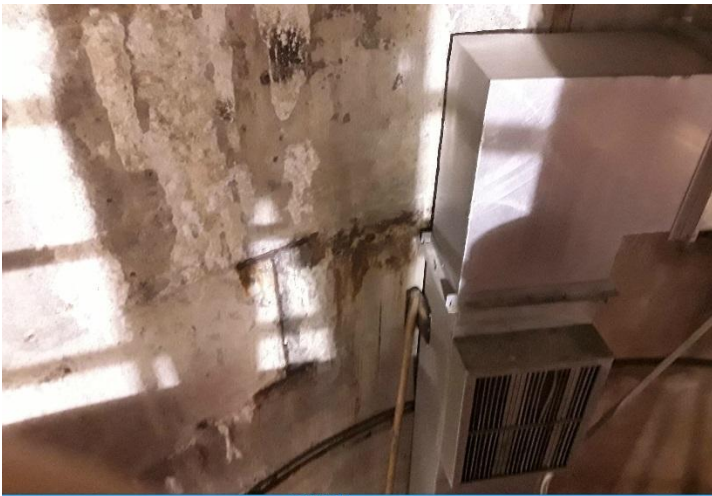
08/23/2017
G- MAIN- Freud Sewage Station - Lowest Level - Sump - 4th down from top floor

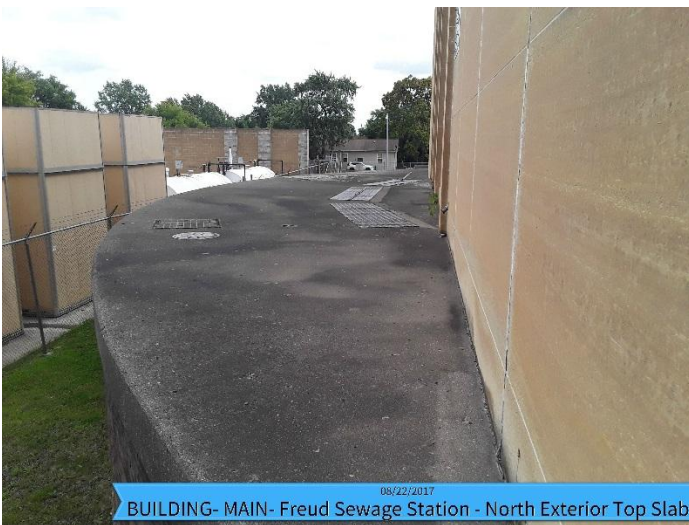
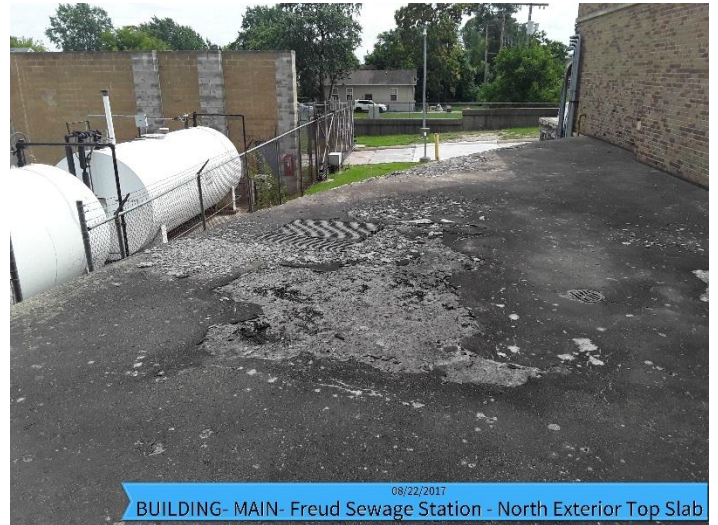
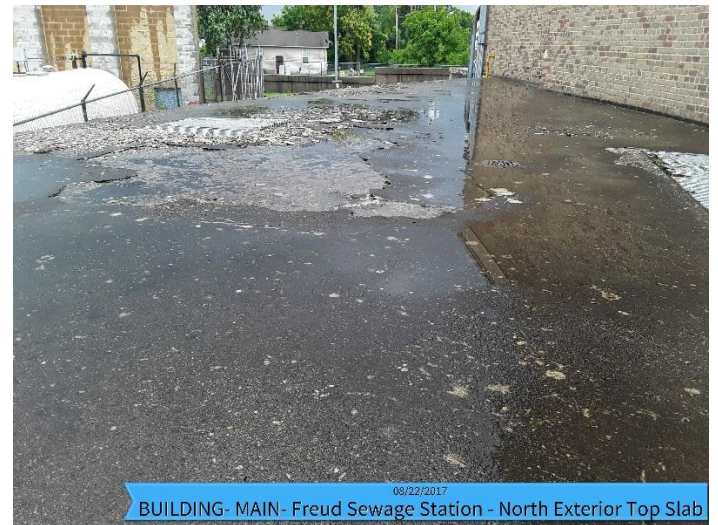
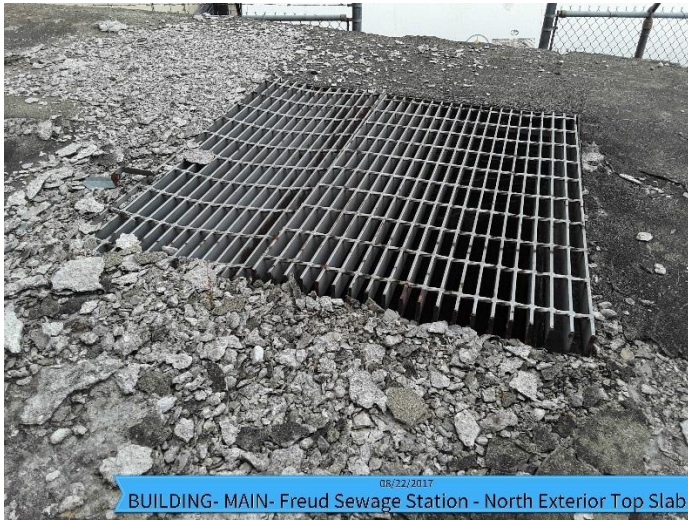
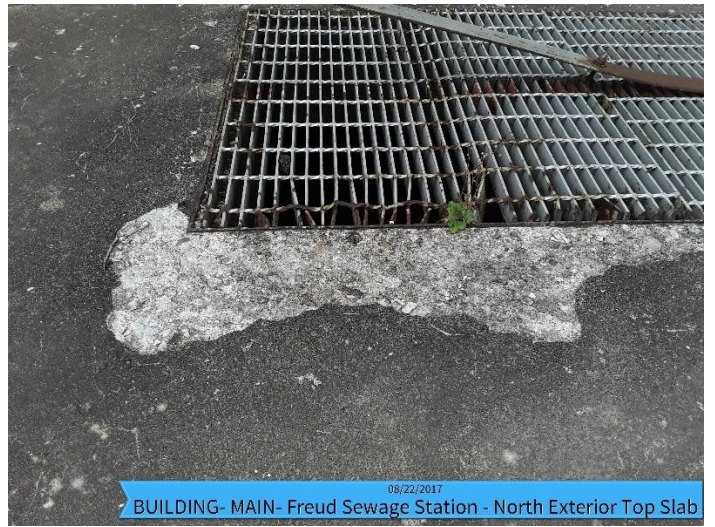
North Exterior Top Slab

The north exterior top slab is an extension of the Pump Station top floor out over the perimeter flume. The western portions of the existing top slab are in good condition but the eastern portions are in very poor condition with significant concrete deterioration and spalling. With the current state of the eastern portion of the top slab, rain water is not draining off the slab but collecting and further deteriorating the concrete top slab. Significant concrete deterioration and spalls along with cracks showing signs of efflorescence were observed on the top slab edges at the top of the brick wall. The eastern portions of the top slab will need to be removed and replaced in the future project. The brick walls below the top slab are severely stained from the concrete and brick efflorescence along with years of rainwater shedding off the top slab. All steel grating pieces on the north exterior top slab (over the flume) are deformed (some bearing bars showing signs of yielding) with cross bars broken and pose a potential safety concern due to loss of live load capacity and from tripping hazard standpoint. No stairs to access this slab exist. New stairs or a new platform (from the east or west exterior top slab) should be considered to provide access to the slab. Handrail along the edges of the top slab should be considered to prevent falls if access to this slab is needed.

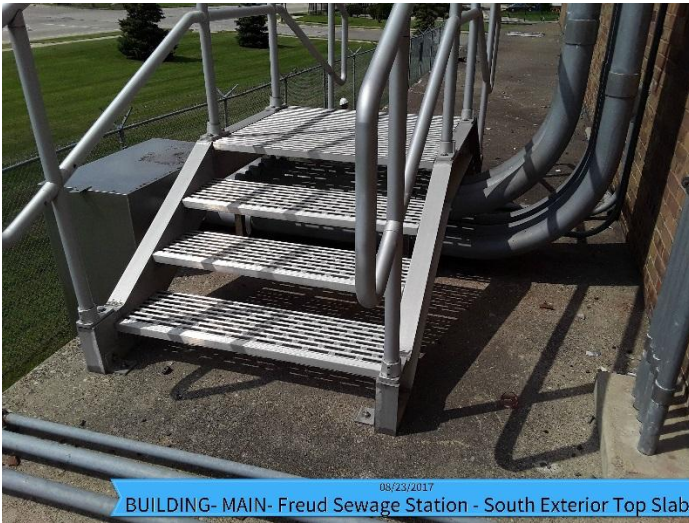
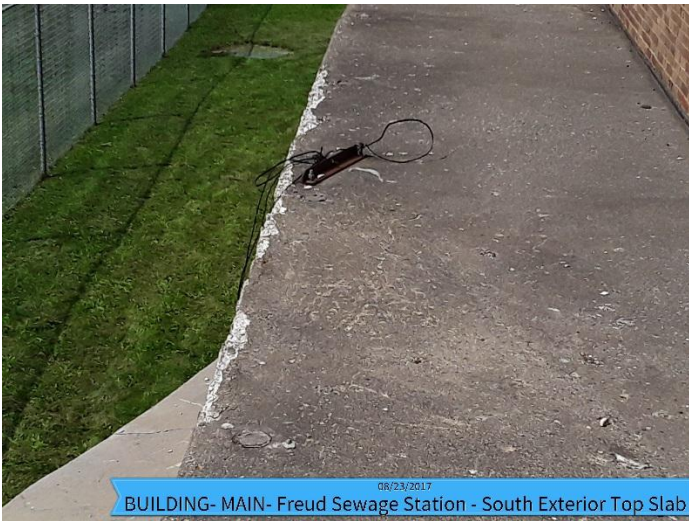
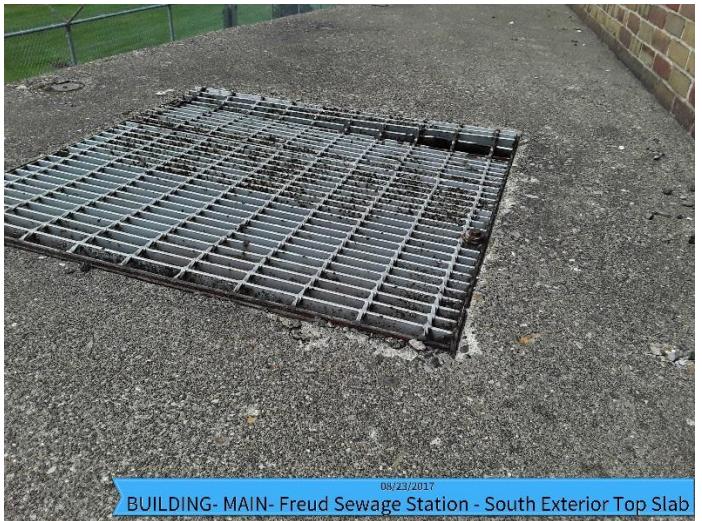
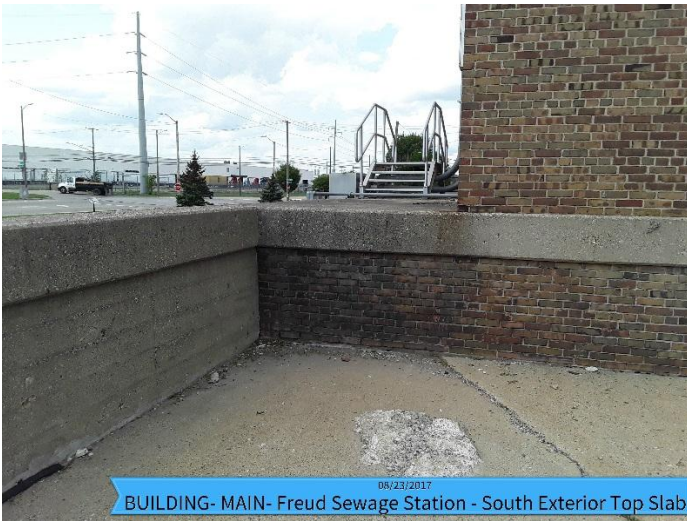
South Exterior Top Slab

The south exterior top slab is approximately a 6-foot wide extension of the Pump Station top floor out over the perimeter flume. The existing top slab appears in good condition with only areas of concrete spall along a 6-foot stretch of the top slab edge. The brick walls below the top slab are stained from the concrete and brick efflorescence along with years of rainwater shedding off the top slab. The steel grating over the flume is deformed (some bearing bars showing signs of yielding) with cross bars broken and pose a potential safety concern due to loss of live load capacity and from tripping hazard standpoint. Some corrosion on steel lintels in the brick wall above windows was observed. No stairs to access this slab exist. Stairs from the eastern driveway to get up to this slab should be considered. Handrail along the edges of the top slab should be considered to prevent falls if access to this slab is needed.

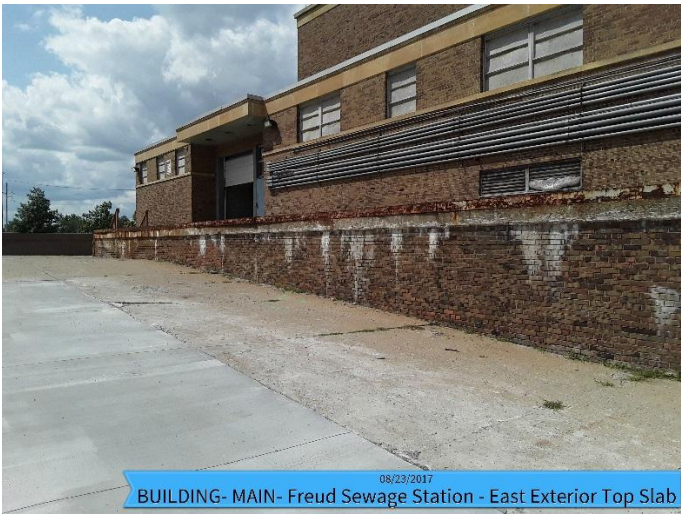
08/23/2017
BUILDING- MAIN- Freud Sewage Station - East Exterior Top Slab

The east exterior top slab is an extension of the pump station top floor out to the east side of the building to provide a loading dock down to the driveway. Approximately one-third of the top slab is in very poor condition with significant concrete deterioration and spalling. Just outside the entrance to the pump station, there is approximately a 16-square foot portion of top slab with significant concrete deterioration where the top two inches of concrete top slab has deteriorated to stone and gravel and exposed rebar can be observed (when stone and gravel is moved). Along the loading dock edge, the steel edge angle has significant surface corrosion and for large stretches of this angle the concrete slab edge has deteriorated so badly that the edge angle anchors have lost their embedment with the concrete top slab and the wall vertical dowels into the top slab are exposed. With the current state of the top slab, rain water is not draining off the slab but collecting and further deteriorating these substandard portions of the concrete top slab. Significant concrete deterioration and spalls along with cracks showing signs of efflorescence were observed on the top slab edges at the top of the brick wall. Portions of this top slab and the entire edge this top slab will need to be removed and replaced in the future project. The brick walls below the top slab are severely stained from the concrete and brick efflorescence along with steel edge angle corrosion and years of rainwater shedding off the top slab.

The steel grating is deformed (some bearing bars showing signs of yielding) with cross bars broken and pose a potential safety concern due to loss of live load capacity and from tripping hazard standpoint. Some corrosion on steel lintels in the brick wall above the windows was observed. Temporary wooden stairs with forward-sloping wooden stair treads are currently used as the main access to this east exterior top slab and pump station. Permanent aluminum or galvanized metal stairs and handrail, that are wider and code compliant, should be considered for proper access (and load carrying capacity of maintenance operations). Handrail is needed along the edges of the top slab to prevent falls. Removable side-mounted handrail should be considered in places to allow for better unloading and loading operations.

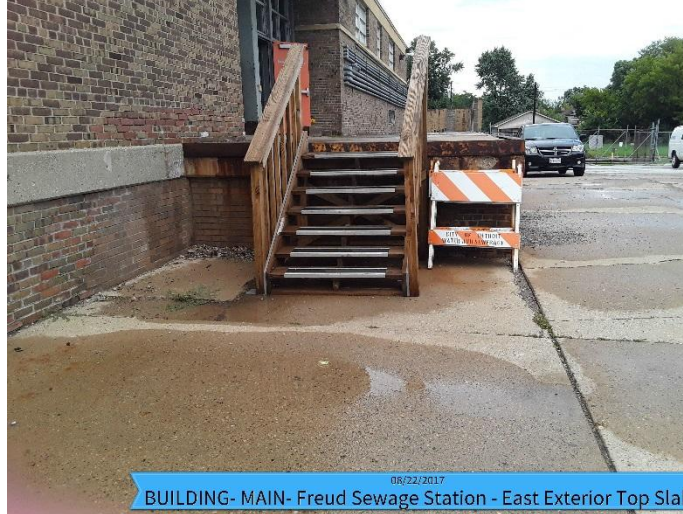
08/22/2017
BUILDING- MAIN- Freud Sewage Station - East Exterior Top Slab

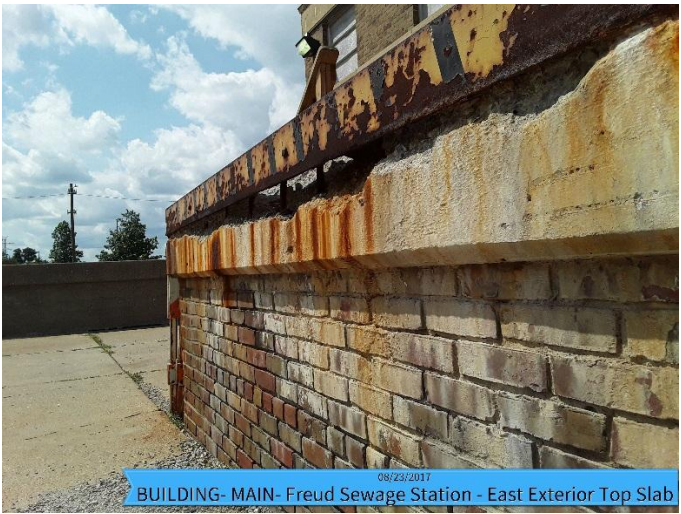
08/23/2017
BUILDING- MAIN- Freud Sewage Station - East Exterior Top Slab

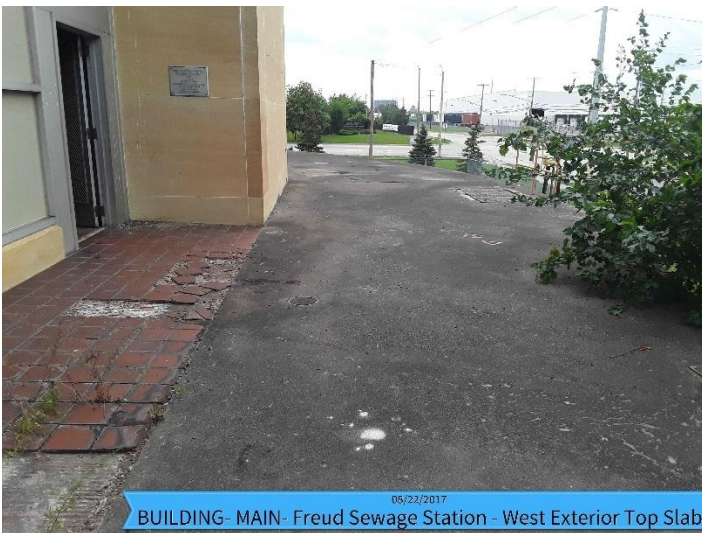
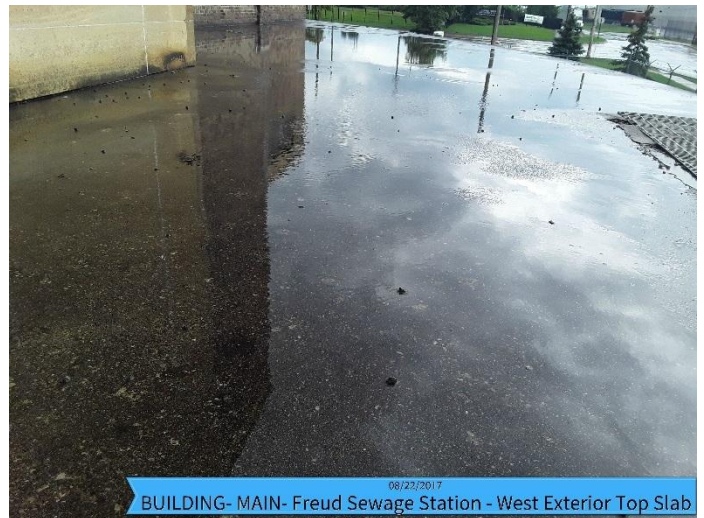
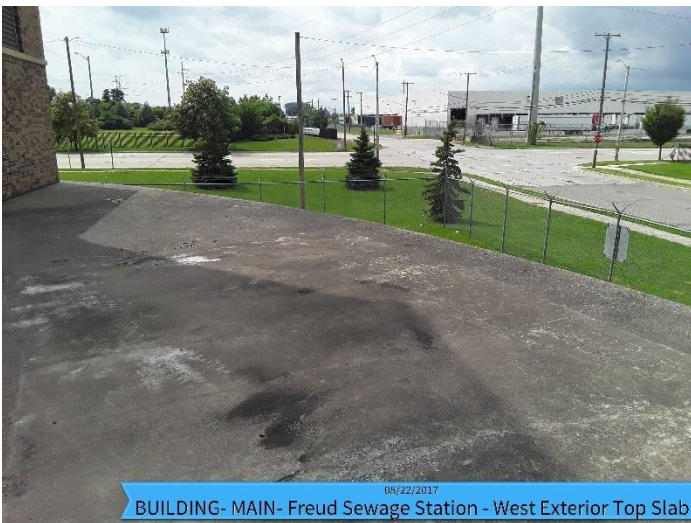
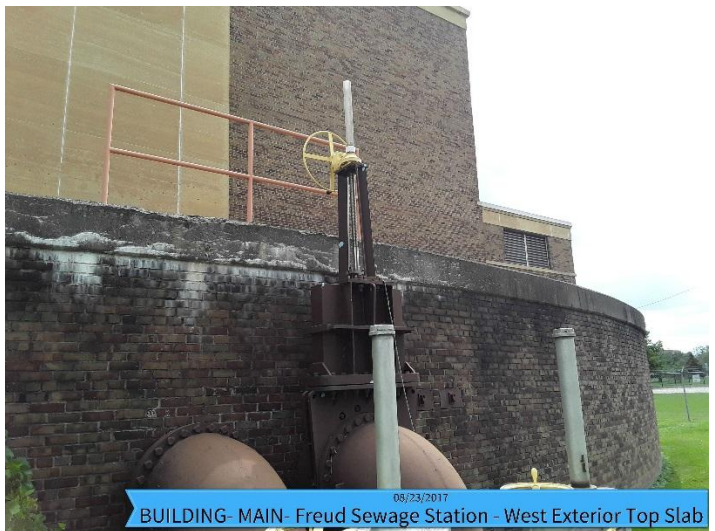
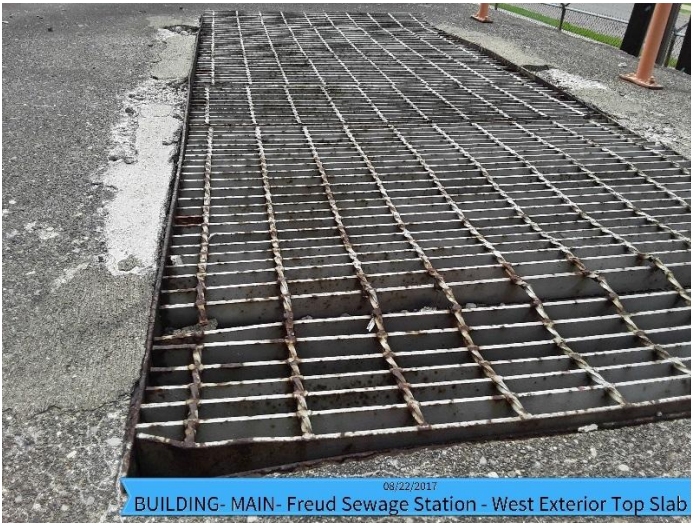
West Exterior Top Slab

The west exterior top slab is an extension of the Pump Station top floor out over the perimeter flume. The existing top slab for the most part appears to be in good condition with only areas of concrete spall along a 15-foot stretch of the top slab edge (at the top of the brick wall) and around the steel grating. The top slab seems flat and only has 1 floor drain just outside building's service door (southern portion of top slab has no floor drain), so not sure how well this top slab drains. The brick walls below the top slab are severely stained from the concrete and brick efflorescence along with years of rainwater shedding off the top slab. Floor tile installed outside the service door is broken or loose likely due to weather exposure, water retention and frequent freeze/thaw cycles.

The concrete stair treads are in fair condition with numerous cracks and efflorescence observed. Steel stair nosings have surface corrosion and some of the stair treads have warped up (embedding of steel nosing to concrete stair tread may have been compromised) and thus poses a potential safety concern (tripping hazard). The steel grating over the flume is deformed (some bearing bars showing signs of yielding) with cross bars broken and pose a potential safety concern due to loss of live load capacity and from tripping hazard standpoint. Handrail along the edges of the top slab should be provided to prevent falls (10 to 20-foot above grade).

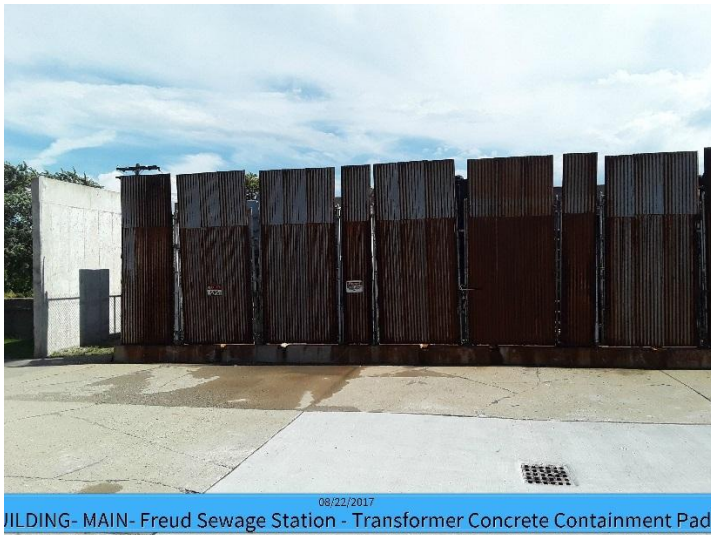
08/22/2017
BUILDING- MAIN- Freud Sewage Station - Transformer Concrete Containment Pad

The transformer containment pad consists of a concrete grade beams with embedded steel channels that the transformers bear on and a perimeter concrete curb with chain link fencing on two sides (backside of the East Site concrete retaining wall on other two sides). This was originally constructed along with the Pump Station in 1955. The existing concrete support grade beams under the transformer support legs appear in good shape with only minor cracks and spalls and the embedded steel channels in the grade beams have surface corrosion. The vertical concrete enclosure walls also appear to be in good condition. The chain link fence posts, metal panels and embedded steel channels are corroding and staining the concrete surfaces. The metal panels attached to the chain link fencing have presented safety concerns in the past because it provides more surface area for wind to act on and has ripped the fence gate portions off in a strong wind storm and struck parked vehicles. Containment of transformer fluids is not currently provided but should be considered.

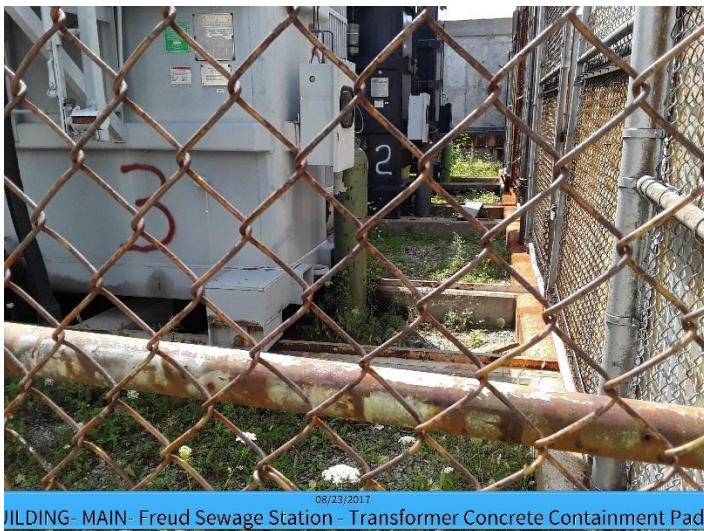
08/23/2017
BUILDING- MAIN- Freud Sewage Station - Transformer Concrete Containment Pad

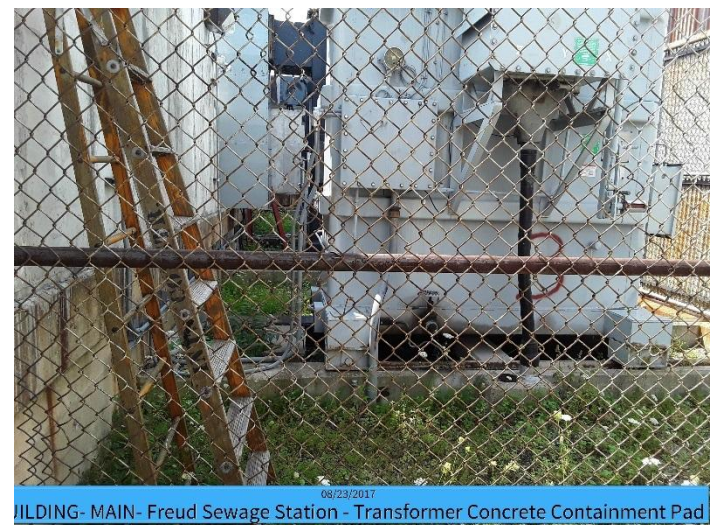
08/23/2017
BUILDING- MAIN- Freud Sewage Station - Transformer Concrete Containment Pad

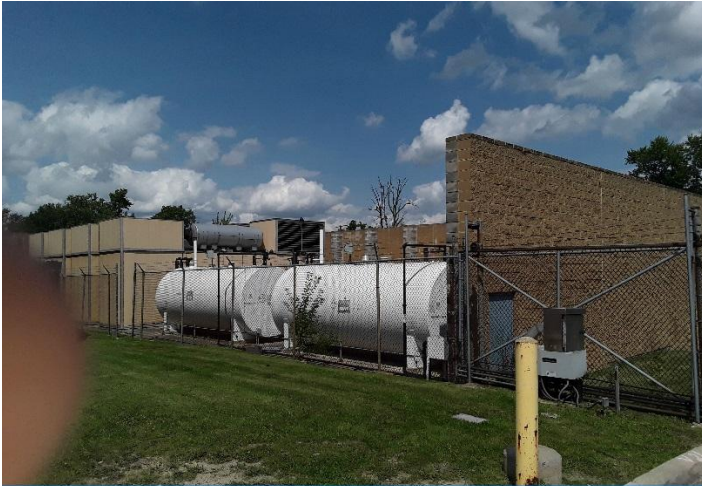
08/23/2017
reud Sewage Station - Generator Pad- Diesel Storage Tanks and Perimeter Wall

Generators and diesel fuel storage tanks are supported from a concrete slab-on-grade that was constructed in 1999. A double-wythe CMU closure wall, with intermittently spaced vertical CMU support pilasters, is provided around three sides of the Generator and Diesel Fuel Storage Tank Pad area to offer protection and a privacy screen. The existing slab-on-grade appears in good condition with only minor water weathering where existing slab drains between electrical enclosures. The CMU closure walls, both split face (on exterior face) and CMU block backup wall are in good condition with only a couple of face cracks and one cutout location observed in CMU backup wall. The concrete slab-on-grade seems flat with its top surface eroded slightly to allow for water drainage between electrical enclosures. Standing water was observed on soil between edge of concrete slab and base of CMU closure walls.

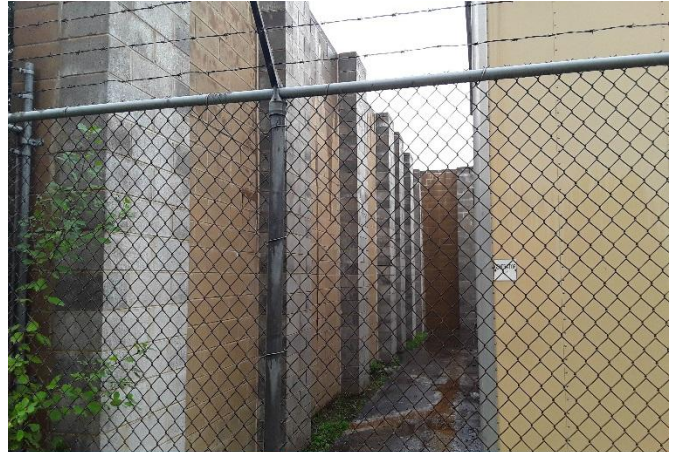
08/22/2017
reud Sewage Station - Generator Pad- Diesel Storage Tanks and Perimeter Wall

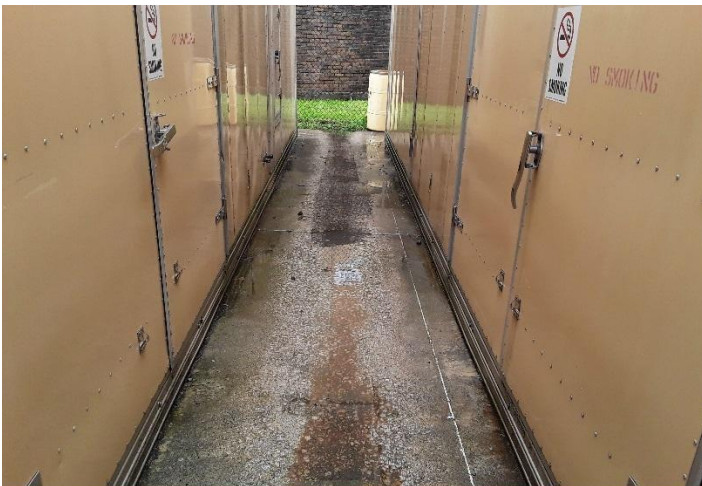
08/22/2017
reud Sewage Station - Generator Pad- Diesel Storage Tanks and Perimeter Wall

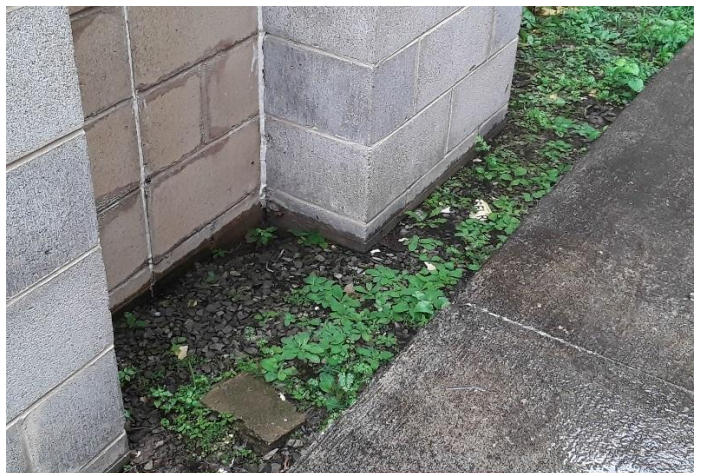
08/22/2017
reud Sewage Station - Generator Pad- Diesel Storage Tanks and Perimeter Wall

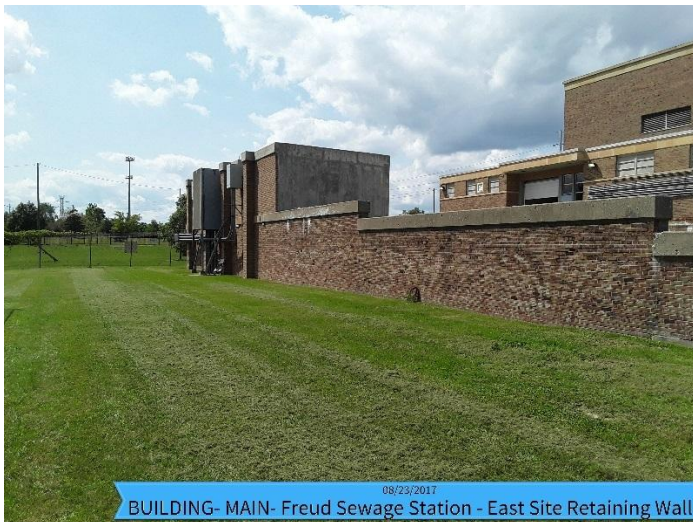
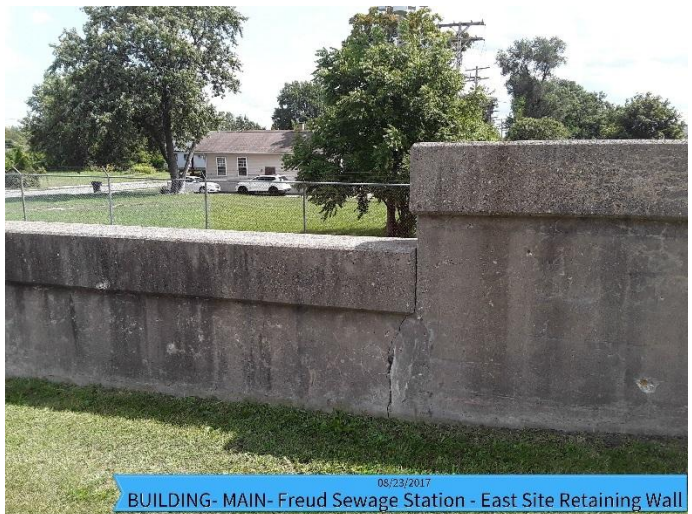
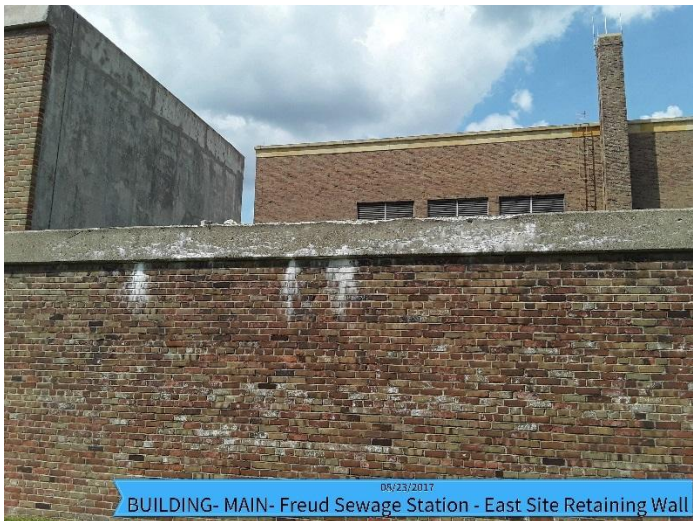
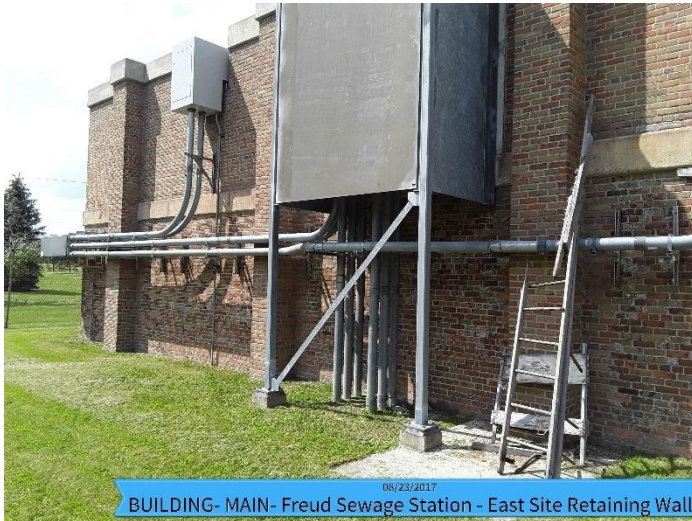
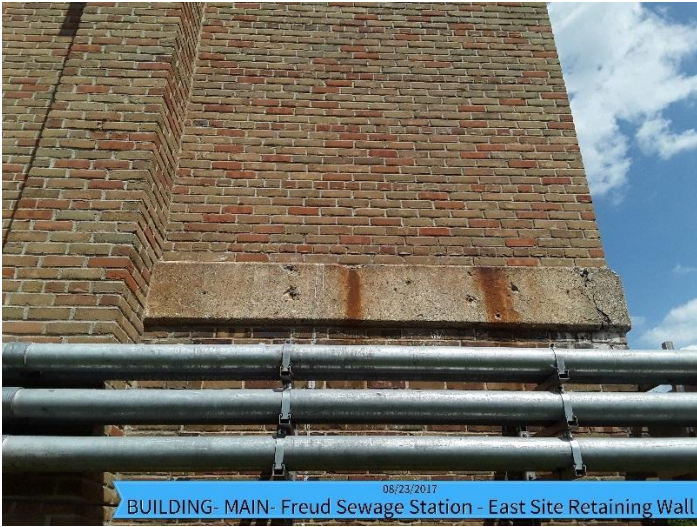
East Site Retaining Wall

The east site retaining wall is a vertical cantilevered reinforced concrete retaining wall with a brick face on the side exposed to public view and a concrete cap at the top. The retaining wall was constructed at the same time as the Pump Station (1955) to help transition the site from the upper driveway on the backside to the lower grade on the front side of the retaining wall and to offer protection and hide the transformers from public view. The retaining wall appears to be in sound condition, with no signs of rotation or substantial cracking in the structural reinforced concrete portion of the retaining wall. The concrete cap at top of brick wall has weathered significantly in certain areas. Hairline cracks, with efflorescence, were observed in portions of deteriorated concrete cap edges, at brick wall control joints, and at changes of wall heights. Exposed resteel was observed in a few locations and signs of corrosion from resteel or steel wall anchors where found in other locations. Numerous cracks in the brick face at wall height transitions, abandoned brick wall anchors, brick wall face voids in two locations, and some weathering of the brick mortar joints (section loss of mortar joints) were observed. On the south side, slight brick wall movement was seen on each side of control joint with loss of filler material and sealant in the joint. Overall, the brick wall face is stained in some areas due to areas of efflorescence and steel corrosion. On the south side, the concrete flume encasement at-grade has a large amount of spider cracking with signs of efflorescence.

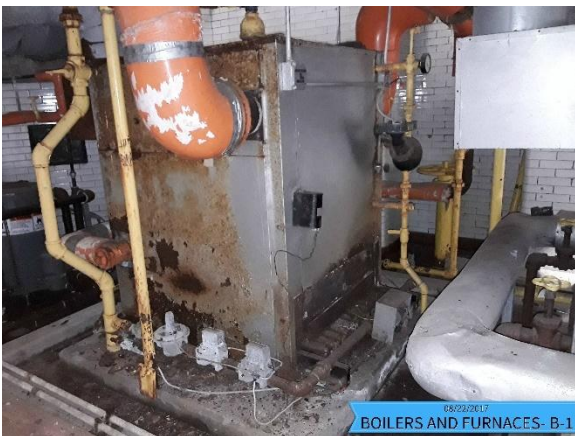
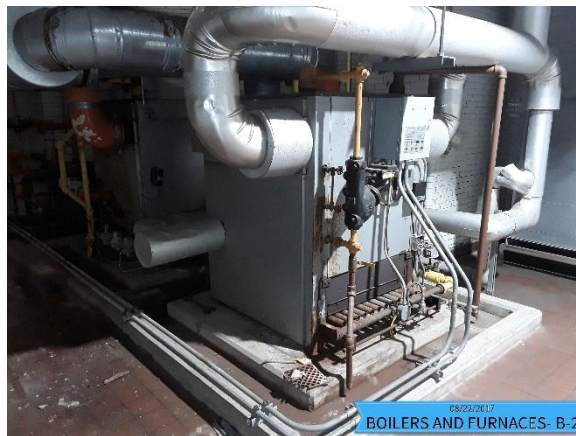
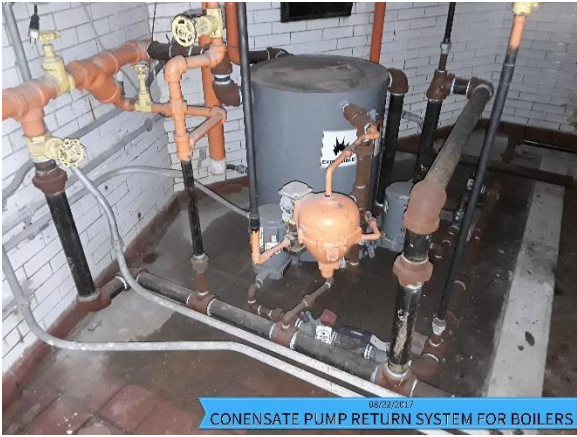
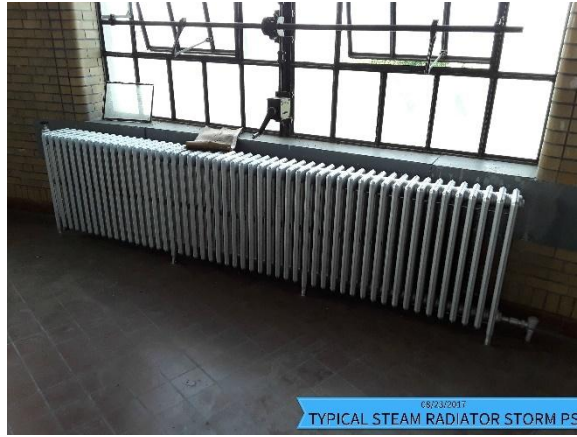
The Storm Water Pump Station is provided with heat from a low-pressure steam system. Steam is distributed via piping to cast iron radiators located in the Motor Room that appear to be original to when the building was constructed. Condensate is returned to the boilers via a condensate return system. The two boilers are located in a lower level Boiler Room. One boiler appears to be non-operational, is very corroded, and has exceeded its service life expectancy. The other is operational, but has also reached its service life expectancy. The condensate return system is separate from the boilers. It consists of a condensate tank, pumps, piping, and controls. It has more than 50 percent corrosion on the piping and unit itself and has exceeded its service life expectancy. The cast iron radiators have been painted and appear in good condition on the exterior for their age. The steam and condensate piping in the Pump Room was painted and appeared in good condition on the exterior. Some of this piping had been replaced in 2001.

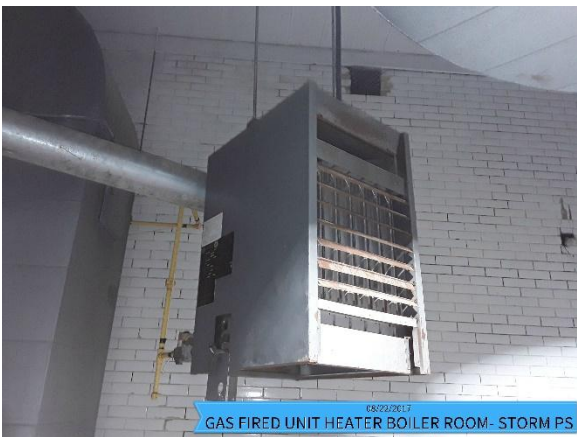
The Boiler Room is heated by a natural gas fired unit heater controlled by a wall mounted thermostat. The unit has slight corrosion and has exceed its service life expectancy.

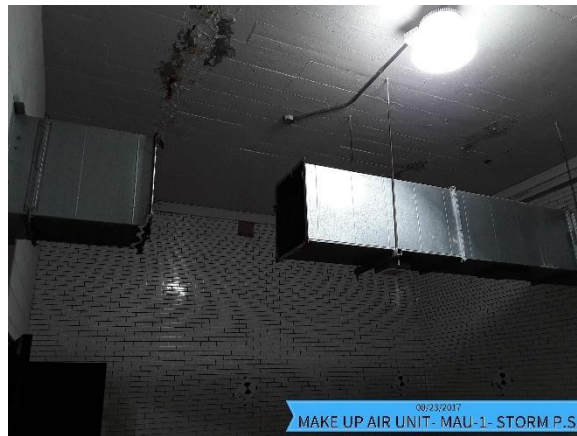
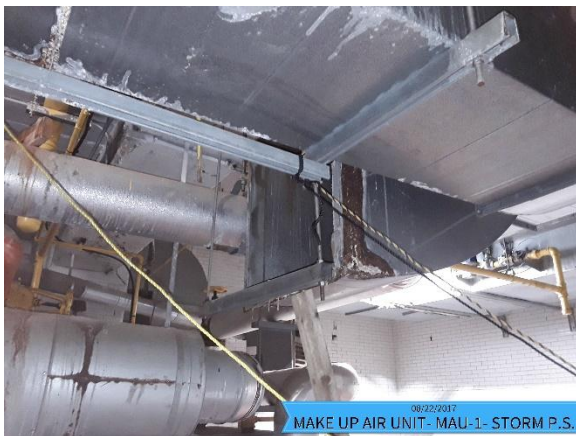
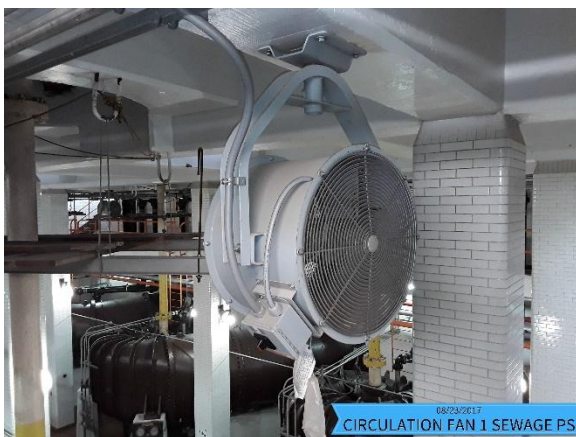
Ventilation for the Pump Room is provided by a natural gas direct fired make-up air handling unit located in the Boiler Room, three propeller type exhaust fans located in the sidewall of the Motor Room upper cupola, and four tube axial circulation fans located in the Pump Room. These units are all interlocked. 100% of outside air is brought in through a wall mounted intake louver and ducted down to the unit. Supply ductwork from the unit distributes air into the Pump Room along both sidewalls. Air migrates up to the Motor Room where it is exhausted through the three exhaust fans. The four tube axial circulation fans located in the Pump Room help to distribute the air within the space. The make-up air handling unit is controlled by a Hand-Off-Auto (HOA) switch, outdoor air sensor, and room space temperature and humidity sensors. A section of the supply ductwork from the make-up air handling unit is removed and lying on the floor. The outside air ductwork to the make-up air handling is corroded with some sections missing. The make-up air handling unit, exhaust fans, and circulation fans have exceeded their service life expectancy.

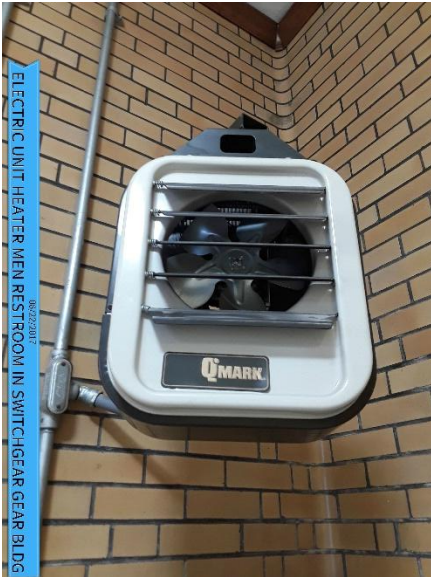
ELECTRIC UNIT HEATER MEN RESTROOM IN SWITCHGEAR GEAR BLDG

The heating for the Primary Switchgear Building is provided by wall mounted electric unit heaters and electric radiant baseboard heaters throughout the facility. The unit heaters are controlled by wall mounted thermostats. The radiant baseboard heaters are controlled by integral thermostats. Each Restroom contains both a wall mounted electric unit heater and an electric radiant baseboard heater. The Janitors Room, Back Entrance Storage Room, and Basement are heated by the electric radiant baseboard heaters only. The Hallway and Switchgear Rooms are heated by only the wall mounted electric unit heaters. One of the unit heaters located in the Switchgear Room is missing the motor and fan blade. These units are approaching the end of their service life expectancy.

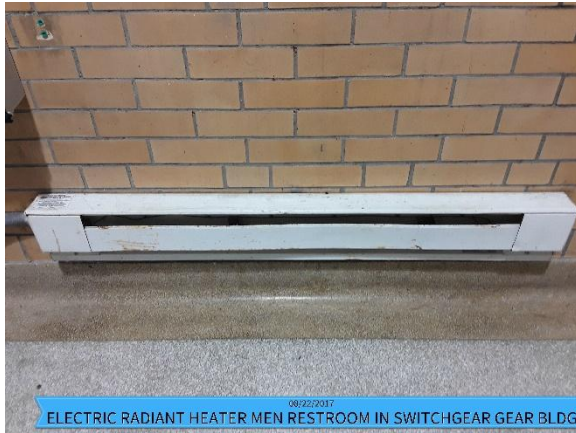
08/22/2017
ELECTRIC RADIANT HEATER MEN RESTROOM IN SWITCHGEAR GEAR BLDG

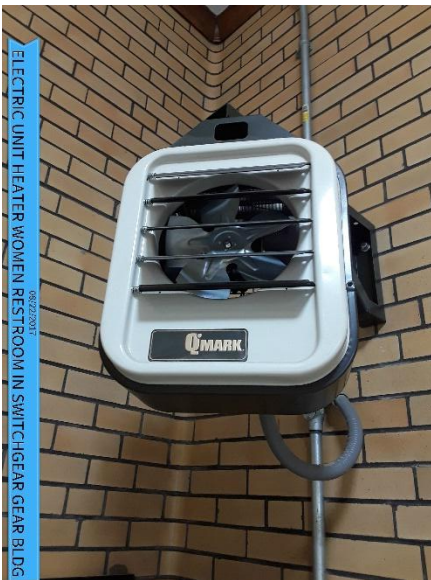
ELECTRIC UNIT HEATER WOMEN RESTROOM IN SWITCHGEAR GEAR BLDG

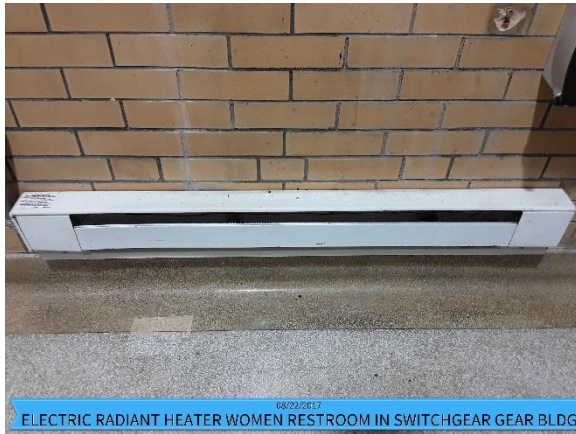
08/22/2017
ELECTRIC RADIANT HEATER WOMEN RESTROOM IN SWITCHGEAR GEAR BLDG
