Great Lakes Water Authority

Freud Pump Station Improvement Project

Project Plan - DRAFT

April 2022

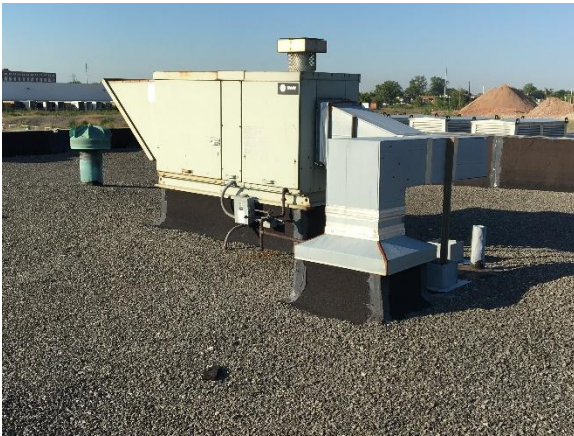
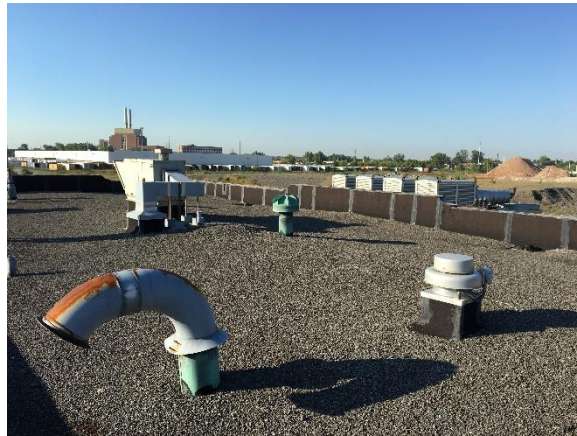
Ventilation for the Primary Switchgear Building is provided by exhaust fans and a natural gas fired rooftop mounted 100% outside air make-up air handling unit. The exhaust fan that serves the Switchgear Room is a rooftop mounted centrifugal type fan. The fans that serve the Transformer Room, Battery Room, and Restrooms are ceiling mounted centrifugal type fans that are located between the ceiling and the roof deck. Air is exhausted from each of these spaces through ceiling mounted exhaust grilles via exhaust ductwork located in the space between the ceiling and the roof deck. This air is then discharged through gooseneck vents located on the roof. The make-up air handling unit distributes air through supply ductwork down to each space where it discharges at ceiling mounted supply diffusers. This supply ductwork is located in the space between the ceiling and the roof deck. The make-up air handling unit is controlled by an HOA switch, outdoor air sensor, and room space temperature and humidity sensors. The rooftop mounted centrifugal exhaust fan that serves the Switchgear Room is interlocked with the make-up air handling unit. The exhaust fans serving the Restrooms are interlocked with the room lighting controls. The Transformer Room exhaust fan is controlled by a humidity sensor, and the Battery Room exhaust fan is controlled by a start/stop switch and is set to operate continuously.

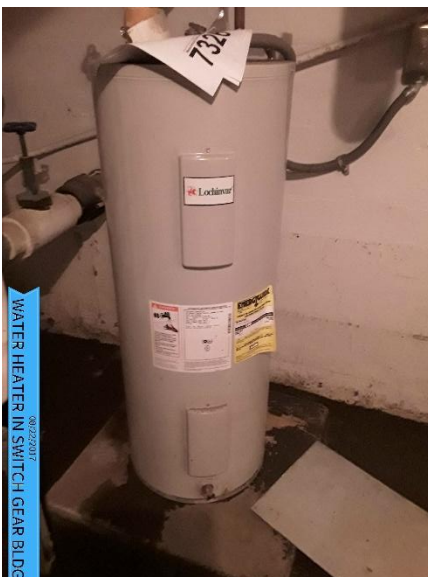
An electric storage type water heater provides domestic hot water for the building. The water heater is located in the Basement of the facility. This unit is approaching the end of its service life expectancy.

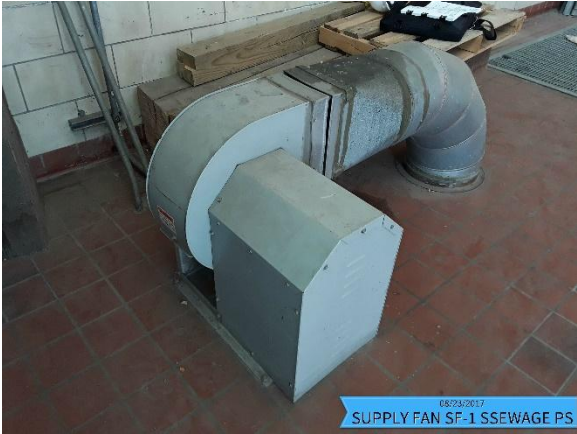
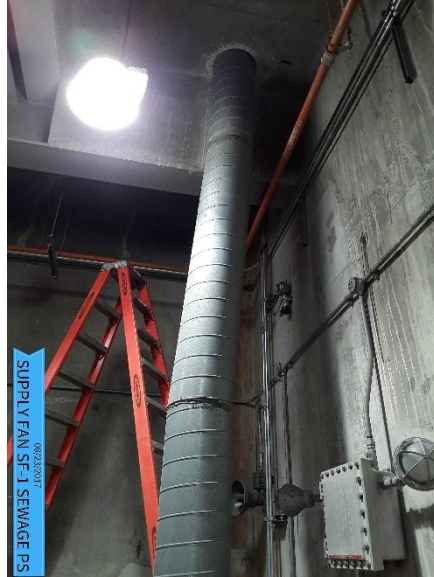
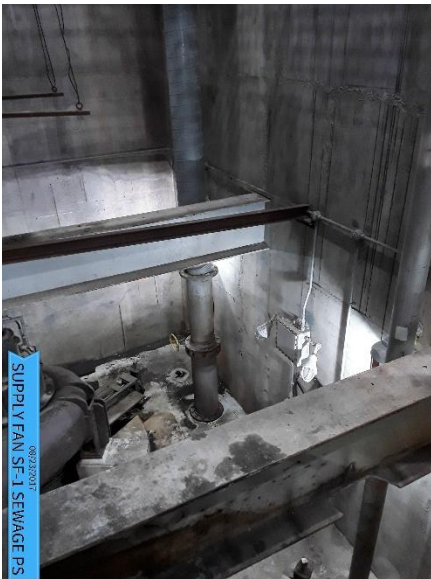
The Wet Well is ventilated intermittently by a utility type centrifugal fan located in the Motor Room. Supply air is distributed down to the Wet Well via ductwork that travels through the lower levels of the Dry Well. The supply

ductwork is approaching its service life expectancy. This fan is operated by a manual switch and interlocked with the ducted rooftop exhaust fans. This unit has exceeded its service life expectancy.

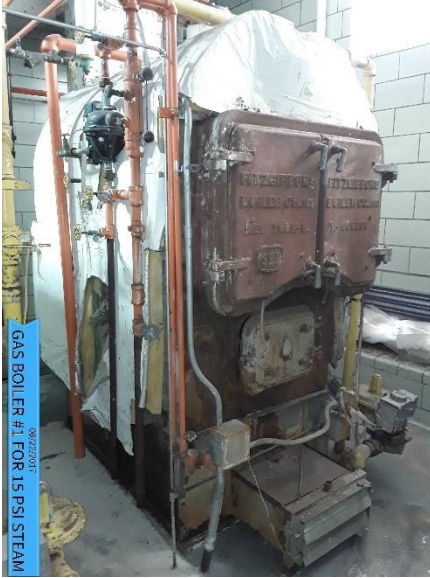
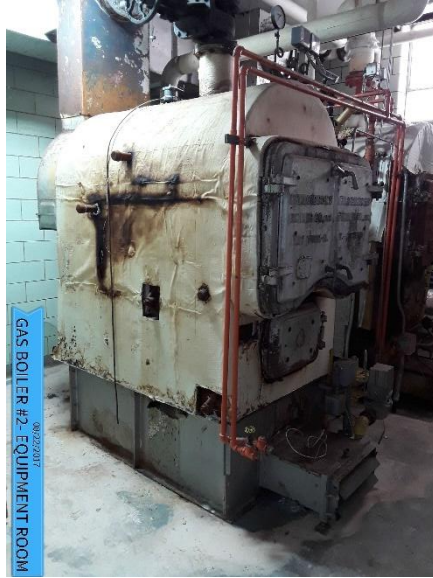
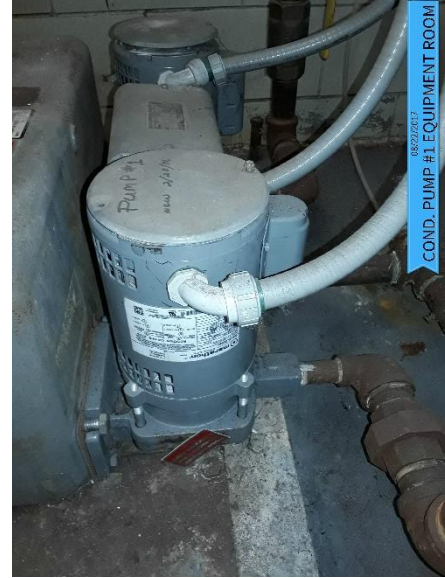
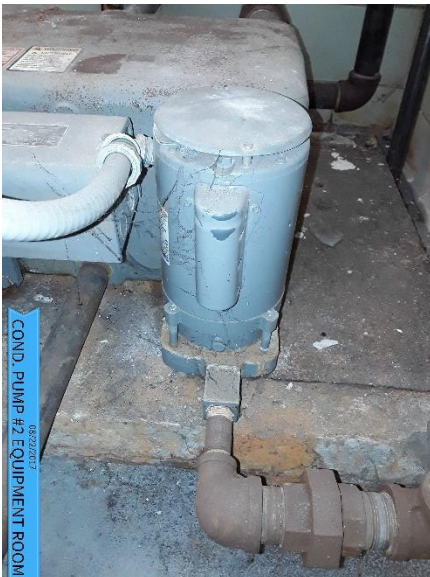
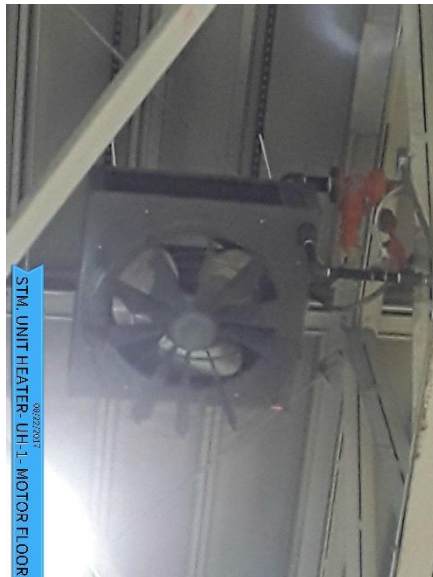
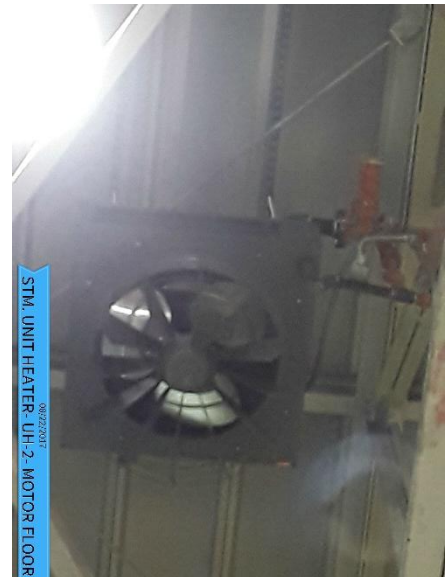
The Storm Water Pump Station is provided with heat from a low-pressure steam system. Steam is distributed via piping to unit heaters located in and around the Motor Room area. These unit heaters are controlled by wall mounted thermostats. Condensate is returned to the boilers via a condensate return system. Two boilers located in the Boiler Room appear to be original to when the building was constructed in 1955. They are non-operational, very corroded, and have exceeded their service life expectancy. The condensate return system has exceeded its service life expectancy. Some of the steam unit heaters have been replaced but still have exceeded their service life expectancy. A total of three unit heaters appear original to when the building was constructed. These unit heaters have exceeded their service life expectancy as well.

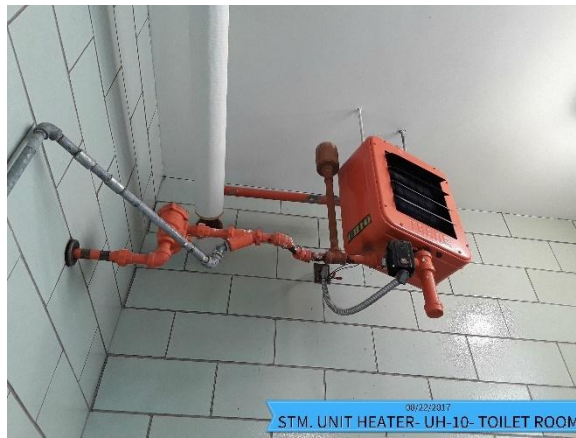
STM. UNIT HEATER- UH-10- TOILET ROOM
08/22/2017

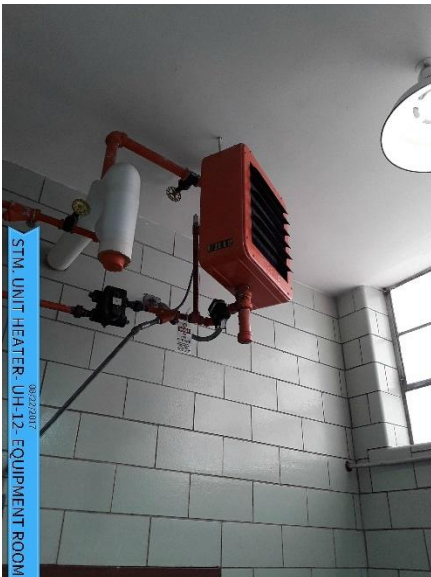
STM. UNIT HEATER- UH-12- EQUIPMENT ROOM
08/22/2017

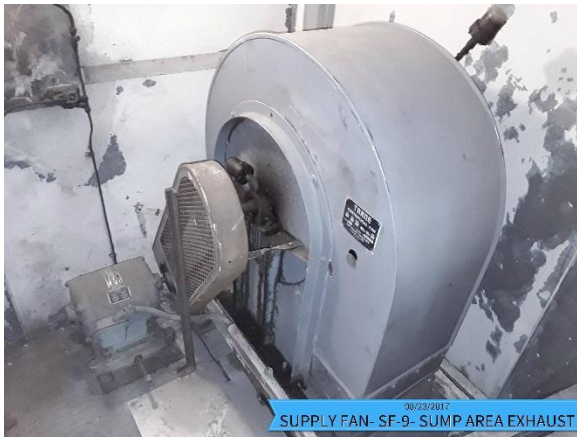
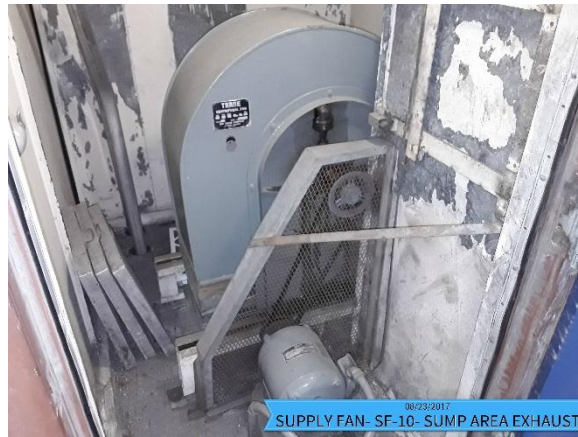
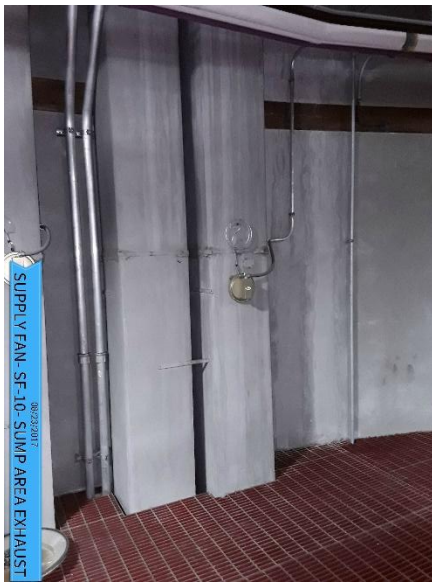
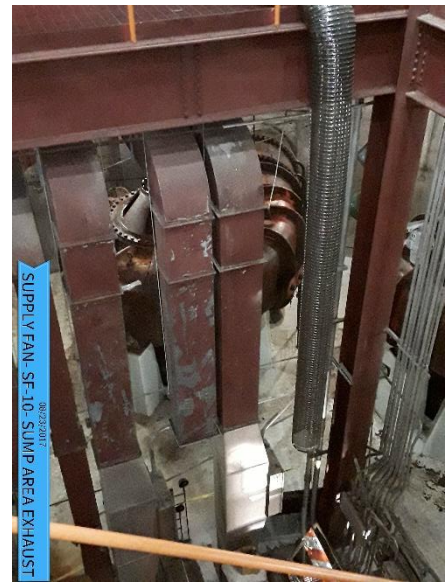
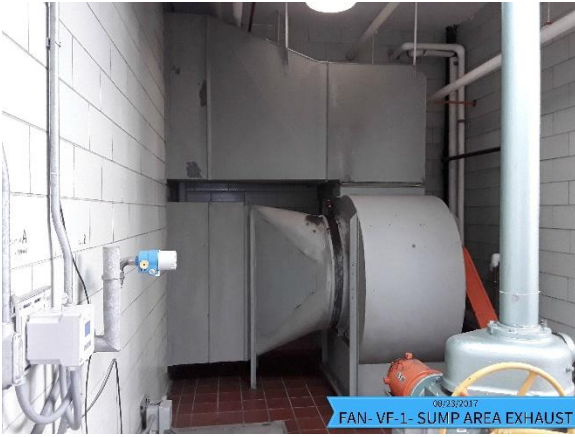
The ventilation system for the Motor Room and the lower levels of the Dry Well down to the Pump Room is provided by two utility type centrifugal fans and one large utility type centrifugal exhaust fan. These fans are interlocked and run on a continuous basis. The two supply fans are each located in small fan rooms where outside air through a wall mounted intake louver is ducted down into the Rooms. From the Fan Rooms, the supply air is ducted down through the Dry Well to the lower levels terminating at the lower Pump Room. The supply air is tempered via electric duct heaters located in the supply ductwork. The exhaust air is ducted up through the Dry Well to the exhaust fan located in the Machine Room area where it is then ducted to a wall mounted exhaust louver and discharged from the building. These fans appear to be original to when the building was constructed in 1955. These fans have exceeded their service life expectancy. Both the supply and exhaust ductwork have reached their service life expectancy.

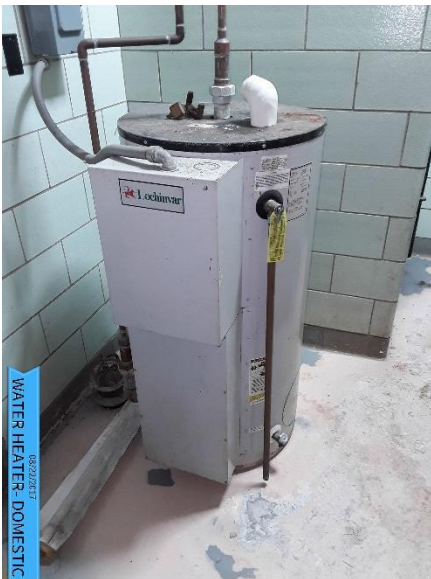
An electric storage type water heater provides domestic hot water for the building. The water heater is located in the Boiler Room of the facility. This unit has exceeded the end of its service life expectancy.

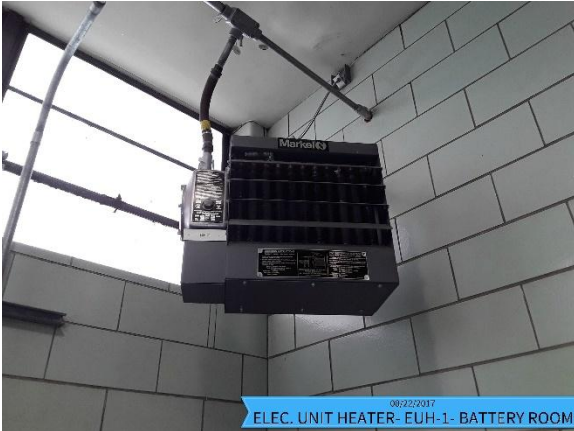
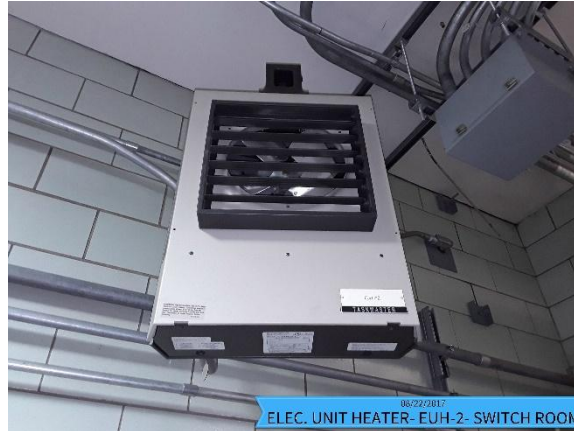
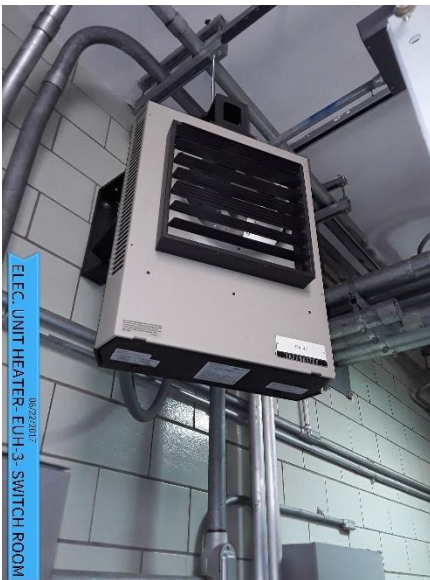
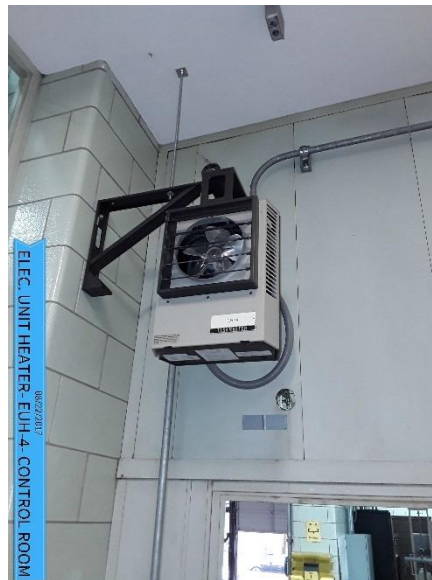
The Control and Switchgear Rooms are heated by wall mounted electric unit heaters, each controlled by wall mounted thermostats. The Battery Room is heated by an explosion proof wall mounted electric unit heater controlled by a wall mounted explosion proof thermostat. The units appear in good condition and are about halfway through their service life expectancy.

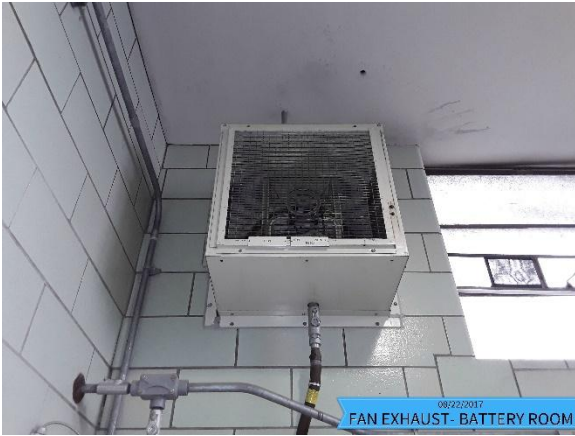
The Battery Room is ventilated by a wall mounted intake louver and wall mounted propeller type exhaust fan. Motors for these units are explosion proof. The fan is operated by an HOA switch and controlled by a 24-hour programmable timer in the Auto mode. The units appear in good condition and are about halfway through their service life expectancy.

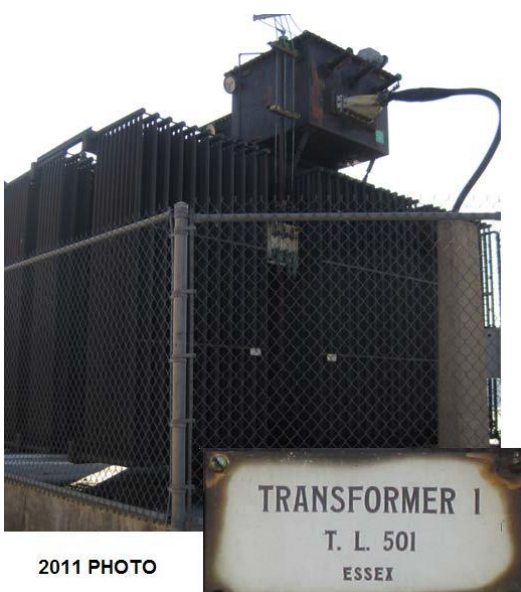
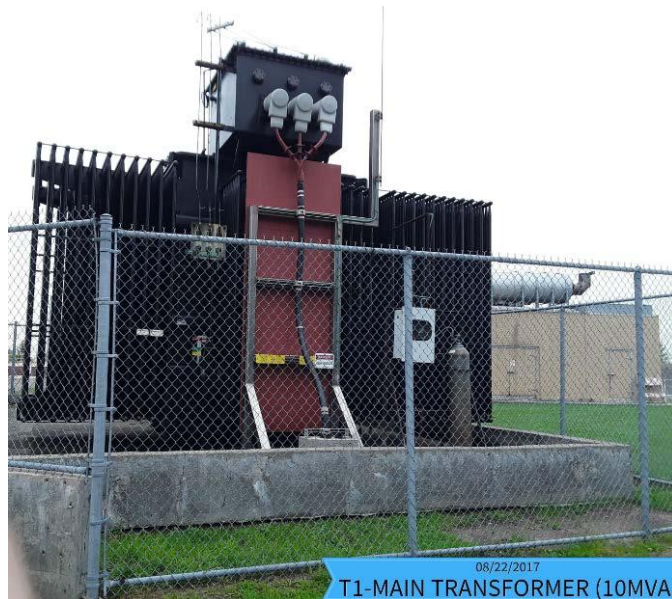
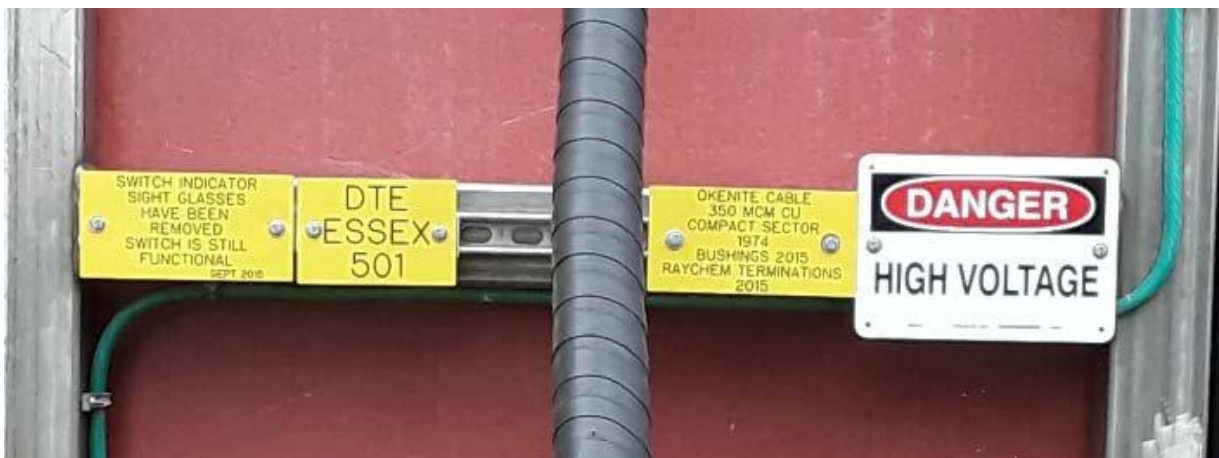
Service transformers T1 and T2 were both originally manufactured by Westinghouse and installed when the pump station was constructed. The transformers have operated well beyond rated and expected life. Transformer T1 appears to have been refurbished in the last 8 years. Typical refurbishing services add another 10 to 20 years to the transformer life. The primary bushings recently failed on transformer T1 and have been replaced. The primary no-load switch on transformer T1 has non-functional indication on the position of the switch. There is a lack of transformer fault and overcurrent protection on the primary side of each transformer.

The transformers should be replaced to allow for another 40 to 50 years of reliable operation. Replacement should include installation of primary protection for the transformer. This should consist of a 27 kV or 35 kV rated vacuum circuit breaker in an outdoor-rated enclosure with programmable protective relaying specific to transformer protection. Protective relaying should isolate the transformer in the event of a transformer internal fault or utility power problem (ANSI 87 differential protection, ANSI 50 instantaneous fault protection, and ANSI 27 undervoltage protection, at a minimum).

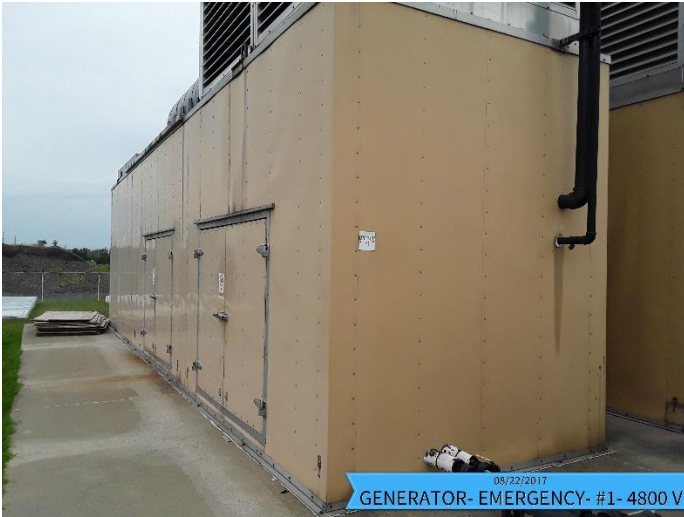
4,800 Volt Generator Units

This pump station has a total of four diesel-driven generator units which were installed in 1999. The rated lifespan of these units is between 10,000 to 20,000 hours of operation. These units are only operated in the event of a loss of utility power or when exercised. The total usage on each engine-generator is under 2,000 hours over the last 17 years. With regular exercising, maintenance, and occasional repair, these units should provide another 40 years of operation.

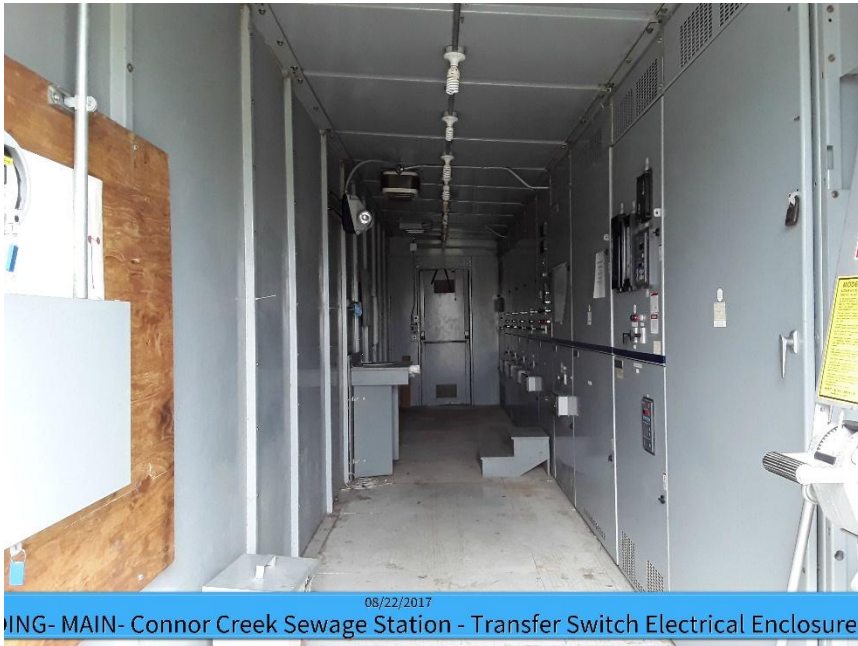
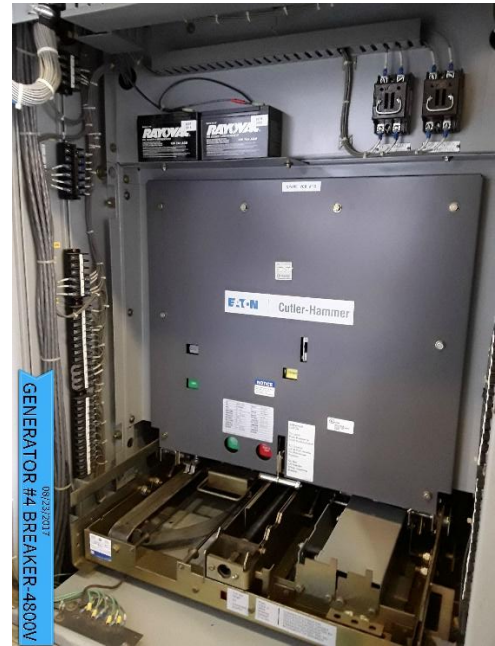
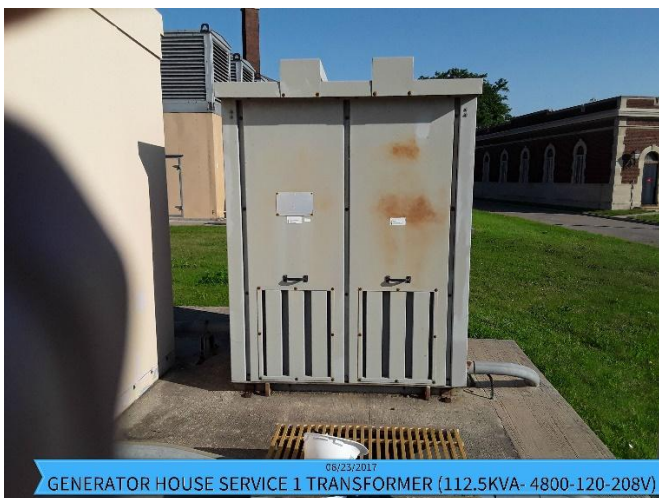
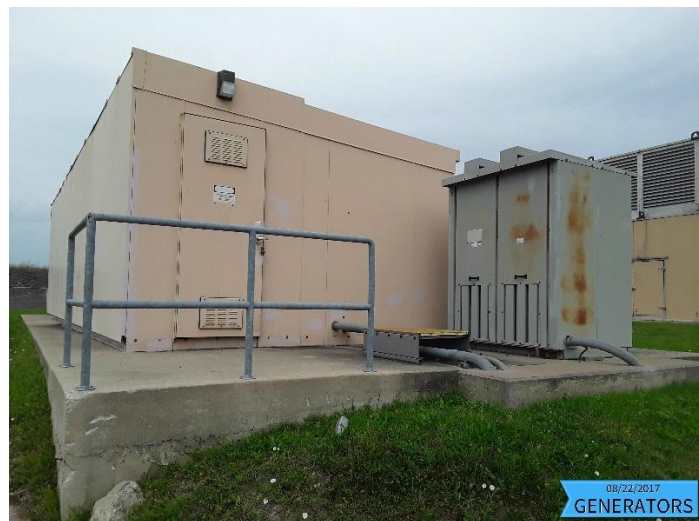
4,800 Volt Generator Switchgear

The 4.8 kV generator switchgear was also installed in 1999 and consists of vacuum circuit breakers. The electrical switchgear is housed in an outdoor walk-in style enclosure. The switchgear has been well maintained and appears in good condition. This switchgear is expected to provide another 40 years of operation. The batteries are located in the first compartment and should be replaced as part of a regular maintenance schedule. Generator switchgear house transformer No. 1 is located outdoors. The equipment is in good condition but the enclosure has some surface corrosion. The corrosion can be controlled by applying a primer and paint manufactured specifically for rusting metal.

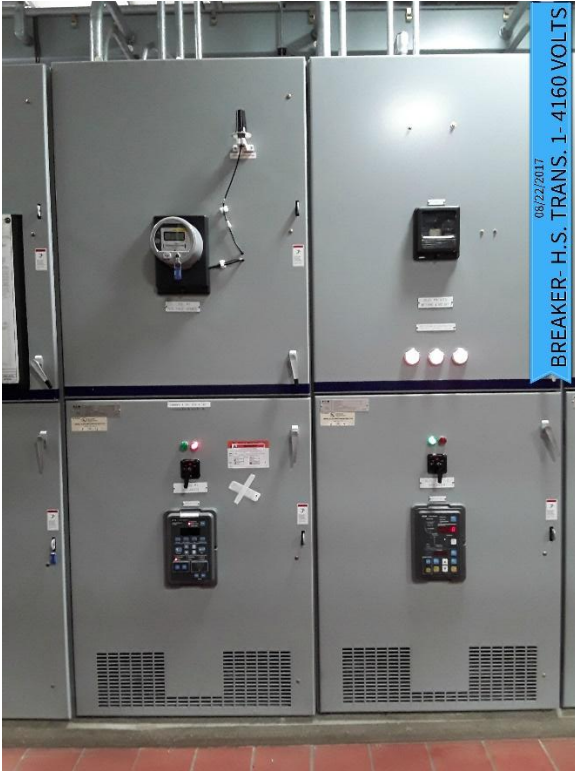
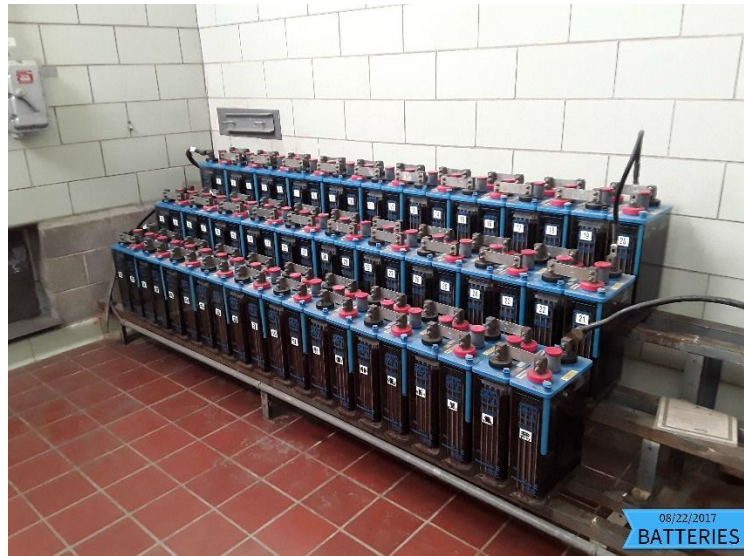
4,800 Volt Main Switchgear

The 4.8 kV main switchgear is located in the switchgear building and was installed in 2003. The switchgear consists of vacuum circuit breakers. The switchgear has been well maintained and appears in good condition. This switchgear is expected to provide another 40 years of operation. The batteries are located in a separate battery room and should be replaced as part of a regular maintenance schedule.

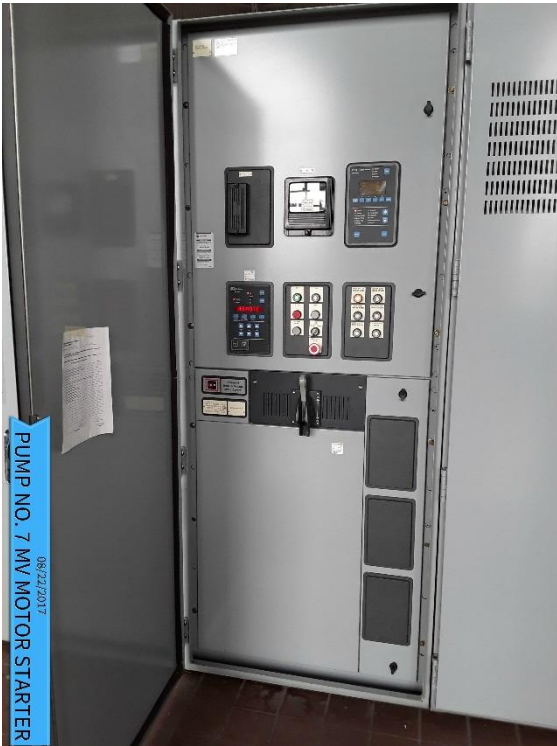
Medium Voltage Motor Starters

The medium voltage motor starters are fused starters with vacuum contactors. All eight motor starters were replaced in 2003 and are in good condition. The motor starters are expected to provide another 40 years of operation.

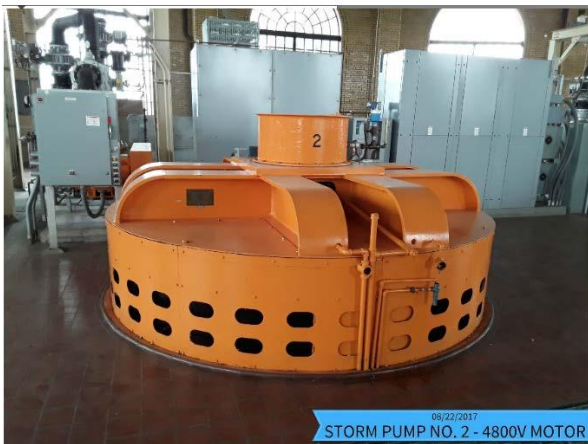
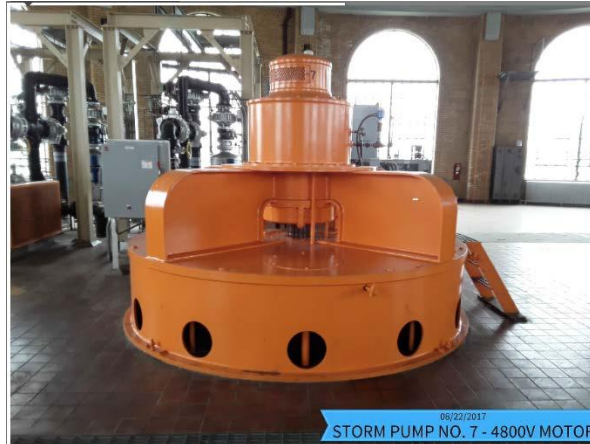
Storm Water Pump Motors

The station has six 2,300 HP and two 2,250 HP storm water pump motors. These medium voltage motors are synchronous, 200 rpm, 36-pole motors. The storm water pump motors are original as installed. It is understood that the storm water pumps/motors 1, 2, 3, and 4 were installed when the station was constructed; storm water pumps/motors 5 and 6 were installed in the 1930s; and storm water pumps/motors 7 and 8 were installed in the 1940s. While the motors are operating sufficiently, they are beyond the expected service life. New motors should be considered, especially if new pumps are provided with the new project.

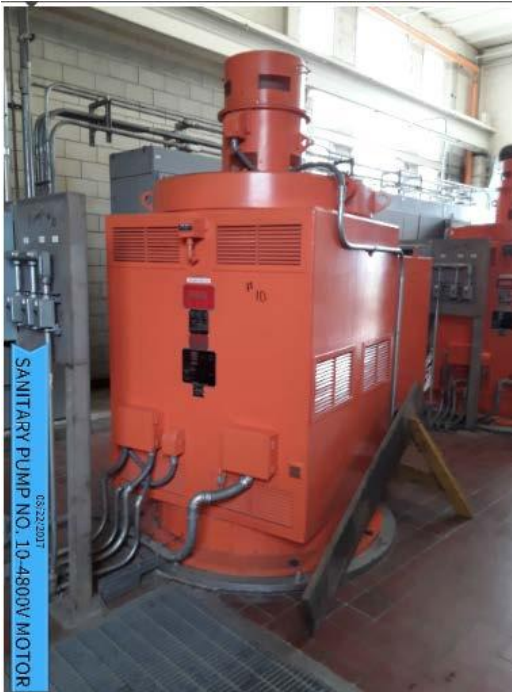
Sanitary Pump Motors

The sanitary station has four medium voltage motors for sanitary pumps (Pumps No. 9, 10, 11, and 12). The motor horsepower are 500 HP, 350 HP, 500 HP, and 200 HP respectively. The motor for Pump No. 9 had been removed for repair at the time of the field visit in August of 2017. The motors for pumps 10, 11, and 12 are 16-pole (450 rpm), 18-pole (400 rpm), and 14-pole (514 rpm) respectively. The existing motors are at the end of their expected service life. New motors should be considered, especially if new pumps are provided with the new project.

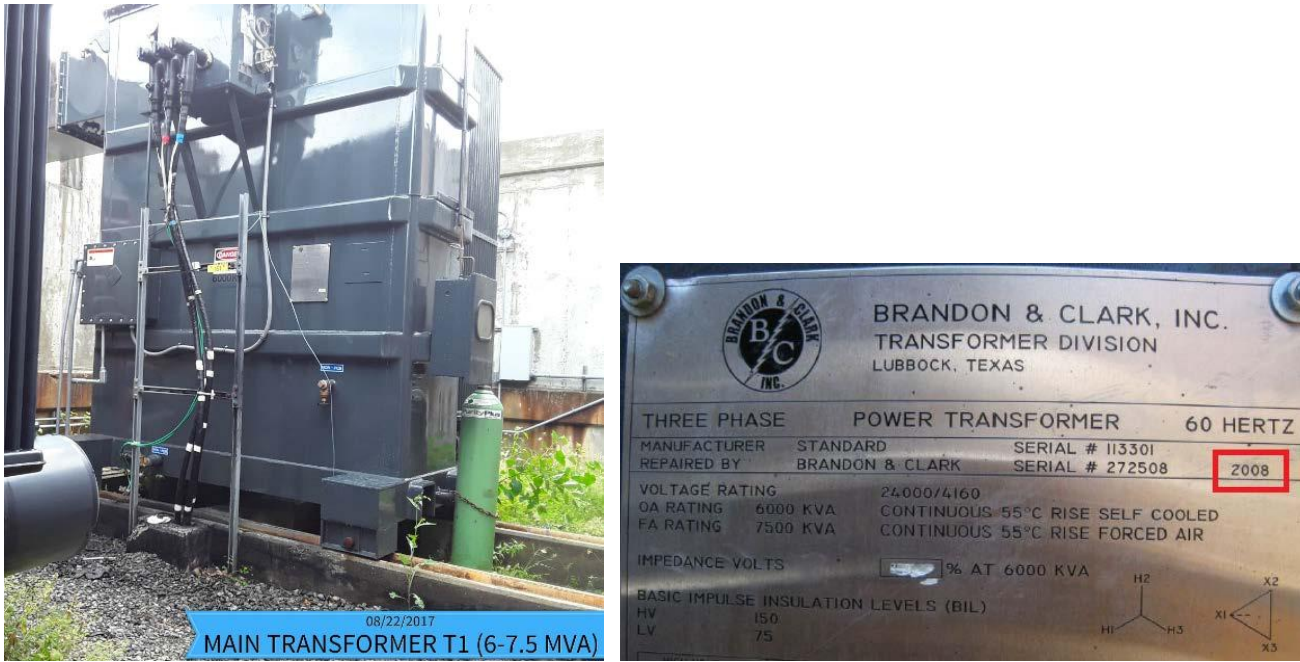
Service transformer T1 was originally manufactured by Standard Transformer and installed when the pump station was constructed in 1955. The transformer reached the end of its typical lifespan about 15 years ago. The transformer was refurbished in 2008 by Brandon and Clark Inc. Typical refurbishing services add another 10 to 20 years to the transformer life. The transformer should be replaced within the next decade to allow for another 40 to 50 years of reliable operation.

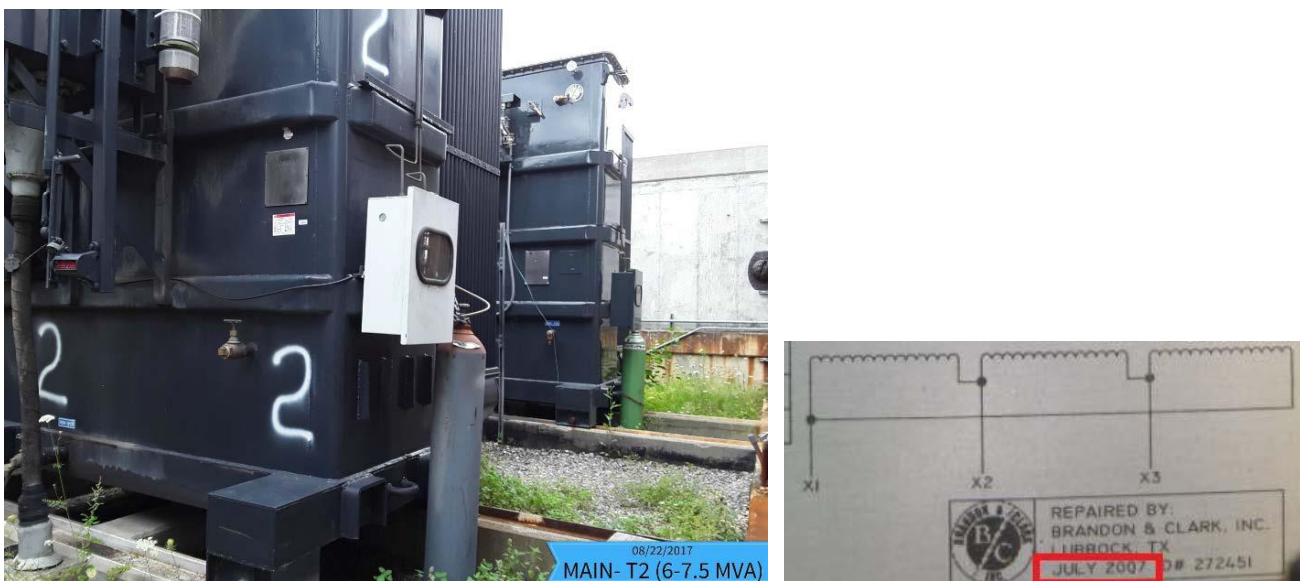
Service transformer T2 was originally manufactured by Standard Transformer and also installed when the pump station was constructed in 1955. The transformer was repaired in 2007 by Brandon and Clark Inc. The transformer should be replaced within the next decade to allow for another 40 to 50 years of reliable operation.

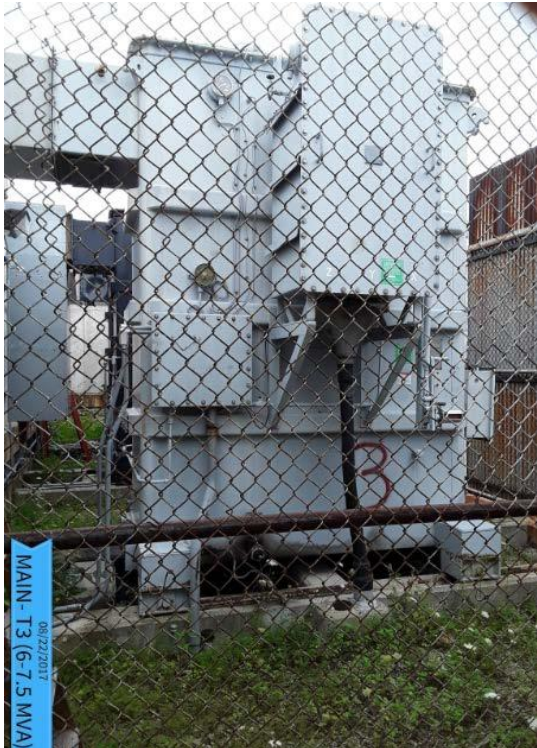
Service transformer T3 was originally manufactured by Standard Transformer and installed when the pump station was constructed in 1955. The transformer was rewound and rebuilt by Westinghouse Canada Inc in

1998. The refurbished transformer is approaching the rated 20 year life for a refurbished transformer and should be replaced soon with a new transformer.

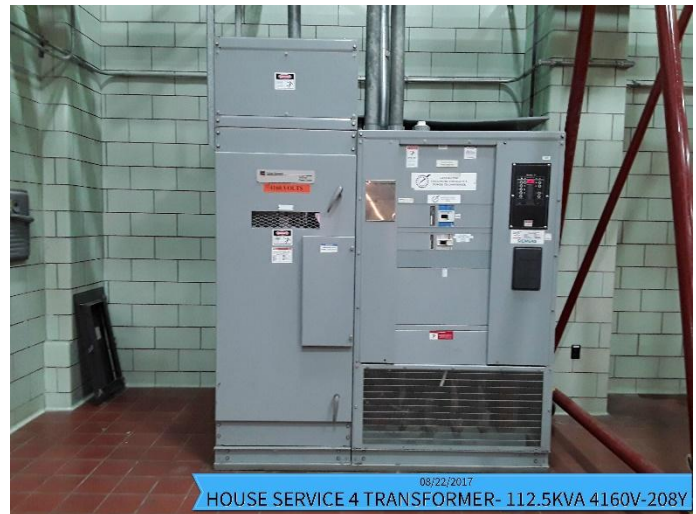
4,160 Volt Generator Switchgear

The 4.16 kV generator switchgear was also installed in 1999 and consists of vacuum circuit breakers. The electrical switchgear is housed in an outdoor walk-in style enclosure. The switchgear has been well maintained and appears in good condition. This switchgear is expected to provide another 40 years of operation. The batteries are located in the first compartment and should be replaced as part of a regular maintenance schedule. Generator switchgear house transformer No. 4 is located indoors and is in good condition.

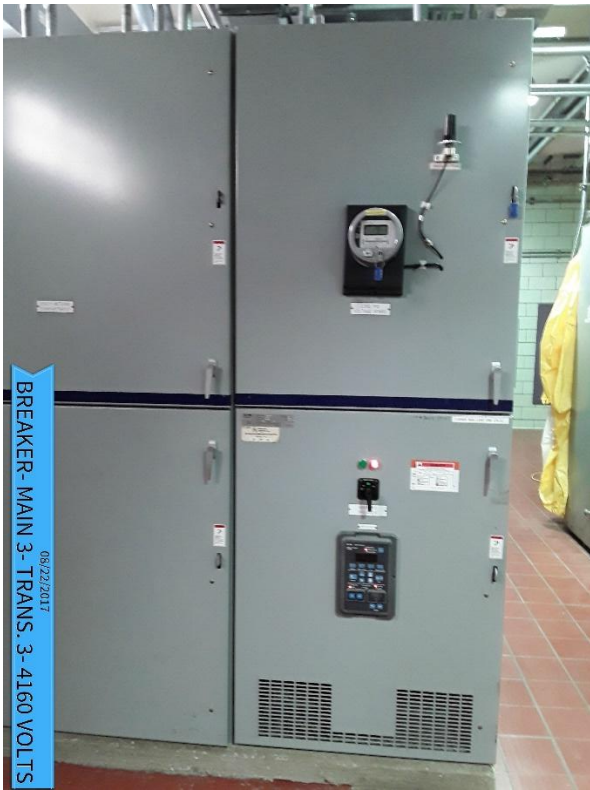
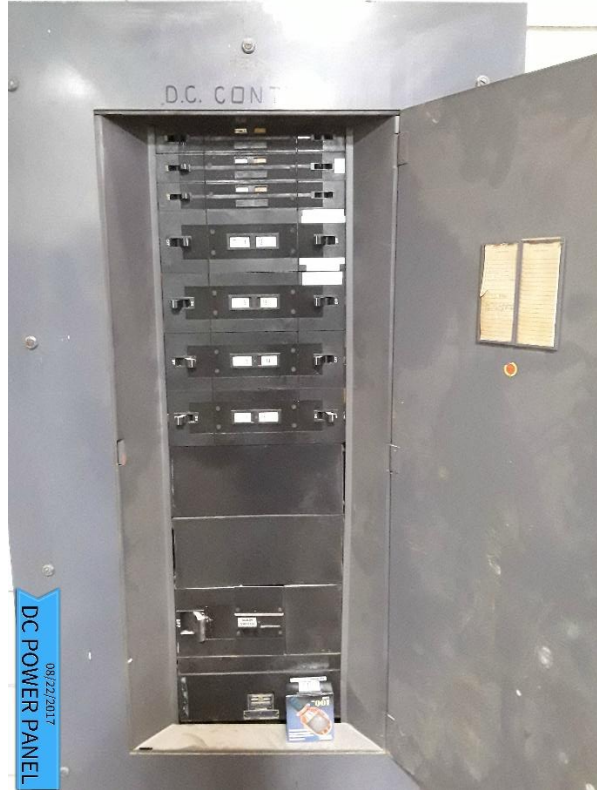
4,160 Volt Main Switchgear

The 4.16 kV main switchgear was installed in 2007 and consists of vacuum circuit breakers. The switchgear has been well maintained and appears in good condition. This switchgear is expected to provide another 40 years of operation. The batteries are located in a separate battery room and should be replaced as part of a regular maintenance schedule. The dc power panel which distributes 125 vdc power appears to be the original panel from 1955. Although currently functional, replacement is recommended due to age and the critical nature associated with the function of the equipment that this panel supports.

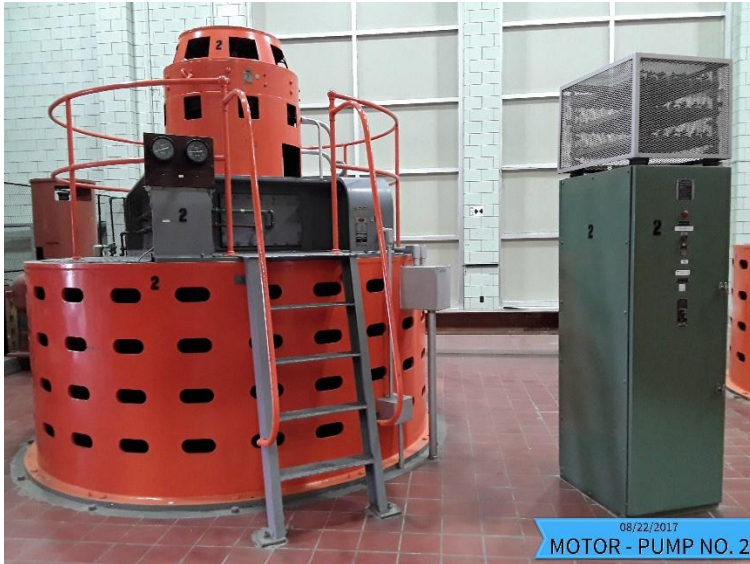
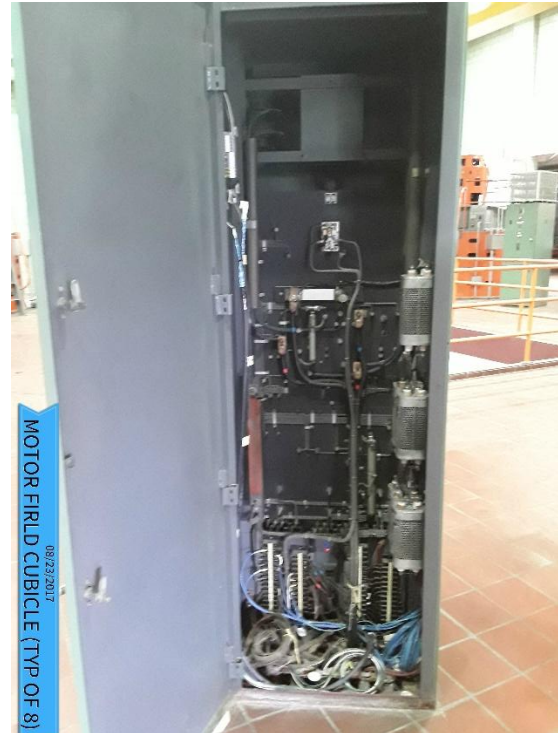
Medium Voltage Motor Starters and Cubicles

The medium voltage motors are currently started by closing the 4.16 kV vacuum circuit breaker and synchronizing with the original 1955 motor field cubicles. The age of these cubicles makes troubleshooting difficult, including repair or replacement of components. Medium voltage motor starters similar to those utilized in the Conner Creek Pump Station, including electronic synchronization, is recommended as a replacement for the current excitation and synchronization control system.

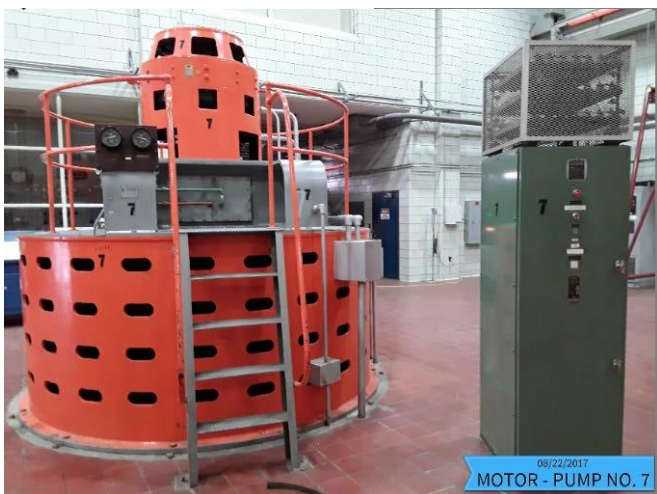
Storm Water Pump Motors

The station has eight 3,000 HP storm water pump motors. These medium voltage motors are synchronous, 225 rpm, 32-pole motors. The storm water pump motors are original as installed during the original pump station construction. While the motors are operating sufficiently, they are beyond the expected service life. New motors should be considered, especially if new pumps are provided with the new project.

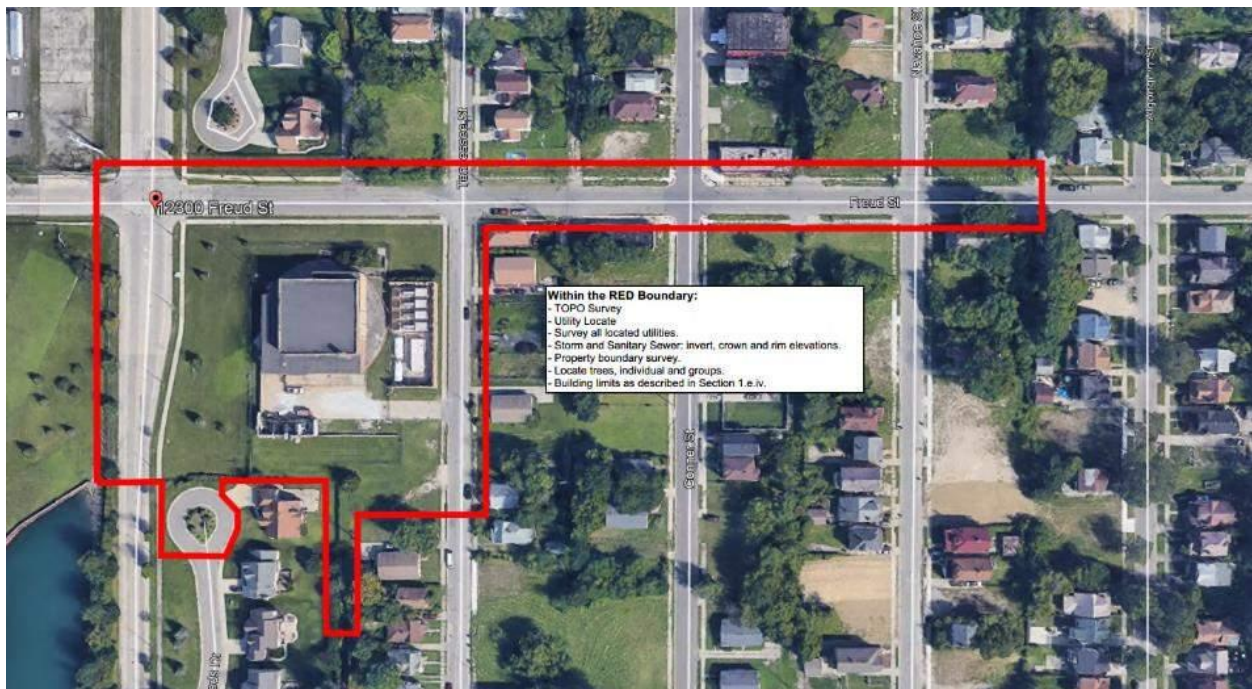
Figure 1: Survey Area of Interest

- Edges of pavement for all streets and sidewalks within the survey limits.
- Limits of existing channel banks and bottom of channel.
- Location and elevations of onsite benchmarks.
- Property limits including the existing right-of-way.
- Existing easements
- Provide survey data in electronic format including graphical representation of structure information (rim elevation, structure down, inverts, structure dimensions, connected pipe material, connected pipe diameter, and connected pipe direction).
- All elevations were obtained using the North American Vertical Datum of 1988 (NAVD88) coordinate system and then was converted to the City of Detroit vertical datum.

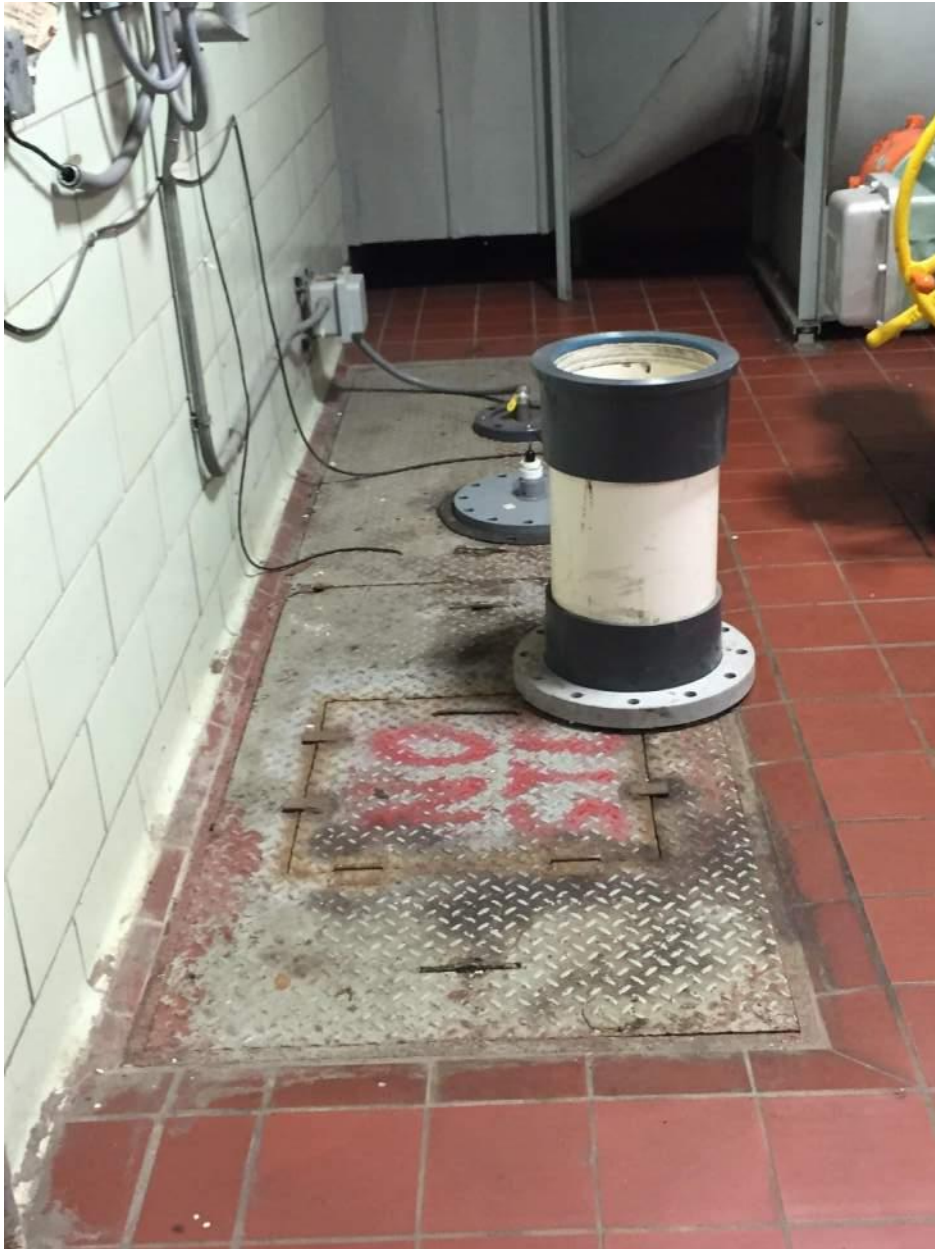
Figure 3: Existing Floor Hatch

Access hatch behind Pump Motor 4

This option utilizes the existing hatch through the motor floor located behind Pump Motor 4. Using this hatch to access the wet well presents room classification concerns for the main motor room. Although original drawings show a ladder from the hatch to the wet well, the condition of the ladder is unknown. The size of the existing hatch (approximately 3-feet by 3-feet) limits equipment from being lowered into the wet well. It would also be very difficult and messy to remove grit and debris from this hatch through the motor room to the exterior of the building.

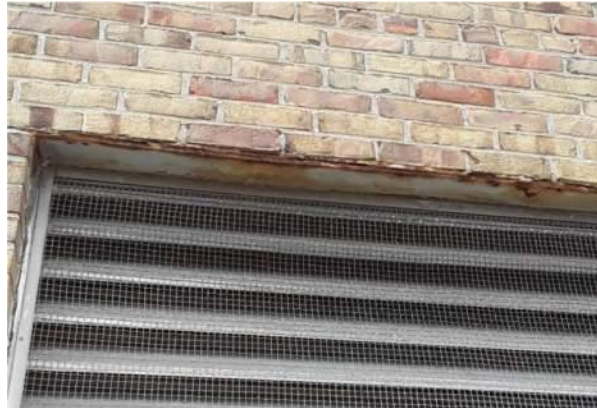
Figure 4: Existing Steel Lintel

Existing steel lintel at Louver opening or window opening show rust and existing coating is peeled off (Figure 4). The steel lintel shall be cleaned (sand blasting) and re-coated per coating spec.

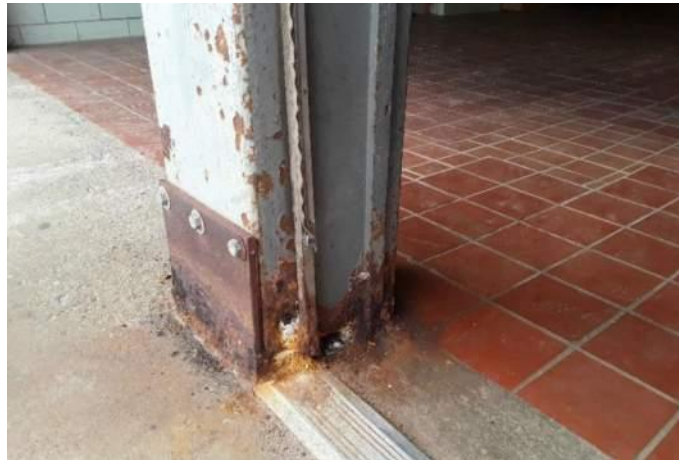
Figure 6: Existing Damaged Column Base

A temporary steel column base repair as shown in Figure 6 was observed at the overhead door adjacent to the South exterior top slab (loading dock). A more permanent repair for this steel column base is needed. The damaged steel column base shall be removed and new steel column shall be added.
