Great Lakes Water Authority

Freud Pump Station Improvement Project

Project Plan - DRAFT

April 2022

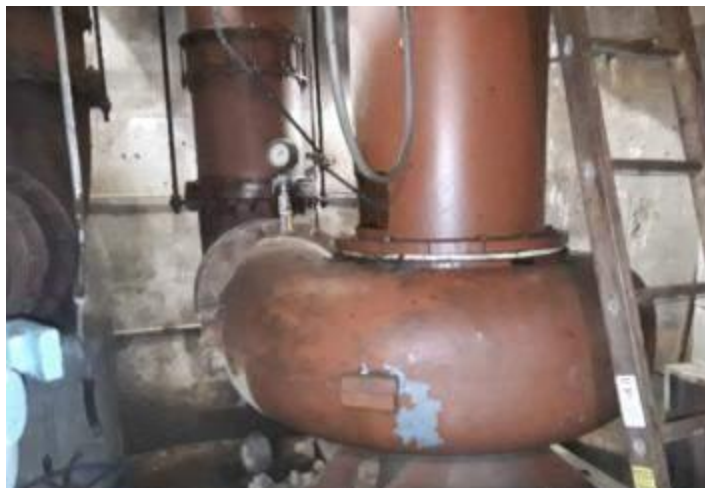
Figure 7: Existing Sanitary Pump

The existing dewatering and sanitary pumps are located at the lowest level in the station. There is minor corrosion at the steel supports. The reinforced concrete floor needs to be checked for condition.

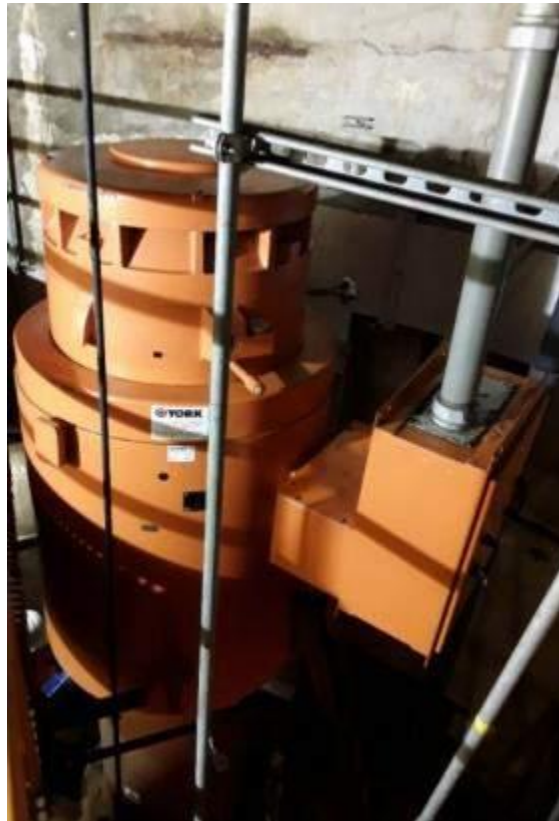
Figure 8: Existing Sanitary Motor

There are two sanitary pumps/motors. New motors shall be considered. The existing motors are close coupled with the pumps. Further field inspection is required.

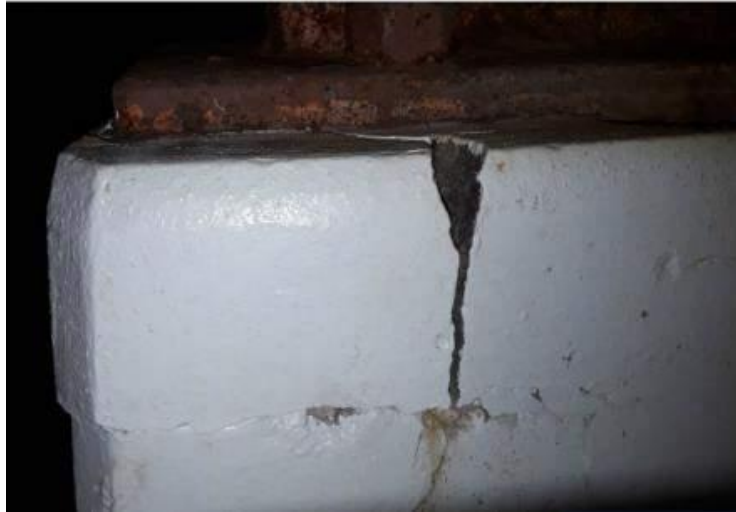
Figure 9: Existing Damaged Concrete Support Pier

The concrete pump support piers are in poor condition (the concrete pump support piers at Pump #5 are deficient). Ninety percent of all concrete pump support piers (6 piers per pump) show signs of concrete cold joints four inches down from the top of the support pier that may have been from original construction. A horizontal hairline crack is also found around all four sides of these concrete pump support piers at this cold joint level. The concrete pump support piers at Pump #5, at least three of them, show signs of anchor bolt concrete breakout cracking. At some pump support piers, the pump support leg steel base plate bears within one-half inch of the concrete support pier edge and the anchor bolt edge distances are four and one-half inches or less. The design of these concrete pump support piers needs to be revisited based on required support of pump loads (vertical, shear and torsion load along with proper anchor edge distances and embedment should be considered). Repairs will be needed to these pump bases. The existing concrete pump support piers shall be removed and new concrete pump support piers shall be provided with epoxy base grout. Existing plan of storm pump layout (ES-01) is attached in Appendix A.

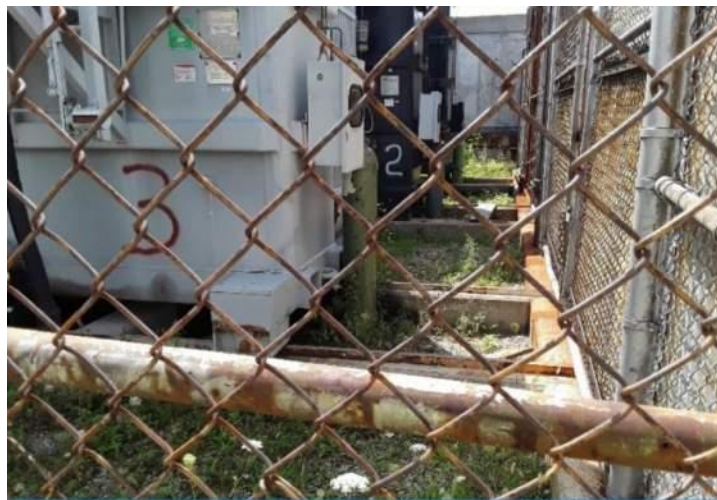
Figure 11: Existing Transformer Foundation

The transformer containment pad consists of a concrete grade beams with embedded steel channels that the transformers bear on and a perimeter concrete curb with chain link fencing on two sides (backside of the South Site concrete retaining wall on other two sides). This was originally constructed along with the Pump Station in 1955. The existing concrete support grade beams under the transformer support legs appear in good shape with only minor cracks and spalls and the embedded steel channels in the grade beams have surface corrosion. The spalling concrete shall be removed and the area to be patched with concrete mortar per concrete repair spec. The concrete cracks shall be repaired with epoxy injection grout. The corrosion on the existing embedded steel channels shall be cleaned and re-coated per coating spec.

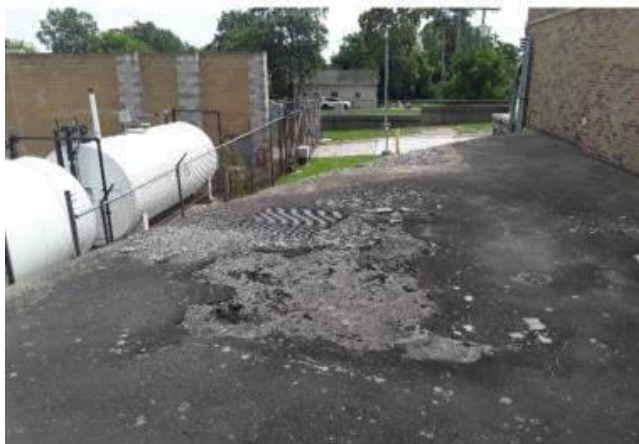
Figure 13: Existing East Exterior Top Slab

The East exterior top slab is an extension of the Pump Station top floor out over the perimeter flume. The Northern portions of the existing top slab are in good condition but the Southern portions are in very poor condition with significant concrete deterioration and spalling. With the current state of the Southern portion of the top slab, rain water is not draining off the slab but collecting and further deteriorating the concrete top slab. Significant concrete deterioration and spalls along with cracks showing signs of efflorescence were observed on the top slab edges at the top of the brick wall. The deteriorating and spalling concrete shall be removed and the area to be patched with concrete mortar per concrete repair spec.

All steel grating pieces on the East exterior top slab (over the flume) are deformed (some bearing bars showing signs of yielding) with cross bars broken and pose a potential safety concern due to loss of live load capacity and from tripping hazard standpoint. No stairs to access this slab exist. The damaged steel grating shall be replaced to new steel grating.

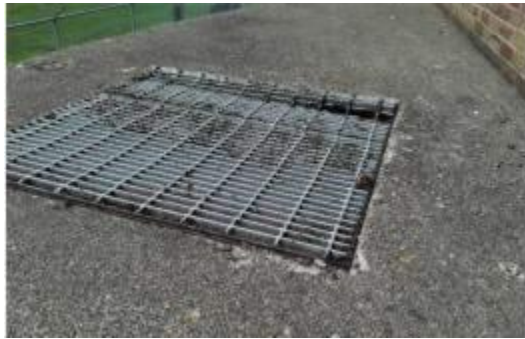
Figure 14: Existing West Exterior Top Slab

The steel grating over the flume is deformed (some bearing bars showing signs of yielding) with cross bars broken and pose a potential safety concern due to loss of live load capacity and from tripping hazard standpoint. The damaged steel grating shall be replaced to new steel grating.

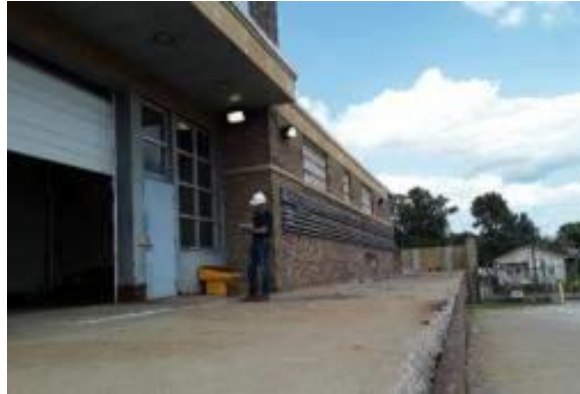
Figure 15: Existing South Exterior Top Slab

The steel grating is deformed (some bearing bars showing signs of yielding) with cross bars broken and pose a potential safety concern due to loss of live load capacity and from tripping hazard standpoint. The damaged steel grating will be replaced with new steel grating.

Temporary wooden stairs with forward-sloping wooden stair treads are currently used as the main access to this South exterior top slab and the pumping station. The existing wooden stair shall be replaced with

permanent aluminum stairs with aluminum handrails as the main access to this South exterior top slab and the pump station. Railing shall be provided along the edge of the top slab and removable side-mounted railing shall be considered in places to allow for better unloading and loading operations.

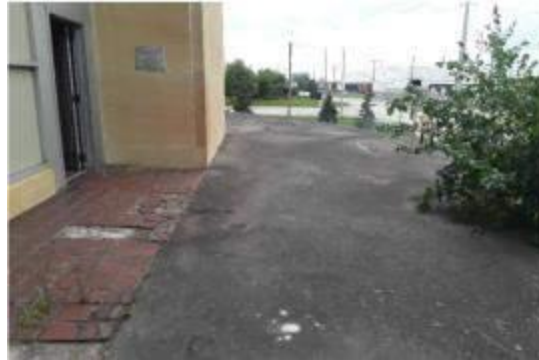
Figure 16: Existing North Exterior Top Slab

Steel stair nosing have surface corrosion and some of the stair treads have warped up (embedment of steel nosing to concrete stair tread may have been compromised) and thus poses a potential safety concern (tripping hazard). The existing stair nosing will be removed and new aluminum stair nosing will be installed.

The steel grating over the flume is deformed (some bearing bars showing signs of yielding) with cross bars broken and pose a potential safety concern due to loss of live load capacity and from tripping hazard standpoint. Handrail along the edges of the top slab should be provided to prevent falls (approximately 10 foot above grade). The damaged steel grating will be replaced with new steel grating. Aluminum Handrail will be provided around the edges of the top slab.

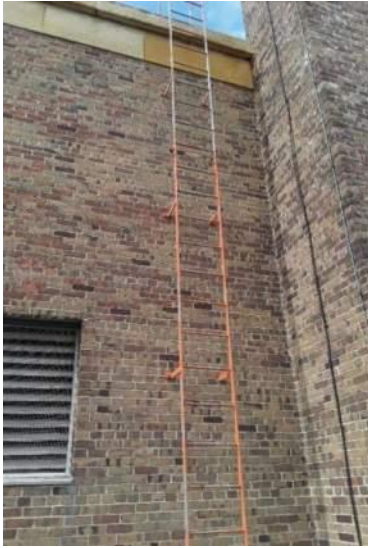
Figure 17: Existing Ladder

- The current roof ladder leading to the upper roof (Figure 17) does not meet code, it will be removed and replaced with a code compliant ladder. The ladder shall include a fall protection system consisting of a vertical rigid track carrier rail securely and permanently attached to ladder, over which travels a sleeve to harness belt can be attached.

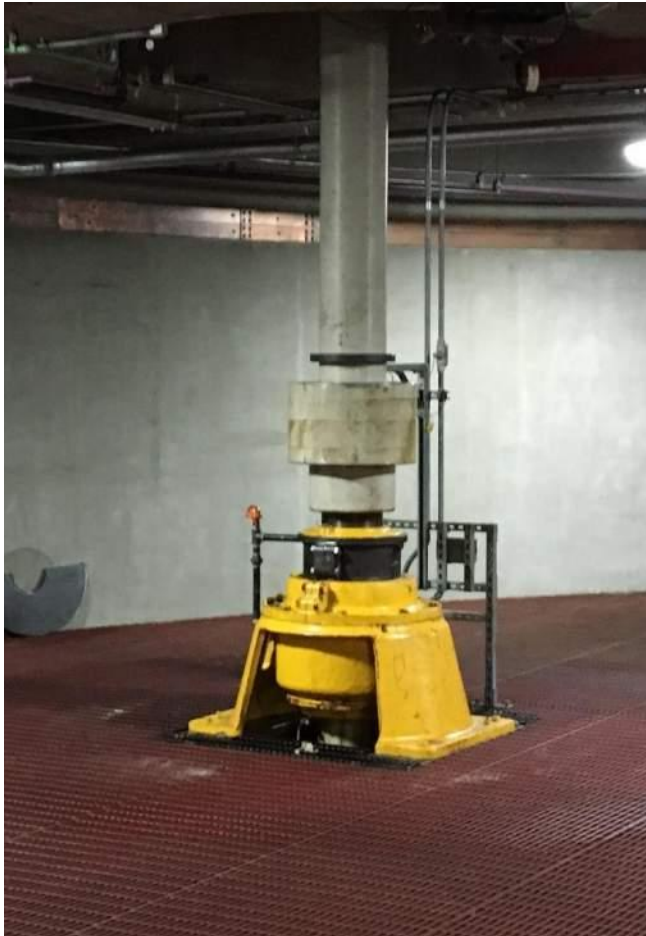
Figure 18: Existing Stormwater Pump Steady Bearing Assembly

In addition to upgrading the rotating assemblies, the existing 13 ½" diameter line shaft and babbitt style sleeve bearings (Figure 18) will be replaced with the following equipment:

The upgraded rotating assembly (and associated accessories), line shaft, steady bearings, and shaft couplings will be replaced based on the current GLWA schedule for stormwater pump upgrades.

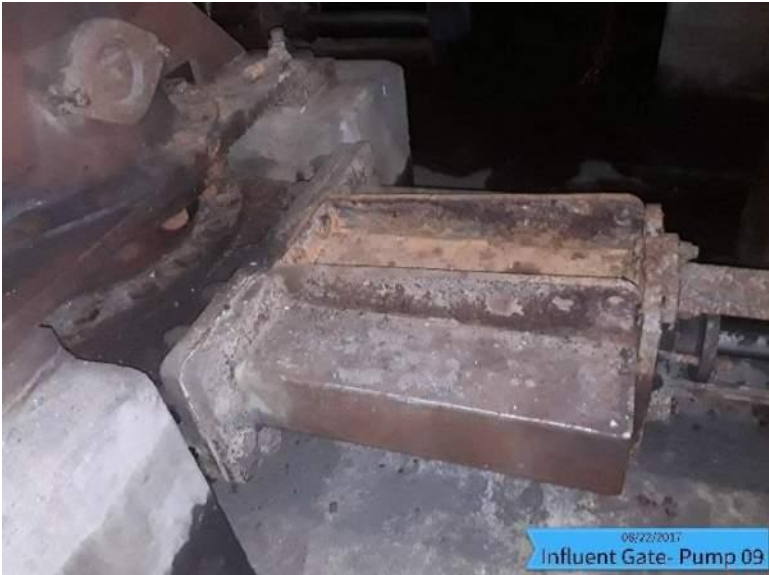
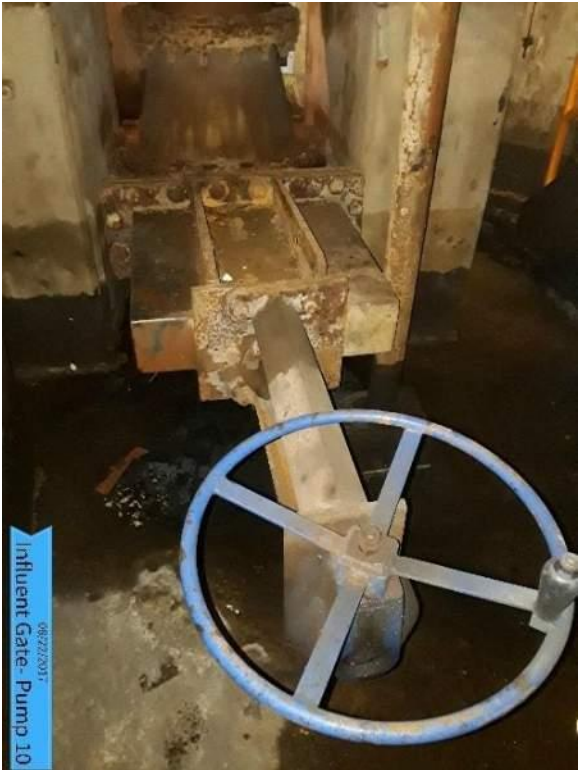
The two existing sanitary pump influent valves (Figures 22 and 23) are located below the existing sanitary pumps and are a knife gate style valve. These have a significant amount of corrosion and one of the operator supports is delaminating due to the corrosion. The electric actuator for gate #10 has been removed and a handwheel has been installed on the gear operator. As mentioned in Section 7.2 (Dewatering Pumps), the existing knife gate valves will be replaced with new plug valves to isolate the pumps and reduce the amount of floor space that is currently being utilized.

Figure 22: Existing Sanitary Pump Influent Gate Valve

Figure 23: Existing Sanitary Pump Influent Gate Valve

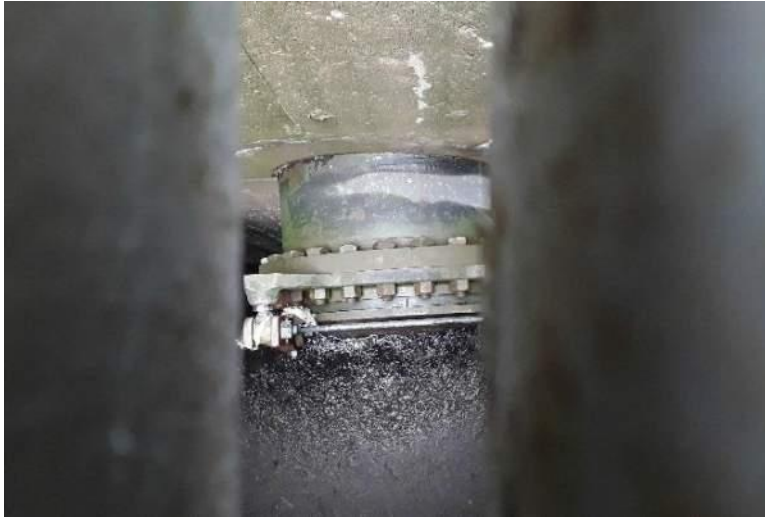
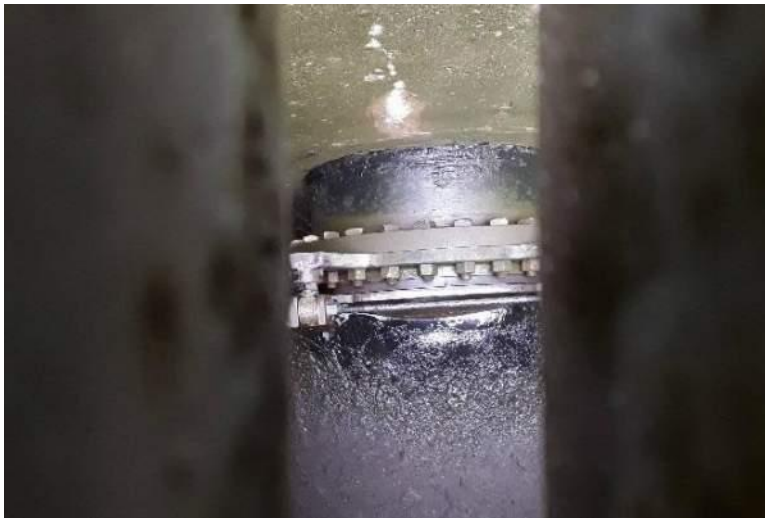
Two flap gates are installed in the discharge channel on the outside of the station (Figures 24 and 25). These are in fair condition with corrosion on both the gates and the hardware.

Figure 24: Existing Pump 9 Flap Gate

Figure 25: Existing Pump 10 Flap Gate

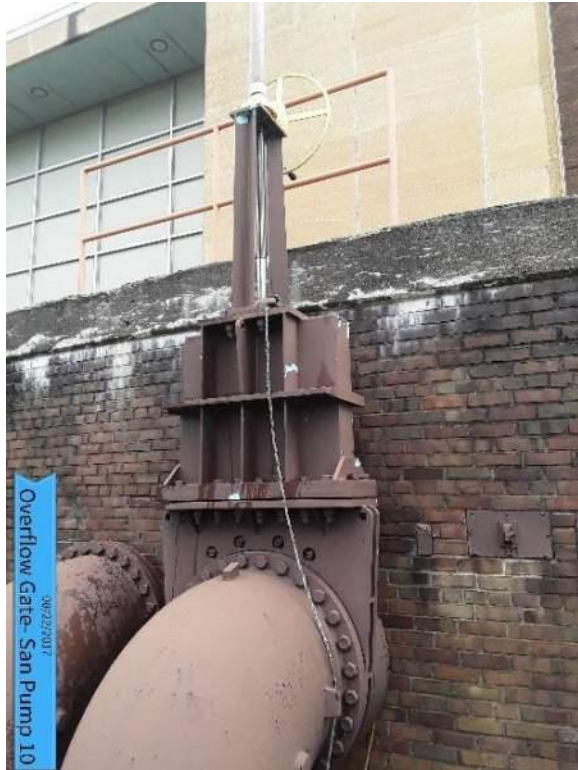
Figure 26: Existing Pump 10 Overflow Gate Valve to the Discharge Channel

The Overflow Gate is located on the discharge for the existing sanitary pump #10 and is an enclosed knife gate type (Figure 26). Corrosion of the valve is minimal, but there is peeling paint exposing what is likely the factory paint underneath. The valve stem and operator are in good condition.

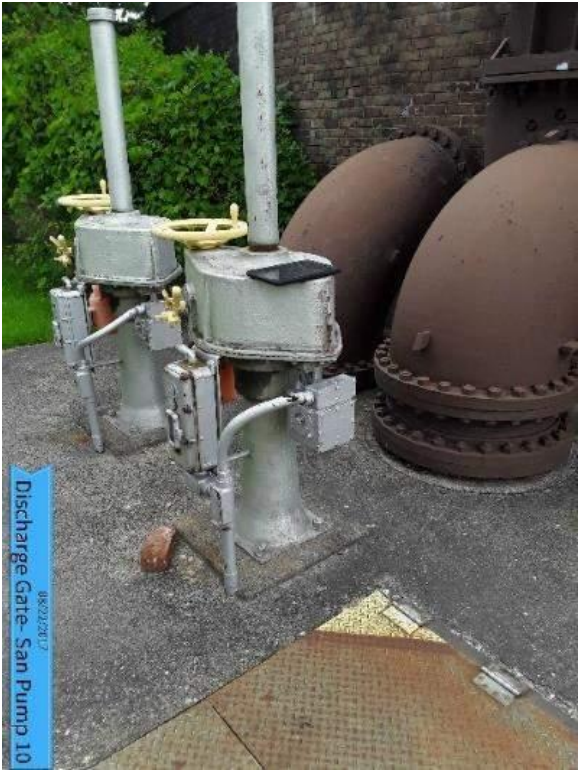
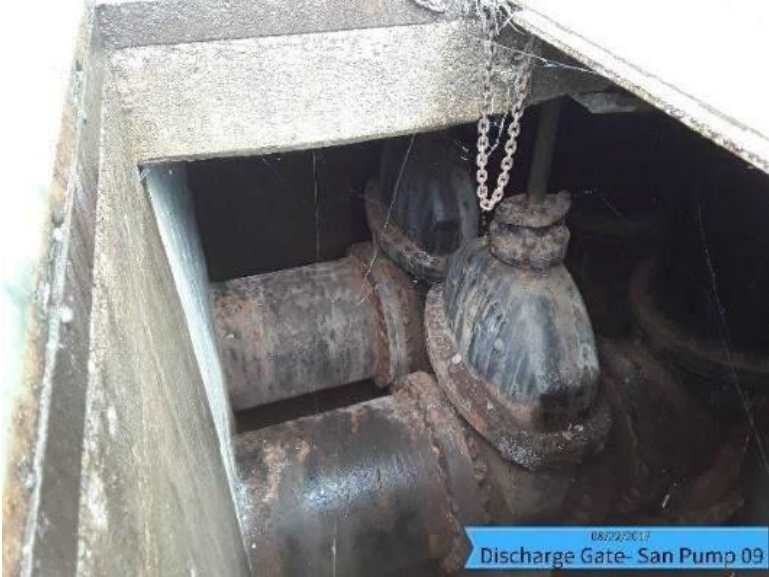
The two Sanitary Discharge Gates (Figures 27 and 28) are gate valves installed in a pit outside the station along the fence. The gate valves and associated piping have significant corrosion due to moisture in the pit. The valve operators and electric actuators are of an older style and have multiple layers of paint that is peeling in some areas. It is not known if these actuators are functional.

Figure 27: Existing Pump 9 and 10 Discharge Gate Valve

Figure 28: Existing Pump 9 and 10 Discharge Gate Valve

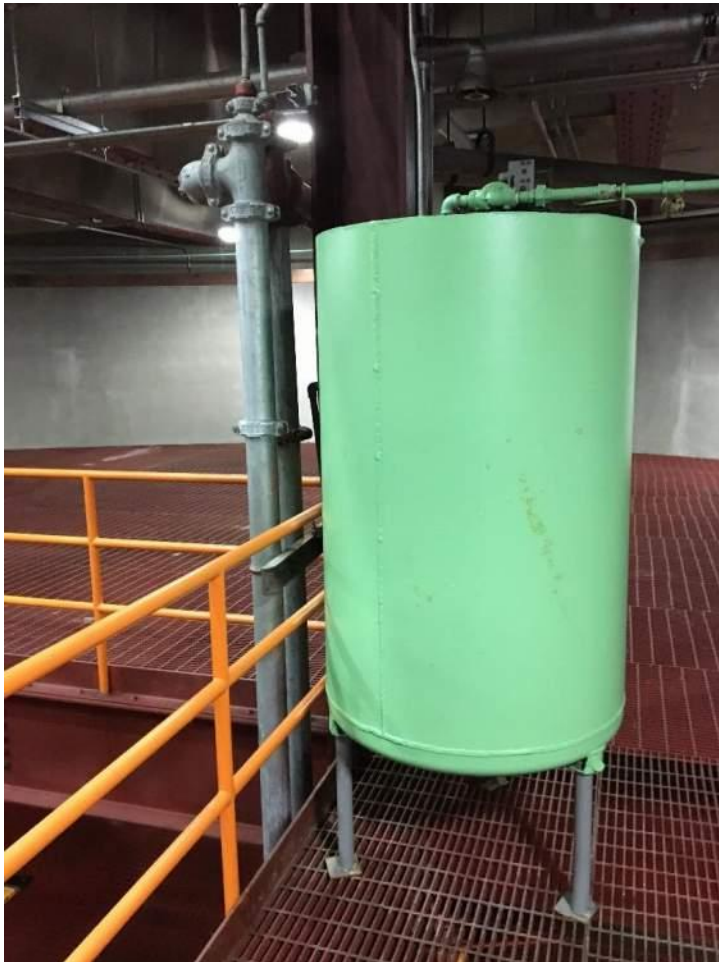
Figure 29: Seal Water System Break Tank

The existing seal water system consists of a break tank and fill valve assembly (Figure 29). The seal water system will be evaluated during the design following the selection of the dewatering pumps, and stormwater pump upgrades. A water demand analysis will be completed, and the seal water system will be upgraded if the system is undersized.
